## Progress with stone consolidants

Developments in stone consolidants show that they have a role as a treatment of last resort, to be used only after other options for slowing the rate of deterioration have been considered.

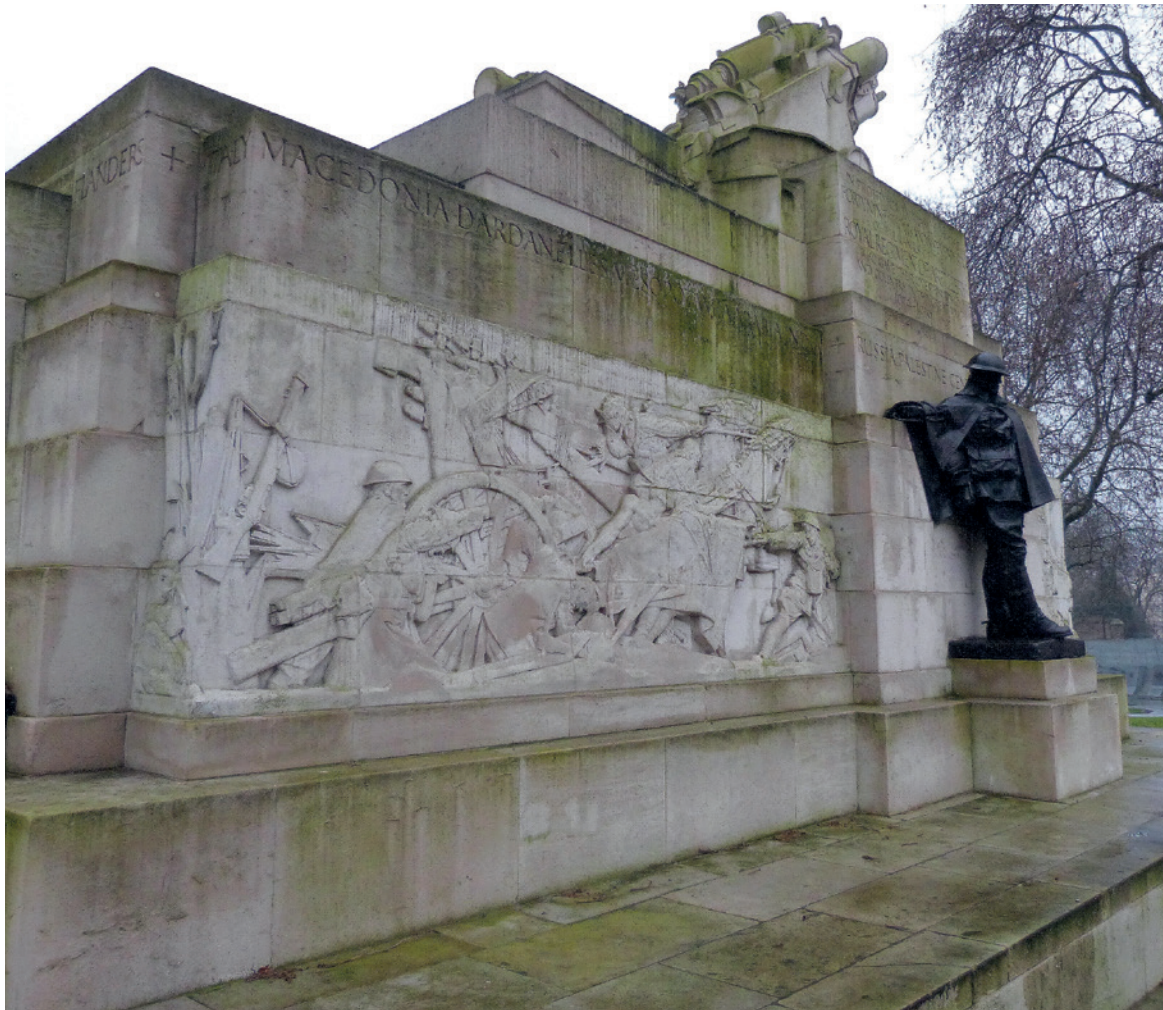
*The Royal Artillery war memorial in London's Hyde Park, showing the carved area treated with Brethane being free of algae*

The magnificent relief carving (by Charles Sargeant Jagger) on the Royal Artillery war memorial at London's Hyde Park Corner was also treated with Brethane. Interestingly, the presence of lead in the treatment has meant that the carvings do not suffer from the accumulations of algae present on the rest of the memorial, but there has been continued loss of detail from the Portland stone and some areas are losing a surface crust 2-3 mm deep. This may be a result of the detachment of the harder consolidated surface.

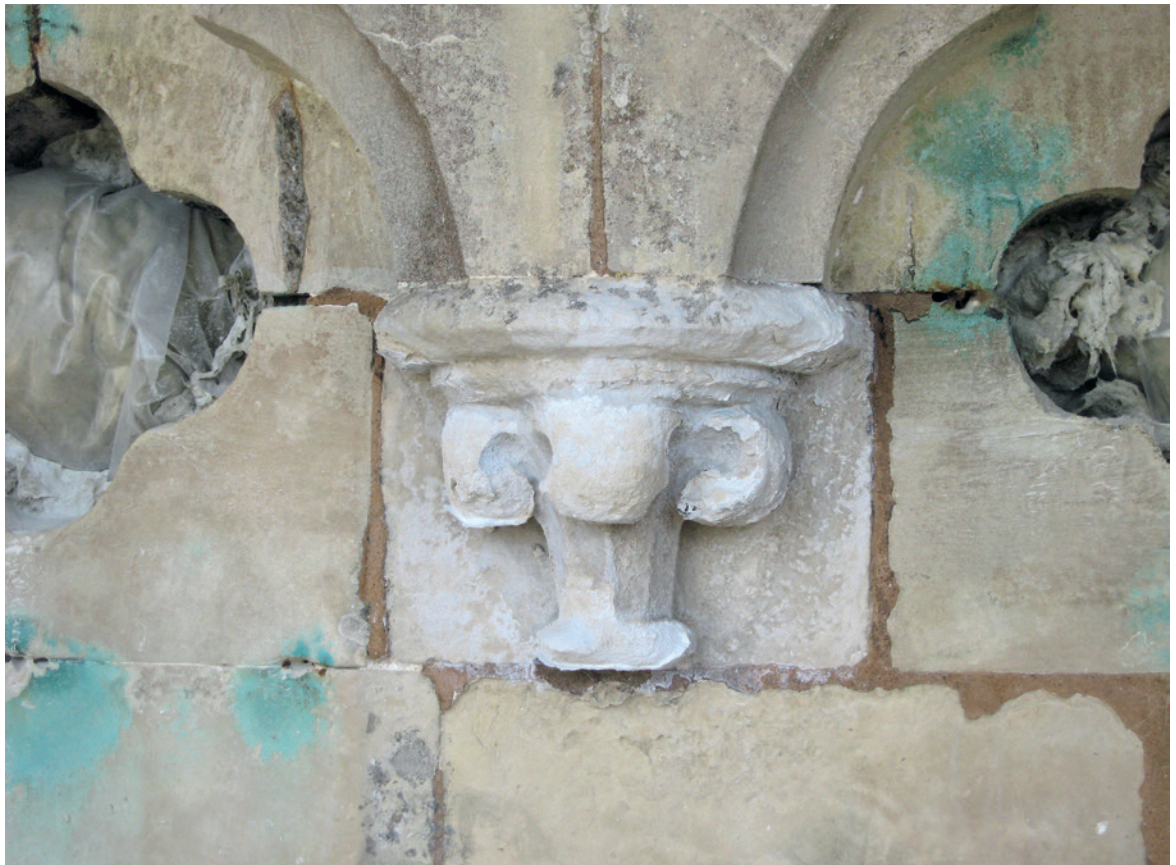
*Nanolime has been used in of trials of consolidation of decayed Chilmark stone corbel at Salisbury Cathedral.*
