RESEARCH NEWS

Dover Castle: the Great Tower project

The survey of the Great Tower

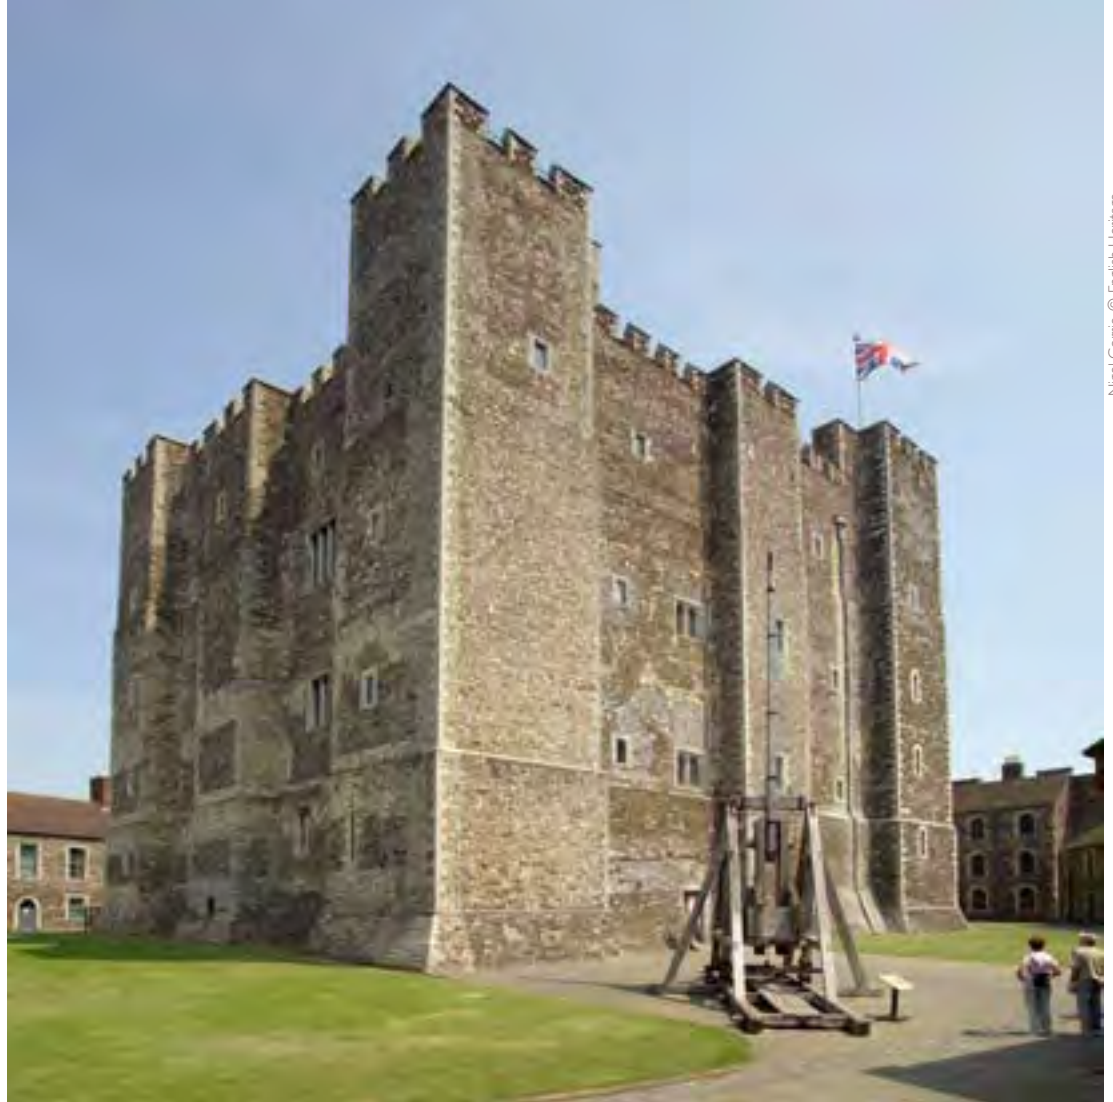
Fig 4: The SW elevation of the Great Tower showing extensive 19th-century re-facing. Though there are clearly two styles at work here, they are likely to date to the same phase of restoration

18th century the Great Tower was converted for use as a barracks and almost all the principal windows were given new Portland stone frames (probably re-used from the now lost 17th-century works). Large areas of face-work and quoins were replaced in Portland stone and a new front wall to the Fore building stairs was erected, along with a new roof. Later in the century, vestiges of the medieval and post-medieval roof structures were lost with the insertion of brick vaults to the second floor. Midway through the 19th century two teams of military engineers appear to have competed to re-clad the SW elevation of the keep (fig 4).

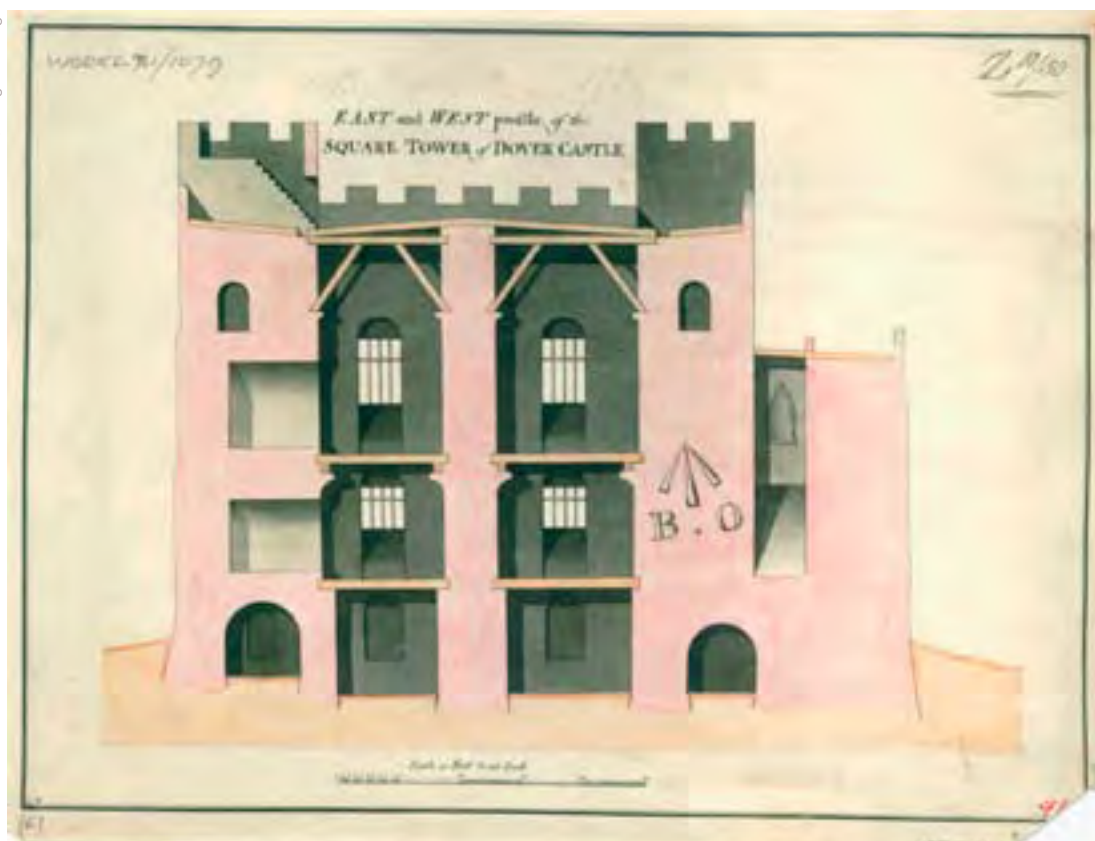
Board of Ordnance section through the Great Tower, 1729

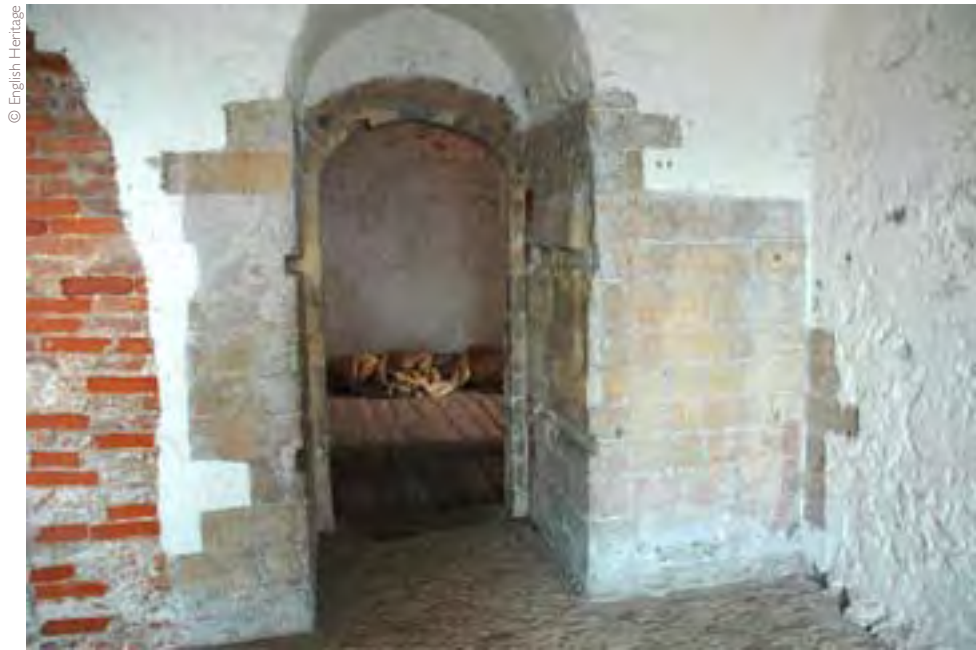
Photograph of panel fixings in second-floor secondary bedchamber

located. However, the accounts also describe the repair or renewal of panelling in six bedchambers, so where were the other two? Channels and round fixing holes for the battens of panelling were noted in the walls of the four principal chambers, and similar round fixing holes were found in two smaller chambers on the south-east side of the Great Tower. Today, these chambers are entered from the north-east side as well as the south west, but on a survey plan of 1827 they are shown with doors on the south-west side

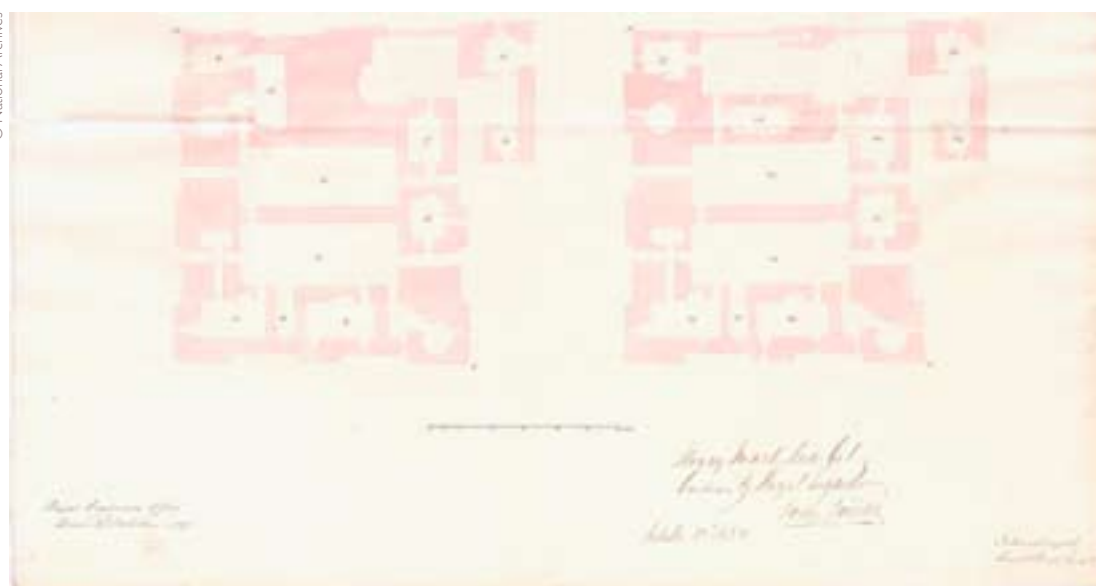
Plan of the Great Tower in 1827, first floor on left, second floor on right

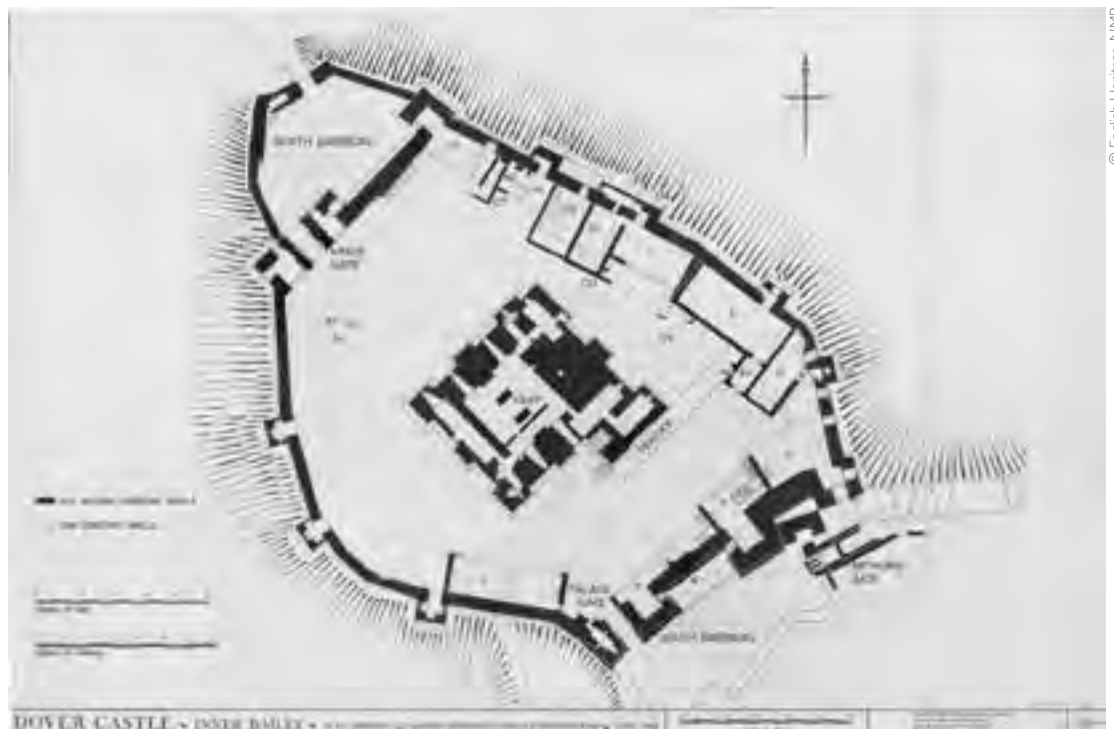
Plan of Inner Bailey –
Arthur's Hall marked E,
Regimental Museum marked F,
Shop marked J,
Keep Yard 9 marked A,
Keep Yard 7 marked C

Some of the architectural form of Henry III's hall can still be determined. It has retained its three service doors at its lower end. There is also some scarring in the side wall where the door into the cross passage from the Inner Bailey survives. At the upper end are the remains of a tall door from the front of the dais out into the Inner Bailey. This may have been the door into a pentice that ran north-westwards to the King's chamber.

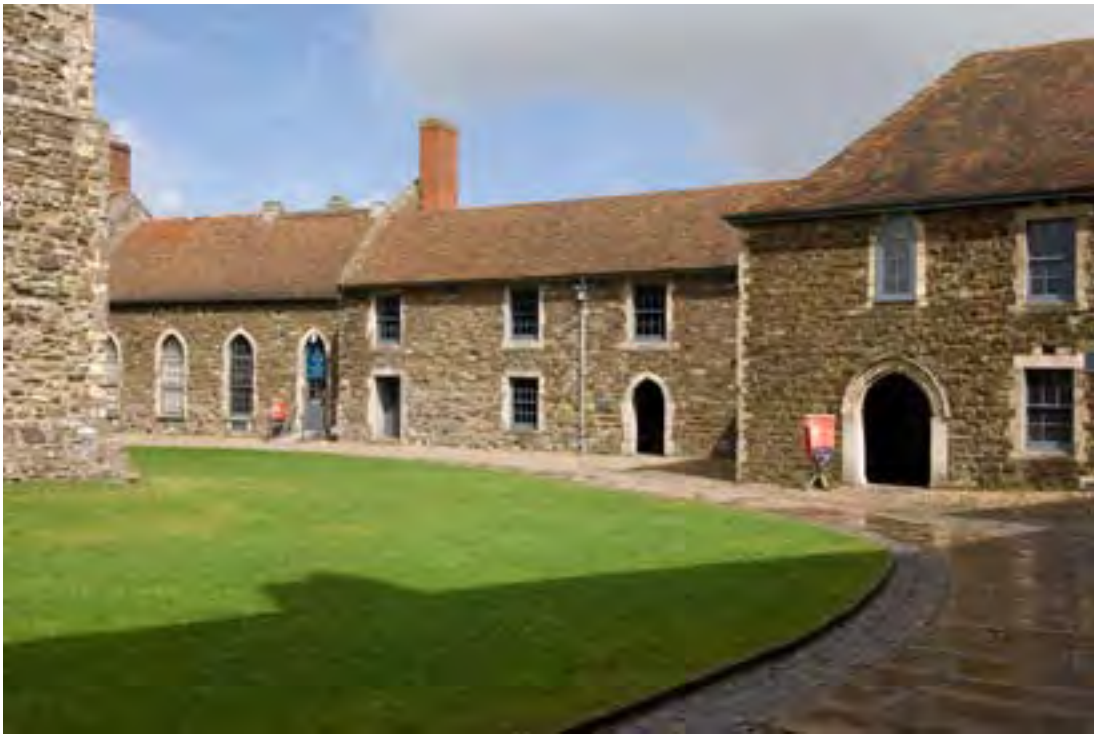
Buildings of north-east side of Inner Bailey - Arthur's Hall in centre

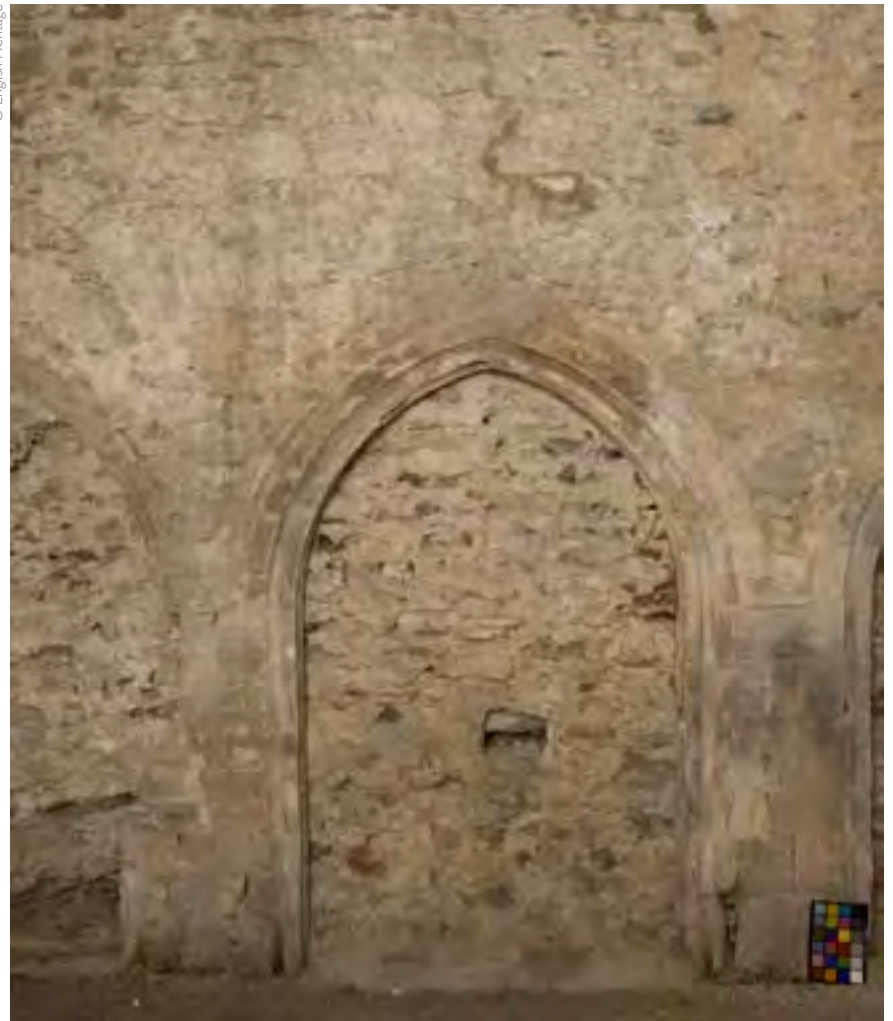
Central service door with remains of earlier arch above and to left

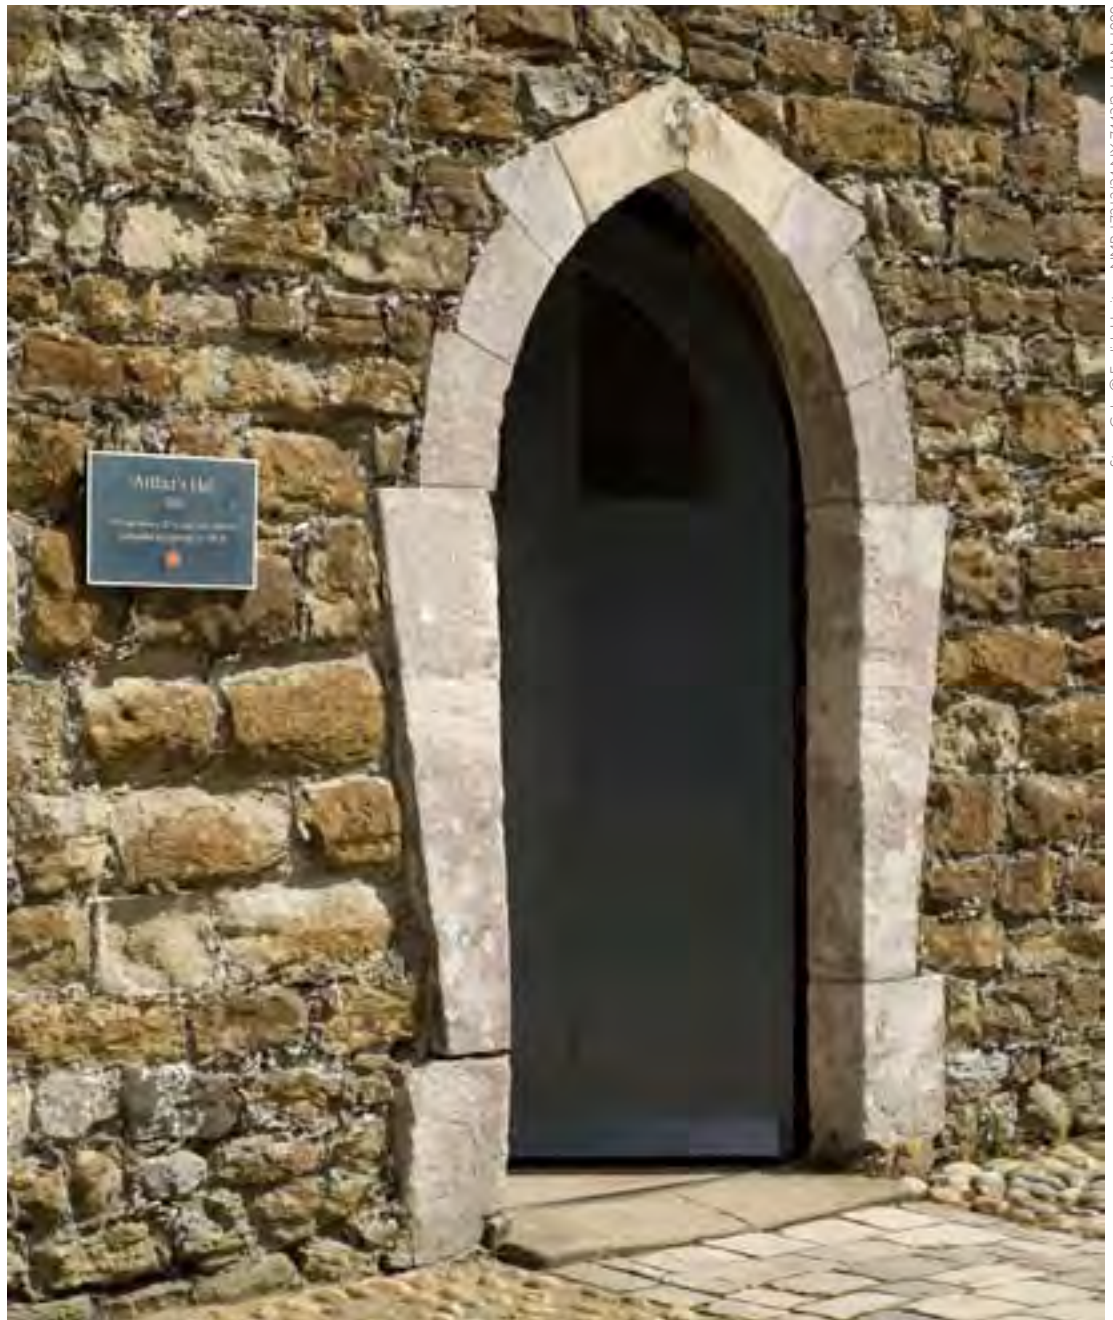
Door of Arthur's Hall with reused trapezoidal stone

Arthur's Hall remained a significant building until the 16th century but its current appearance is the result of a programme to create barracks in 1745-56. Like several buildings intended for use by ordinary soldiers (e.g. Keep Yard 7), its window and door jambs include pieces of stone that

probably came from the 1620s 'Rusticke dore'. By contrast, the one medieval building that was adapted for use by officers in this period – Keep Yard 8 – has windows and doors constructed with new stonework.

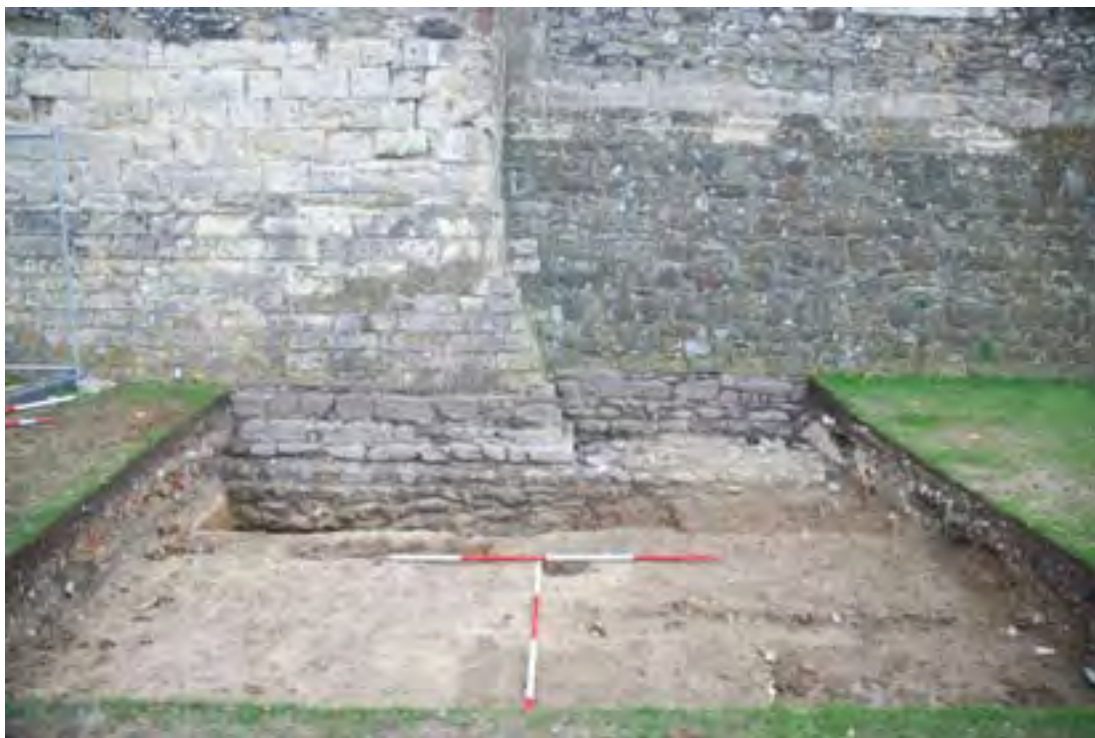
Trench A showing Great Tower footings, Caen-stone surface (foreground), and sondage against wall to expose early construction evidence

landform. The larger trench on the north side (Trench A) immediately demonstrated that the 'finished' landscape height against the building was always intended to be at its current height, because the nicely dressed facing stops at the turf. However, this turf is new, with evidence from the 1960s showing that a further 0.50m of the footings were exposed. These exposed footings were repointed with flint galletting (a style popular

in the 18th century) suggesting the ground level had been reduced by the time the Inner Bailey was converted to barracks. Below the modern deposits we found a layer of Caen-stone chippings and dust that appears to be the builders' yard surface during the construction of the Tower. This in turn sat on various levelling deposits of clay that filled in the natural dip to the east, and which show up in Rigold's work as deliberate mound-building.

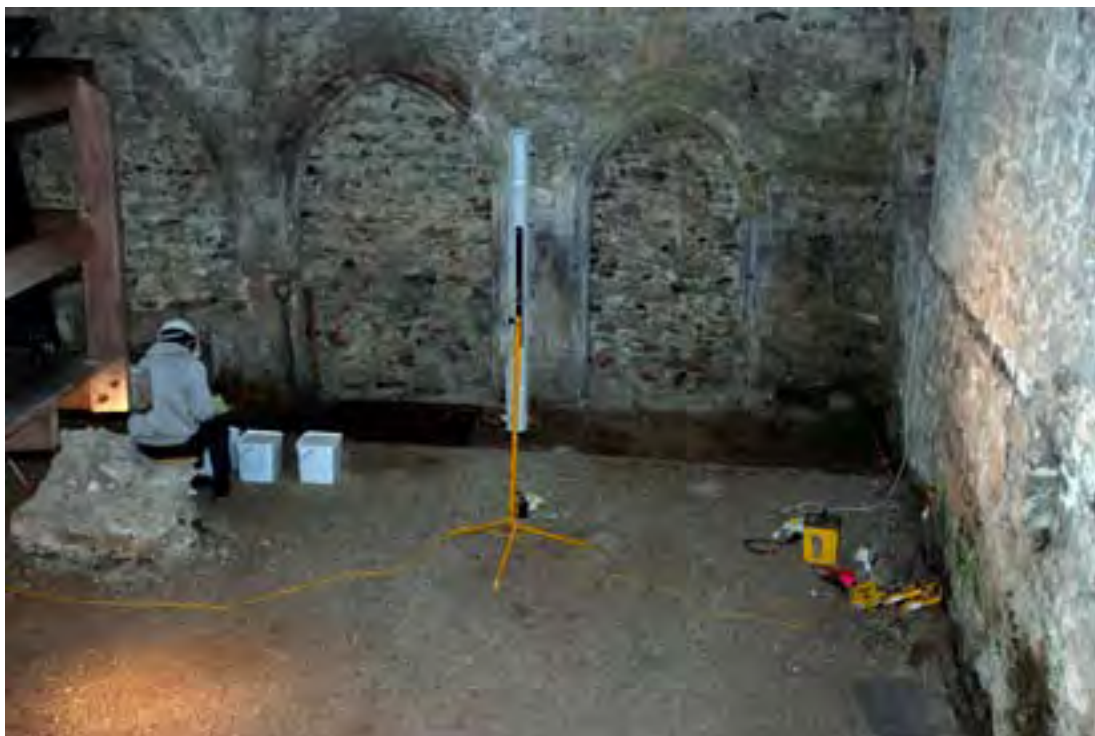
Trench C, in front of blocked medieval doorways, from walkway in Arthur's Hall

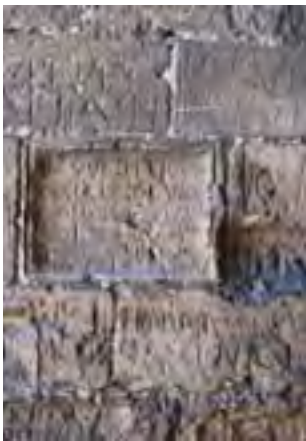
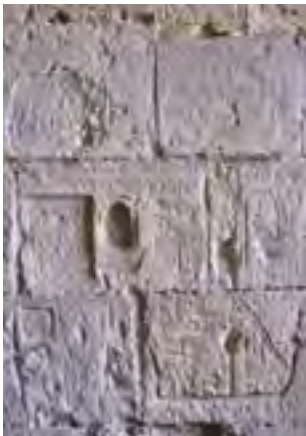
Example sections of historical graffiti

For all nine trial areas 207 stereo pairs were captured on site from which 979 DSM’s have so far been generated. Although this processing work is still in progress, once complete it will be supplied to Paul Pattison (EH’s Senior Properties Historian) to facilitate the next stage of analytical

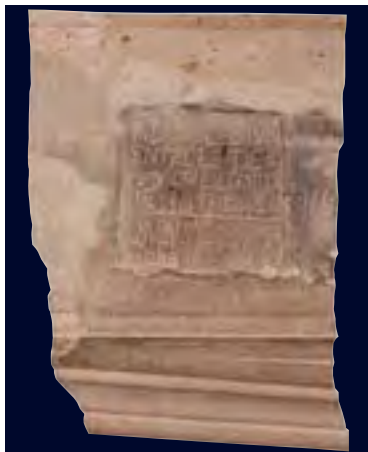
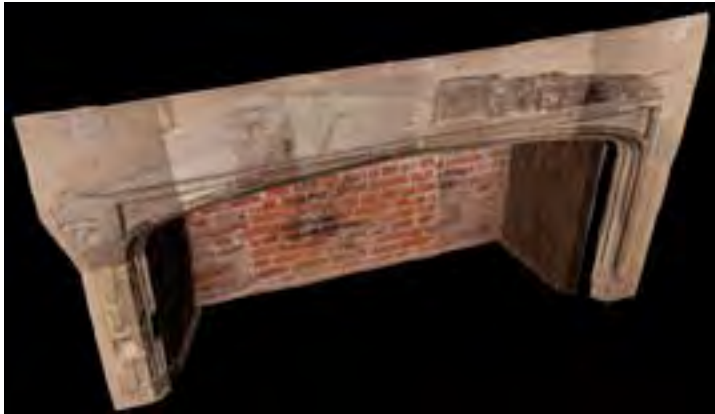
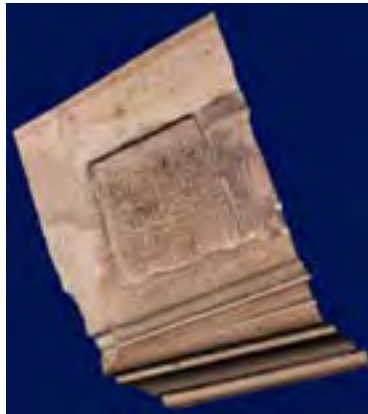
Left: Example outputs for Chamber fireplace

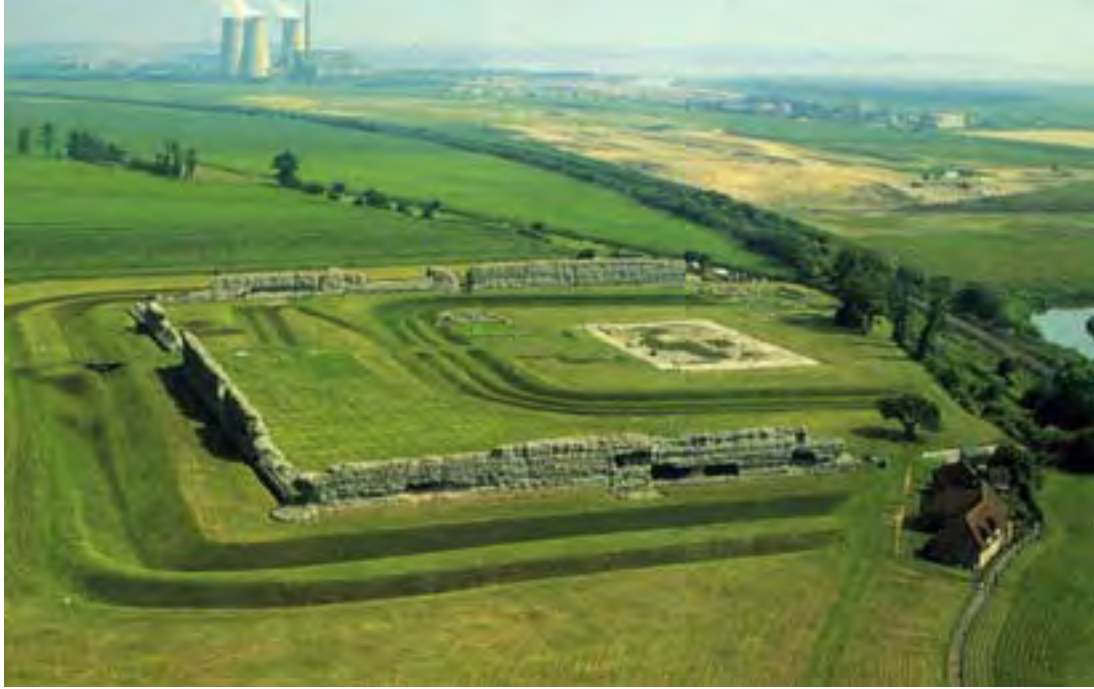
Aerial photograph of the Saxon Shore site looking north. The excavation trenches lay to the east, at the base of the slope near the railway line

The only accessible location where this question could be elucidated was at the base of the slope to the immediate east of the site. At this point a long section of the collapsed eastern wall of the Saxon Shore fort lies at the foot of the incline. The exact location of the foundations of this wall is unknown. Coring during 2001 showed that the break of slope across which the fallen wall lies was once the edge of open water. At first sight it appeared that the wall fell into water or mud. A single C14 date suggested that silting began in the 14th century, and that the wall collapse occurred after this. In order finally to clarify these issues, a series of six trenches were excavated along the fallen wall during the autumn of 2008.

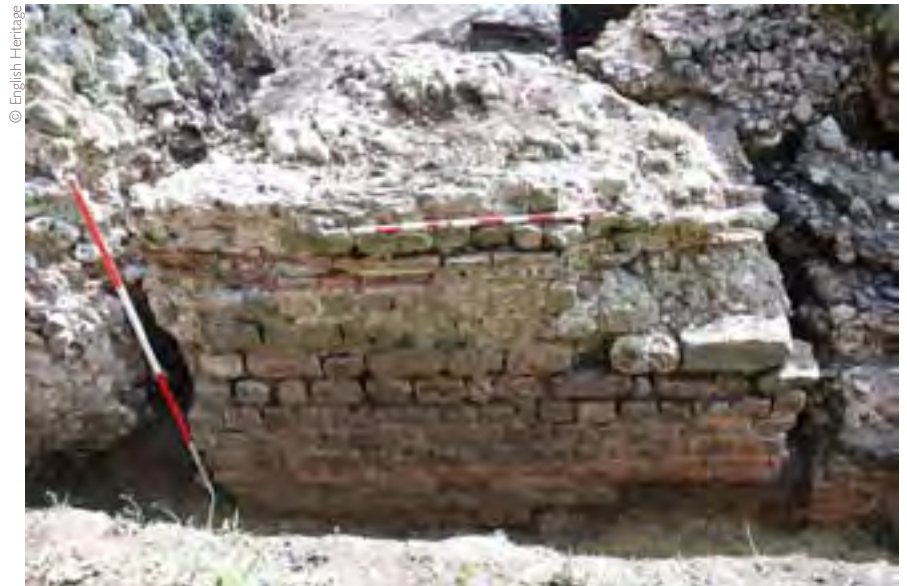
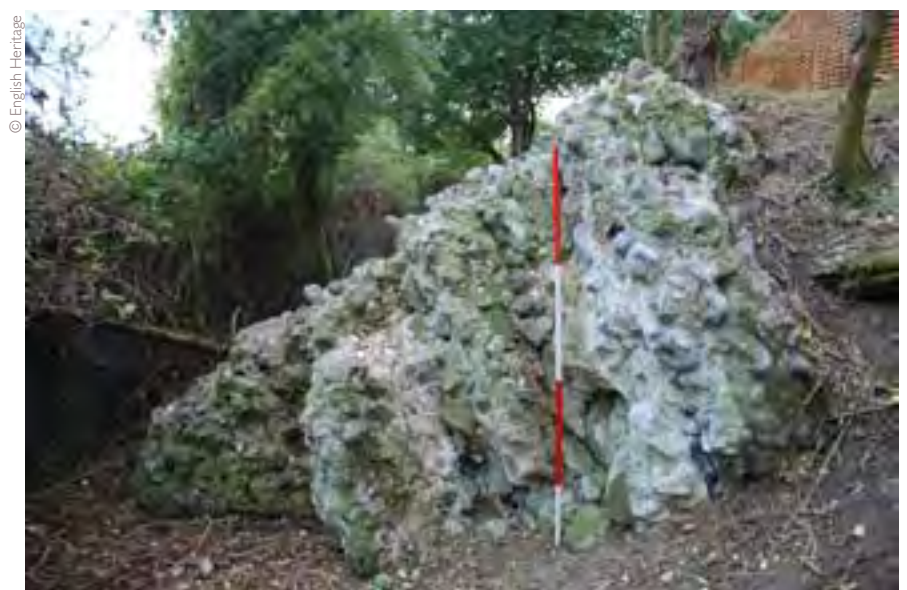
Below: The two stages of collapse. First the section with the tile course fell, then the whole wall fell and slid down-slope at 45 degrees

The wall was cleared of thick vegetation, cleaned and recorded using laser scanning. It was clear that the wall collapsed in sections. Two large segments which had become detached from the standing wall had rolled down slope, flipping over completely so that the exterior tile-coursed facing faces west. The rest of the wall then collapsed in a single event, falling on its face, and sliding bodily down the slope, leaving its base exposed. The pieces of earlier collapse embedded in the ground at the foot of the slope caused the wall to part around them as it slid.

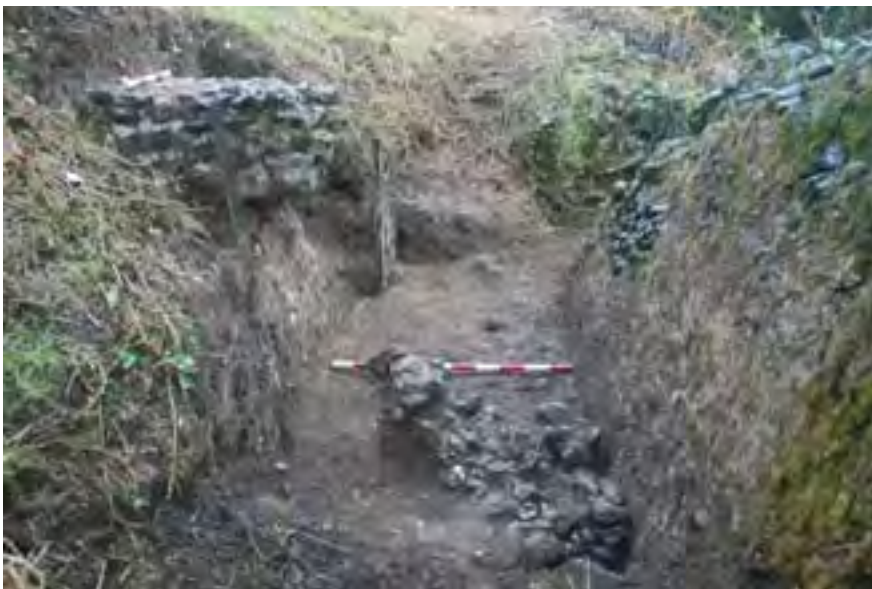
Right: The natural processes beneath the collapsed wall. Waterlain silts at the bottom give way to orange clay laid down in marsh conditions. Above this is the buff colluvium

the lowest silts, which lay above naturally lain gravel, contained later 14th-century pottery and peg tile, suggesting the date for the use of the structure.

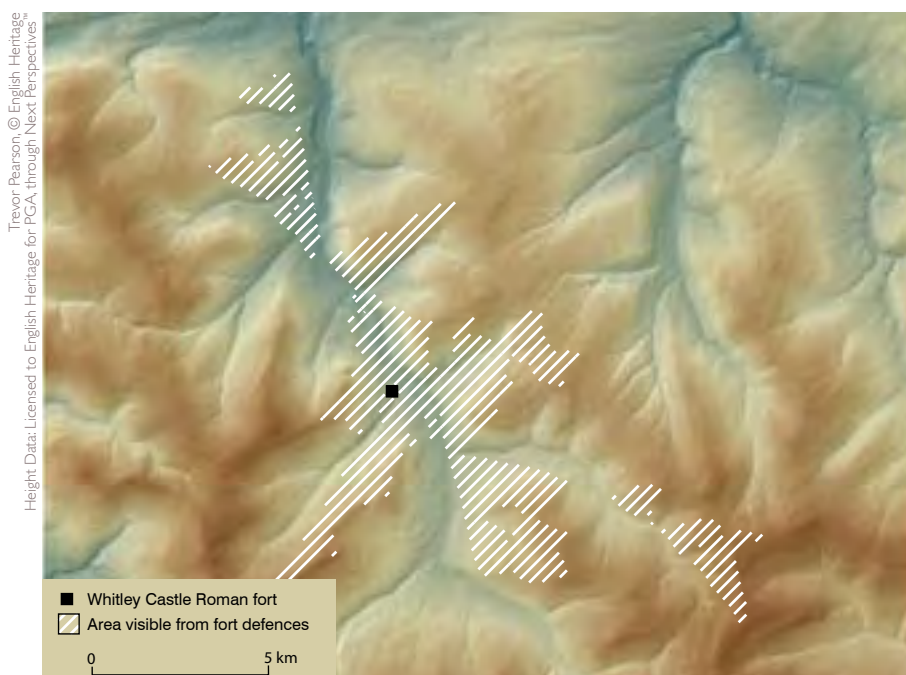
The results of a viewshed analysis of Whitley Castle applied to a digital landscape model of the Roman fort's immediate surroundings

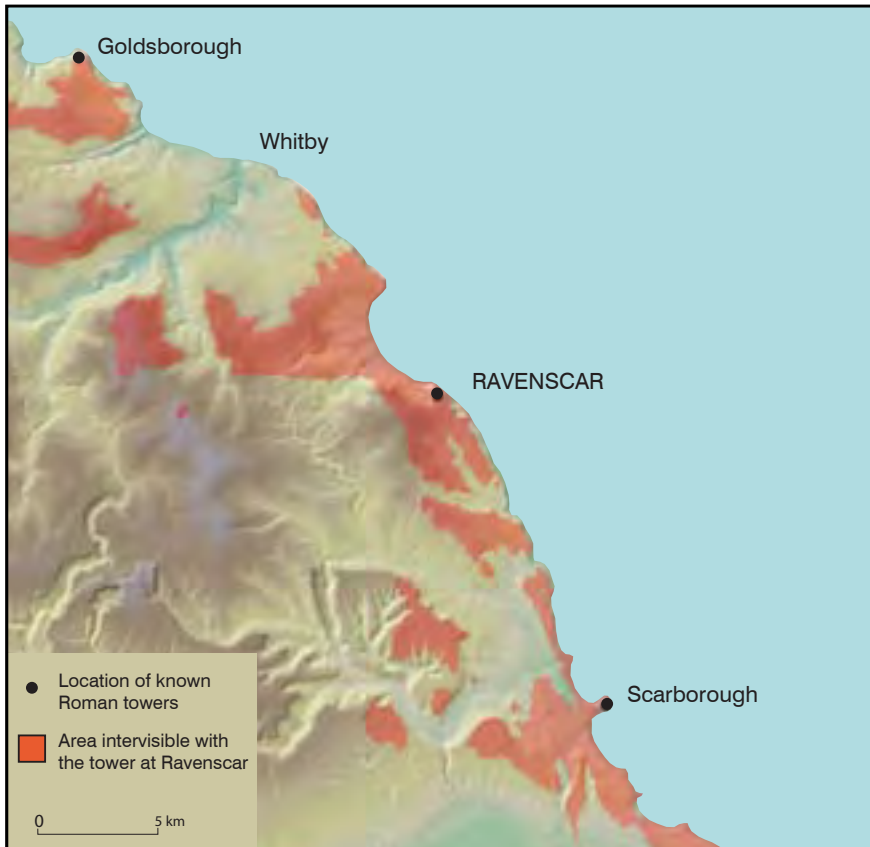
A viewshed analysis of part of the Yorkshire coast indicates that the Roman towers at Goldsborough and Ravenscar would have had to have stood at least 30m high to have been intervisible. It seems unlikely that the towers were this high and instead the analysis lends weight to the possibility of an intermediate watch tower, probably at Whitby

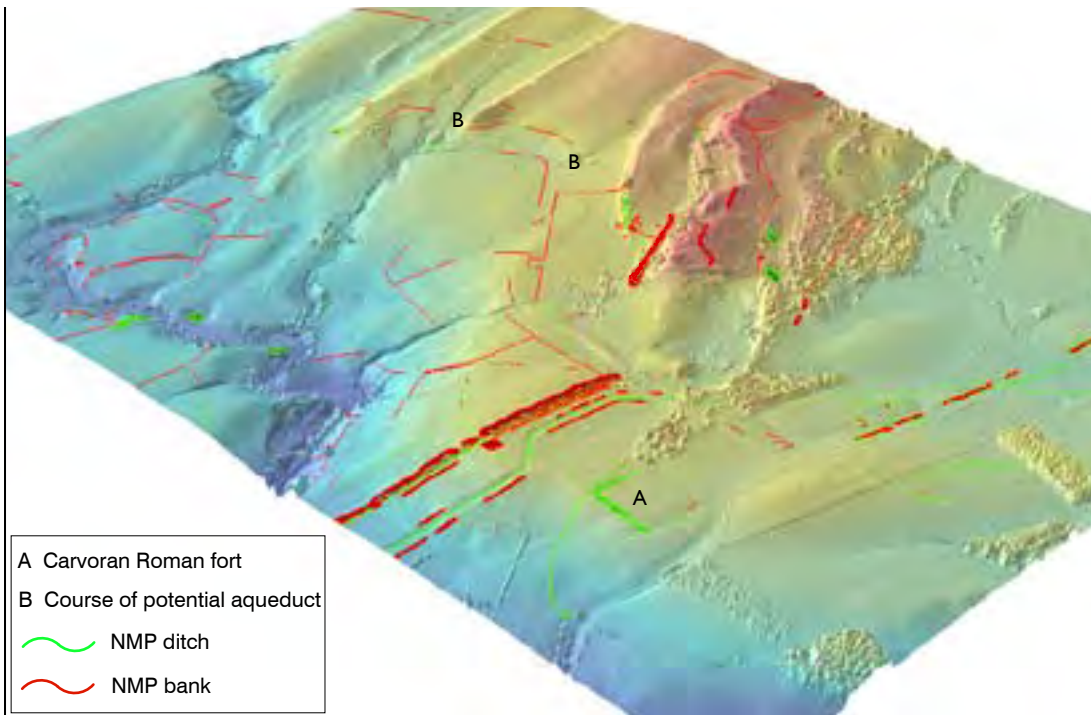
A 3D digital model of the landscape around the Roman fort at Carvoran showing the location of a potential aqueduct

Analysis and synthesis of data mapped from aerial photographs as part of the National Mapping Programme (NMP) within a GIS environment has also been enhanced by the use of Next Perspectives™ data. The resolution of the height data means that subtle differences in height and topography can be identified. During the Hadrian's Wall NMP project a number of linear ditches were noted to the north of the Roman fort at Carvoran. Fortunately, the fort and its hinterland just fell within an area of 2m Digital Surface Model (DSM) data coverage. The resolution and accuracy of this data is such that even small features such as hedges and buildings are modelled in the DSM. A 3D model of the landscape was created in GIS using this data. The NMP data and Next Perspectives™ aerial photography were then draped over the model, enabling the features to be viewed in 3D. Spot heights were taken along the course of the linear feature and contours produced along the length of the feature to assess the direction and steepness on incline. Though this did not entirely rule out the initial interpretation of the feature as the fort's aqueduct, it is now thought more likely to have been a quarry track.

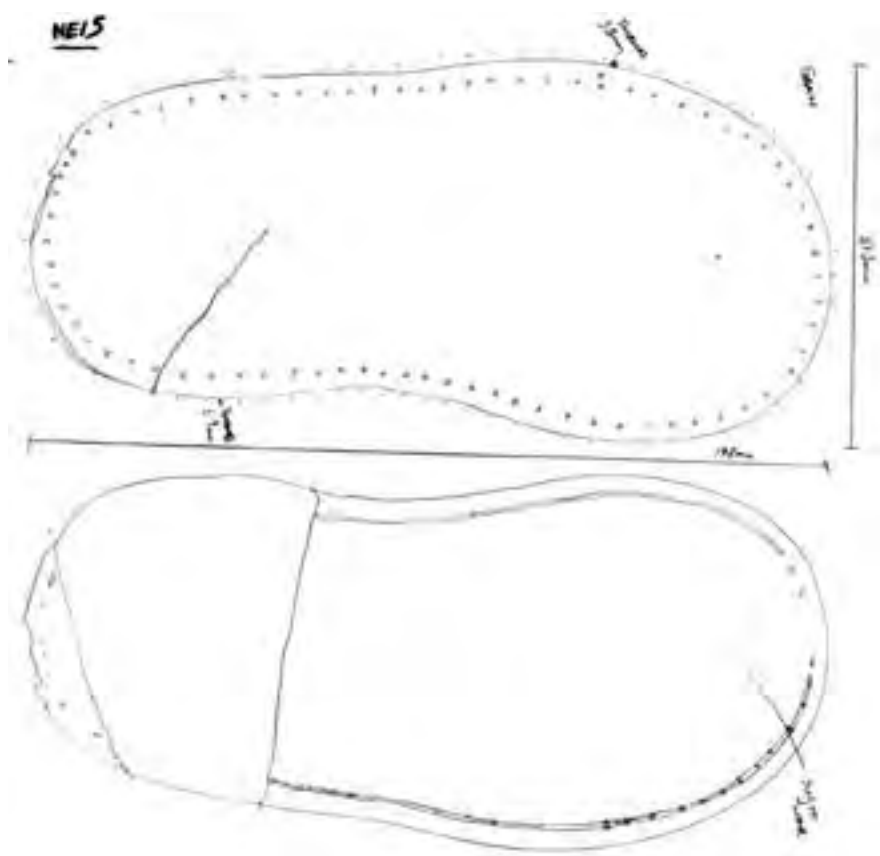
Annotated drawing
before conservation

Before treatment commenced all the pieces were recorded using photography and annotated drawings. The pieces were briefly described and their condition recorded using the score sheet. Points (1 to 4) were given in the categories of pre-burial damage, cohesivity, friability and flexibility: the higher the number the better the condition of the leather. An additional flexibility test was carried out whereby flexibility was defined as the degree in change of movement when the leather was suspended over an edge. The degree of movement was measured in degrees, with 0° being no change and 90° being the maximum change. The recording was repeated after treatment. All information regarding one piece of leather was recorded on a specially designed object sheet.

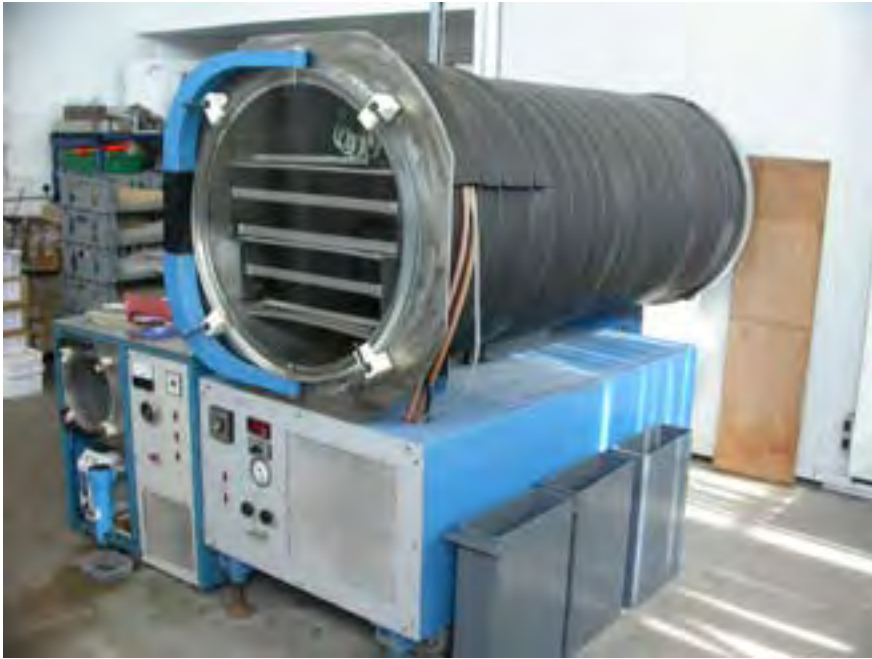
Vacuum Freeze Dryer at Fort Cumberland

- *Freeze drying took place in a vacuum freeze drying chamber.*
- *Non-vacuum freeze drying was carried out in a domestic chest freezer with the addition of silica gel and a fan. Both freeze drying and non-vacuum freeze drying rely on sublimation whereby frozen moisture in the leather directly transfers from the solid to gas phase with no intermediate liquid phase. For non-vacuum freeze drying the fan blows a constant stream of cold air over the leather and this carries the sublimed moisture over to the silica gel where it is absorbed.*

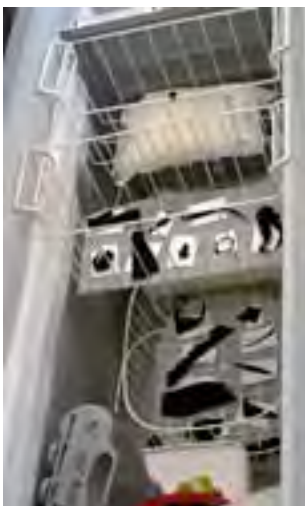
Non-Vacuum Freeze Drying, view inside the chest freezer (bottom left corner: fan, centre: leather in wire baskets, top: silica gel)

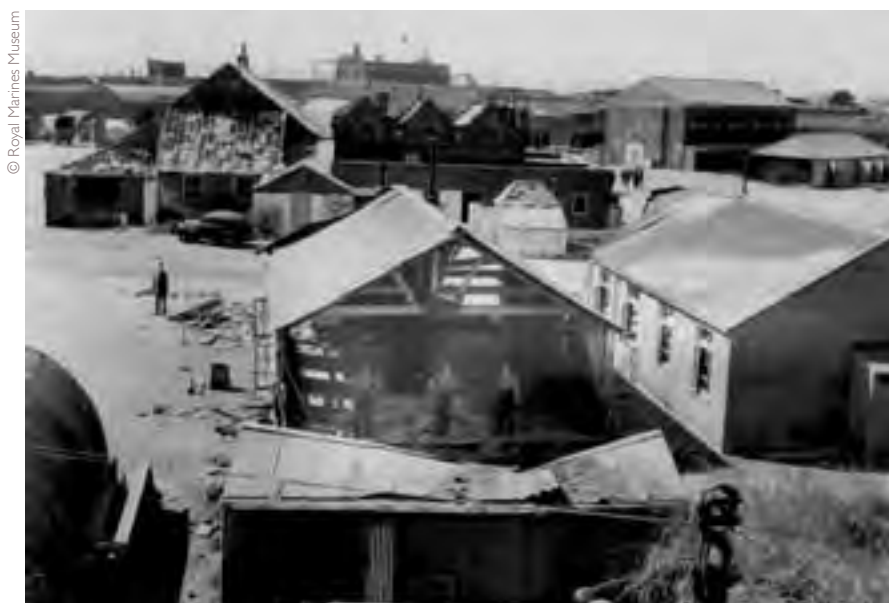
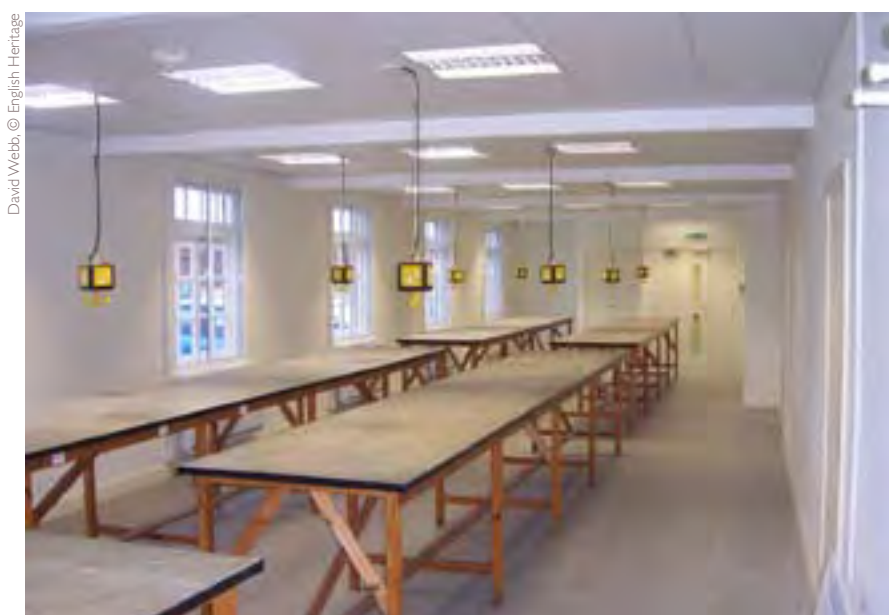
Top: The building after bombing in World War II

Bottom: The refurbished interior of the finds processing building

Among the smaller contributions new survey of earthworks at Damerham, Hants will drive new research into an intriguing landscape. At Fort Cumberland a new, refurbished, finds processing facility will greatly improve working conditions in this area.
