## Ivy on Walls

Prepared for Historic England by Dr Martin Coombes and Prof Heather Viles, Oxford Rock Breakdown Lab (OxRBL), University of Oxford; and Alan Cathersides, Historic England

Discovery, Innovation and Science in the Historic Environment

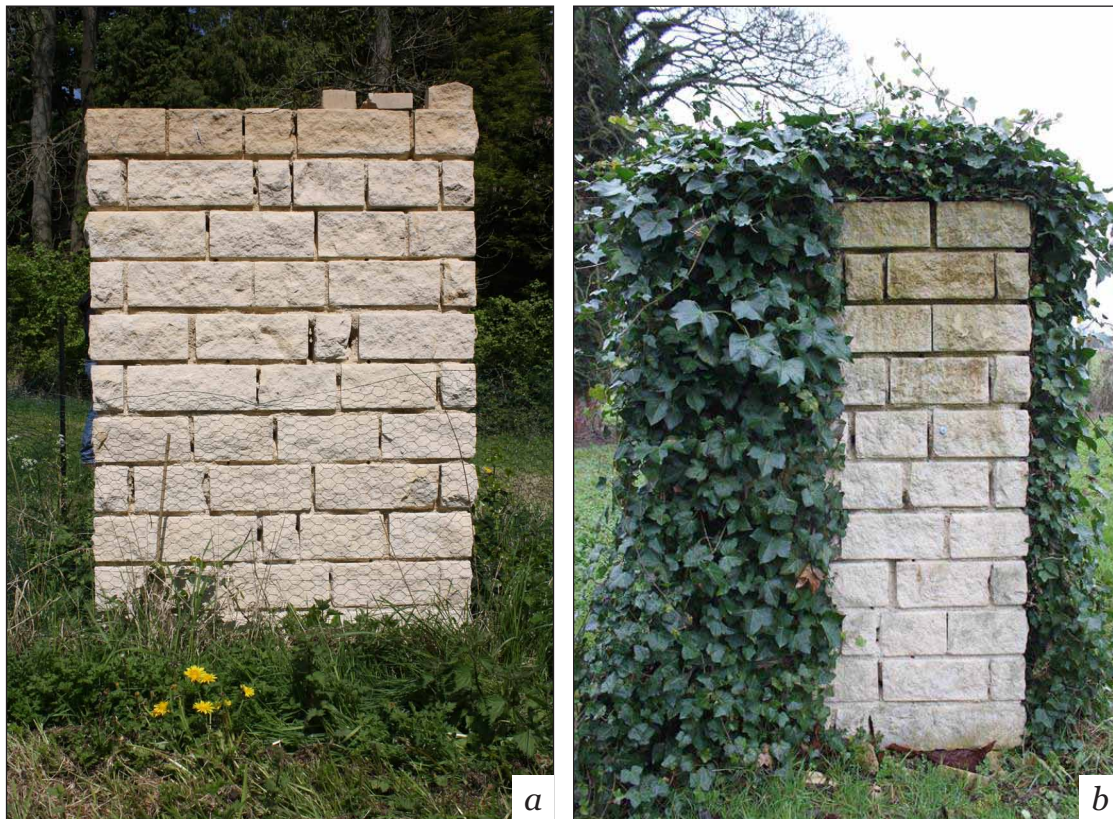
*Figure 1-2. Ivy test wall, Wytham Woods: (a) in 2009 ©Heather Viles, (b) in August 2015.*

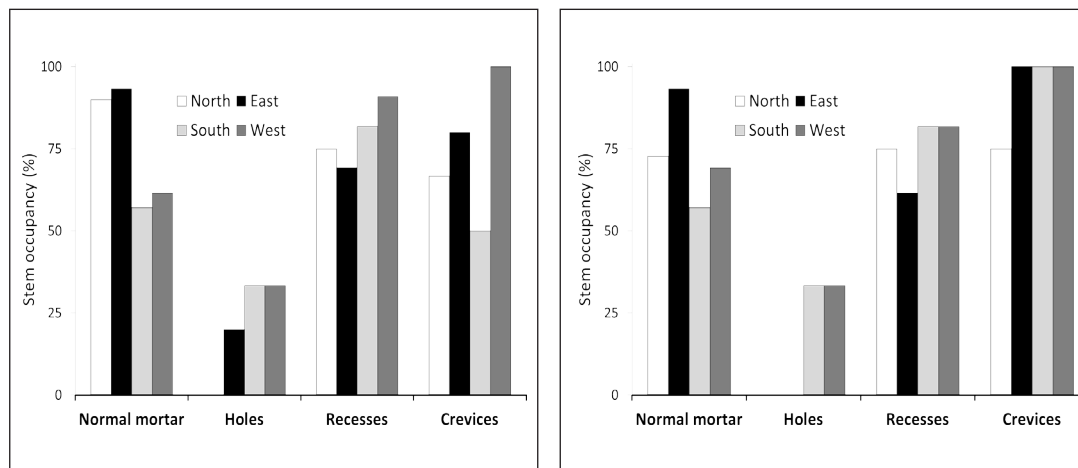
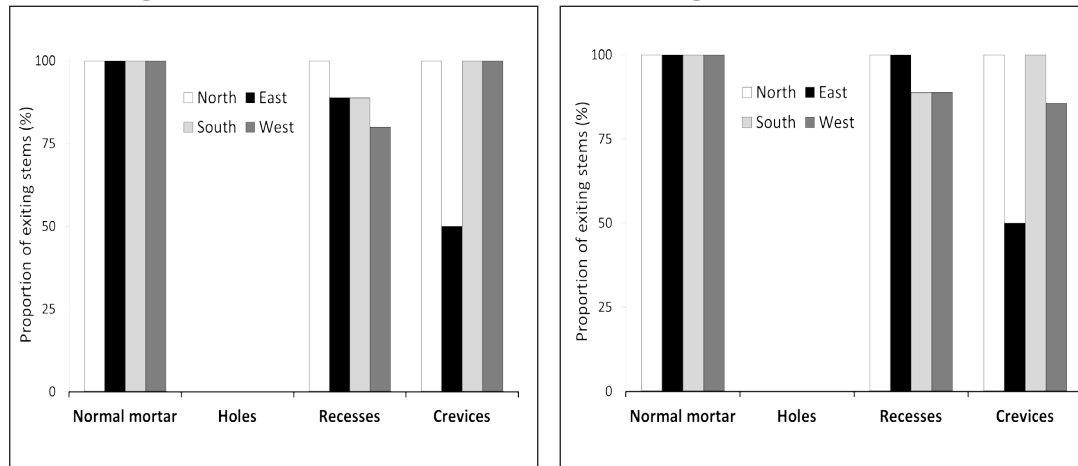
**(a) Defect occupancy: Summer 2013**      **(b) Defect occupancy: Summer 2014**

**(c) Exiting stems: Summer 2013**

*Figure 2-2. Stem occupancy (%) of available mortar defects in the Wytham test wall in (a) 2013 and (b) 2014 and the proportion (%) of these that were exiting in (c) 2013 and (d) 2014.*

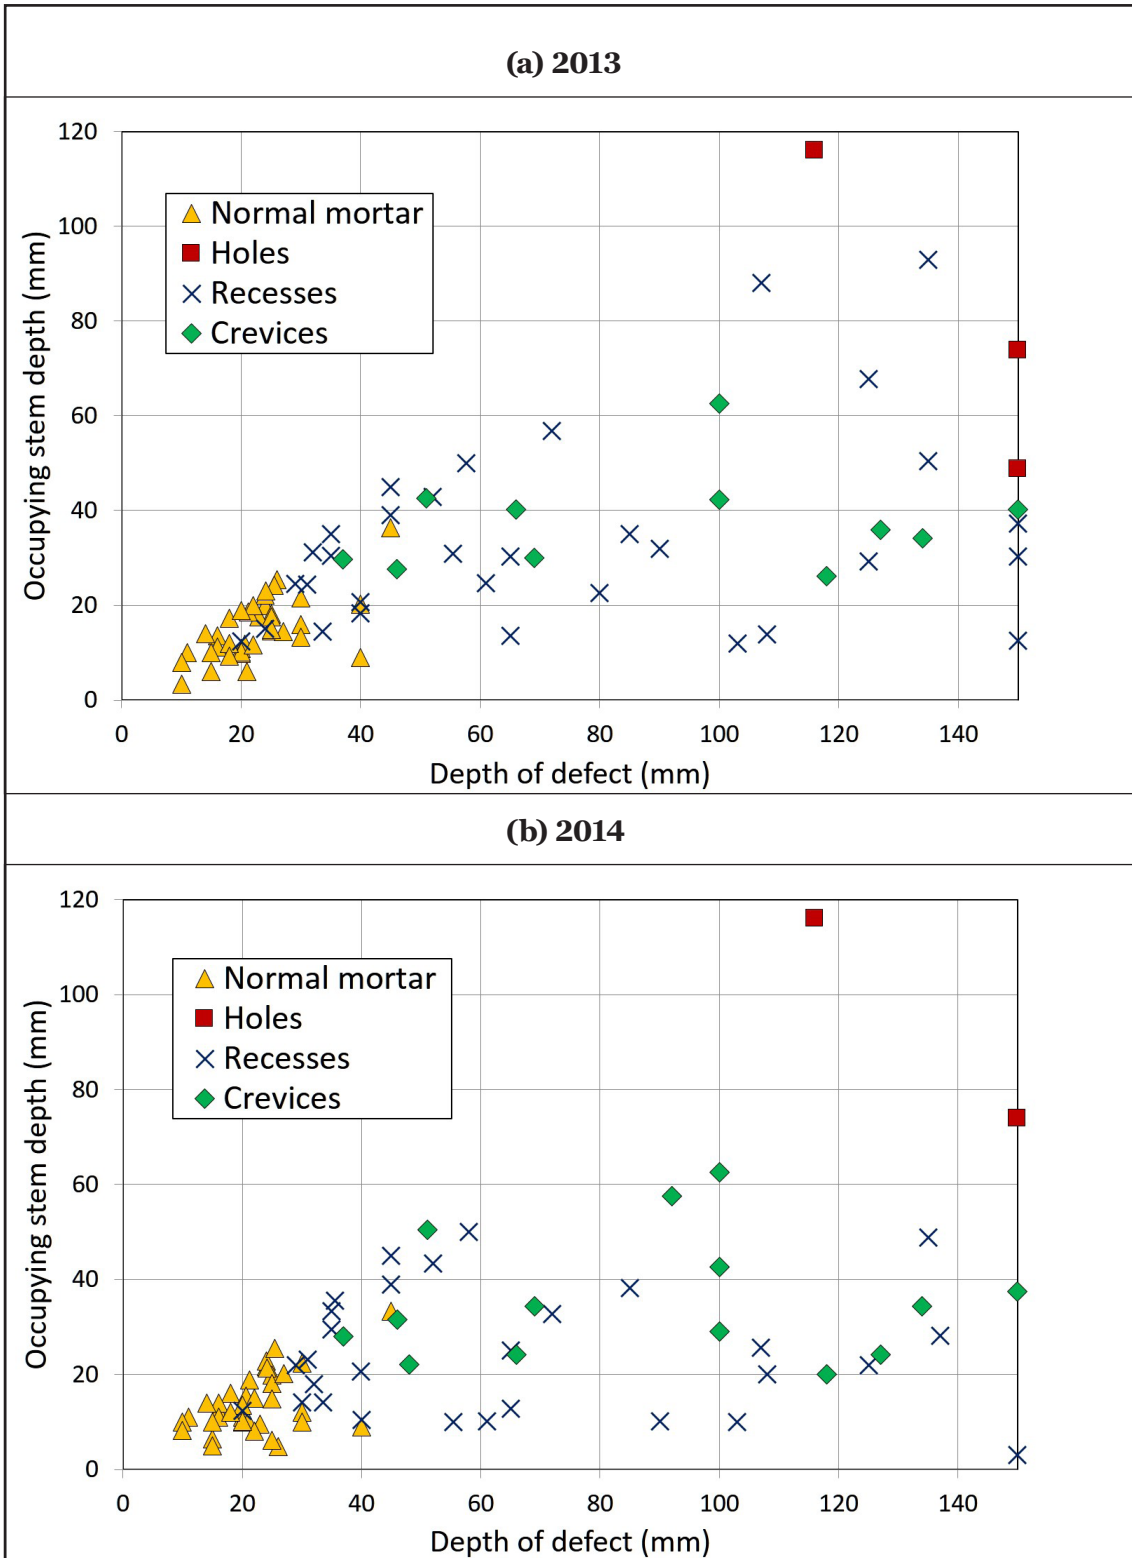
Figure 2-3. Relationship between available defect depth and the depth of occupying ivy stems at the Wytham test wall in (a) 2013 and (b) 2014 (all measured depths are minimums).

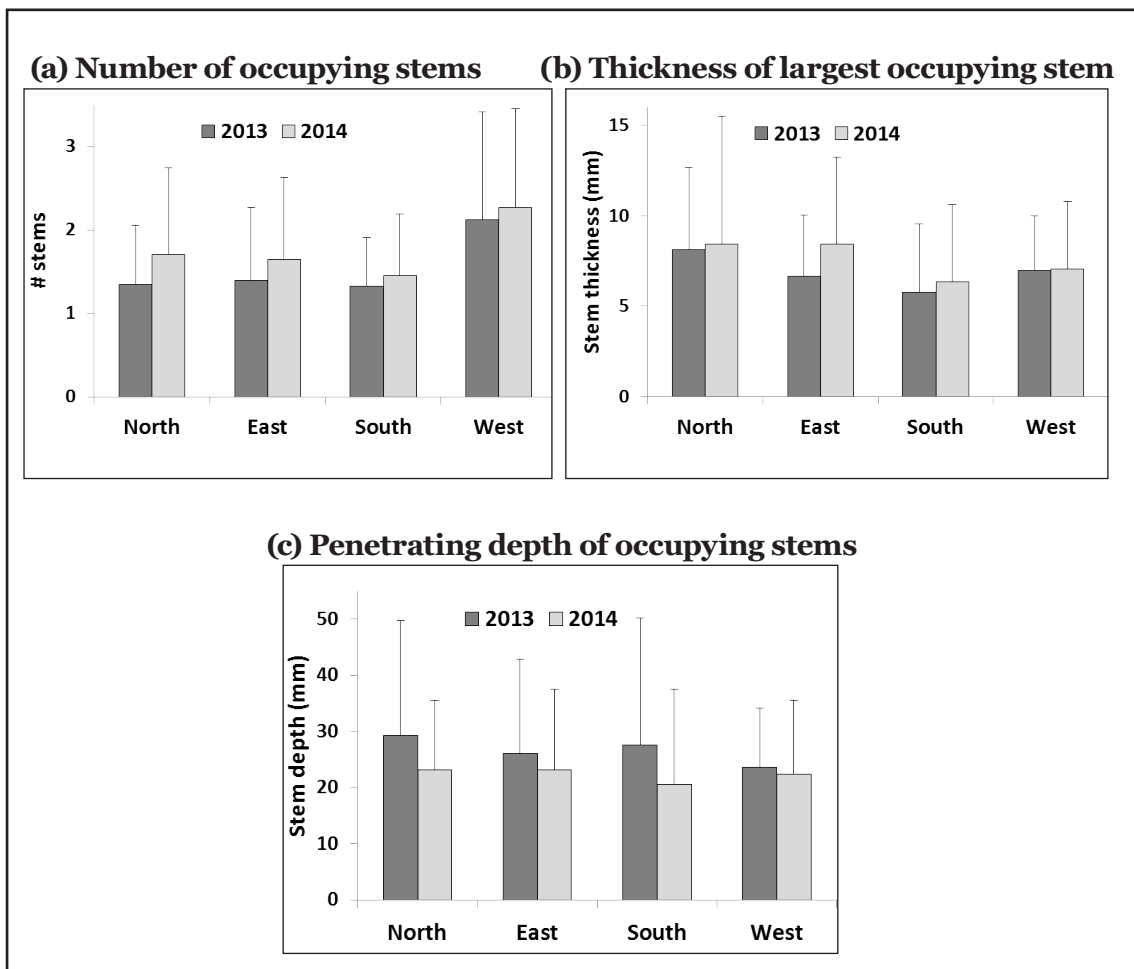
Figure 2-4. Stem occupancy in all defect types in mortar joints at the Wytham test wall in 2013 and 2014: (a) number of stems; (b) thickness of largest stem; (c) penetrating depth of largest stem (averages +SD).

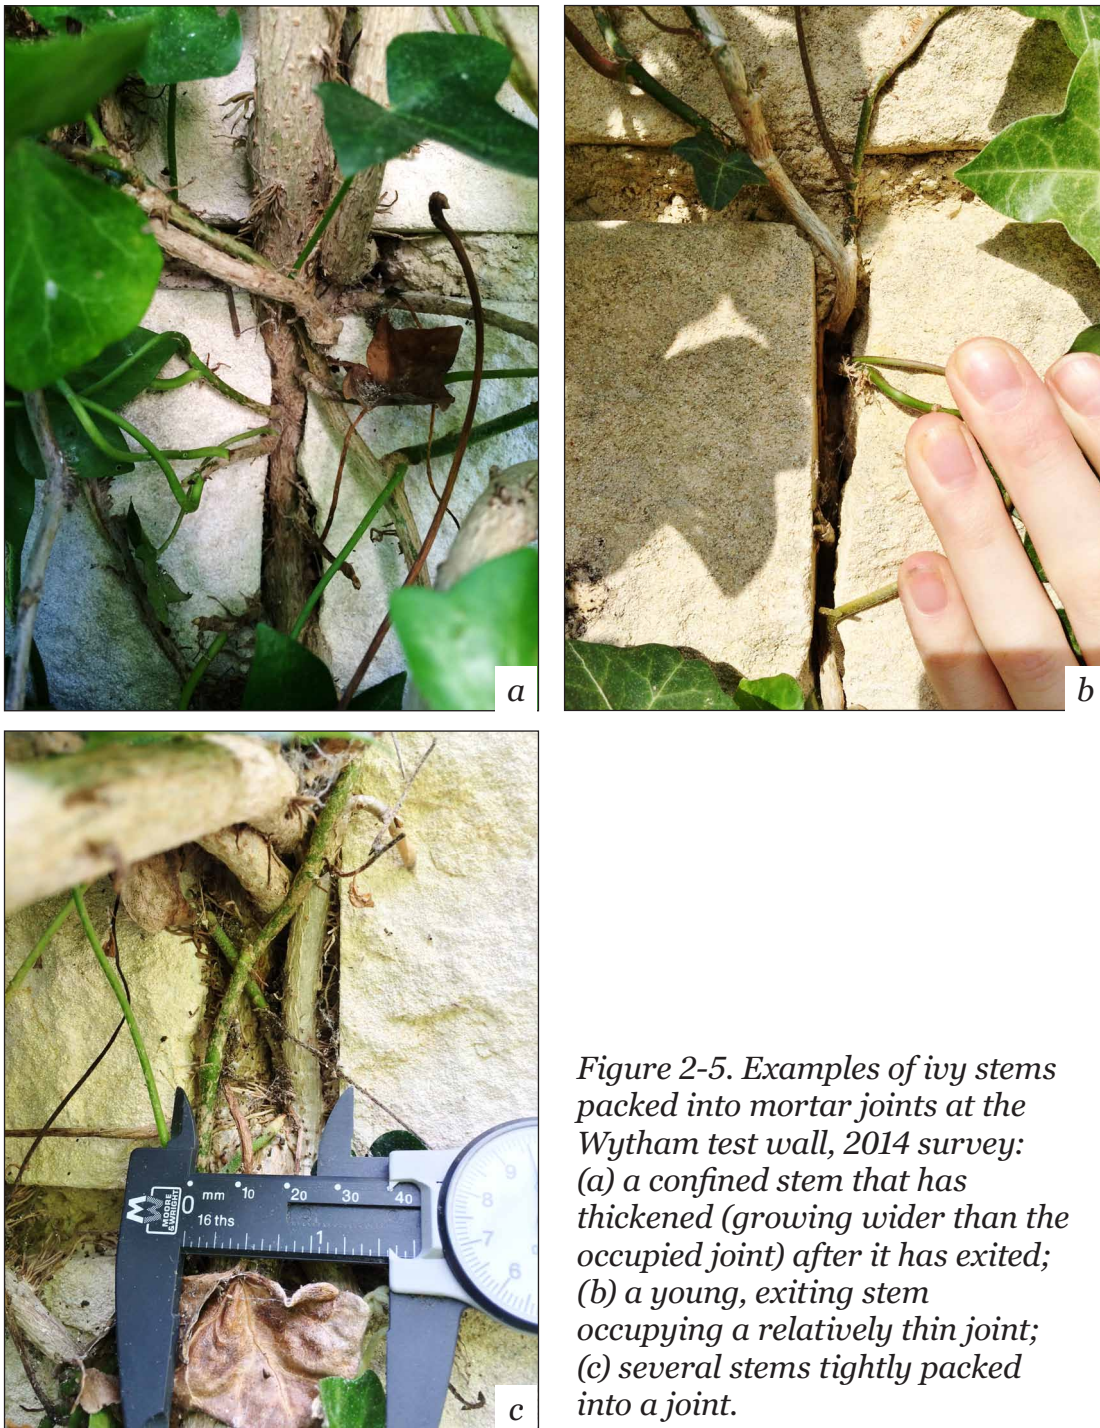
*Figure 2-5. Examples of ivy stems packed into mortar joints at the Wytham test wall, 2014 survey: (a) a confined stem that has thickened (growing wider than the occupied joint) after it has exited; (b) a young, exiting stem occupying a relatively thin joint; (c) several stems tightly packed into a joint.*

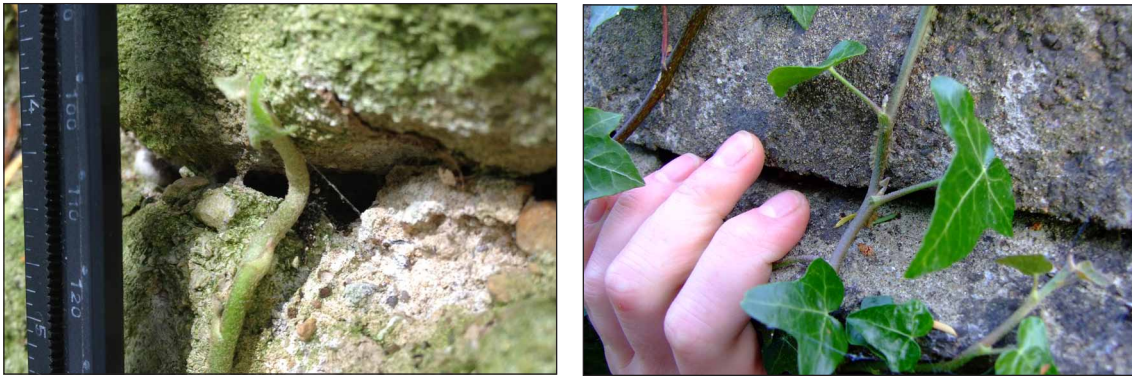
*Figure 2-6. Examples of juvenile stems growing over rather than into defects, Holywell Cemetery, Oxford.*

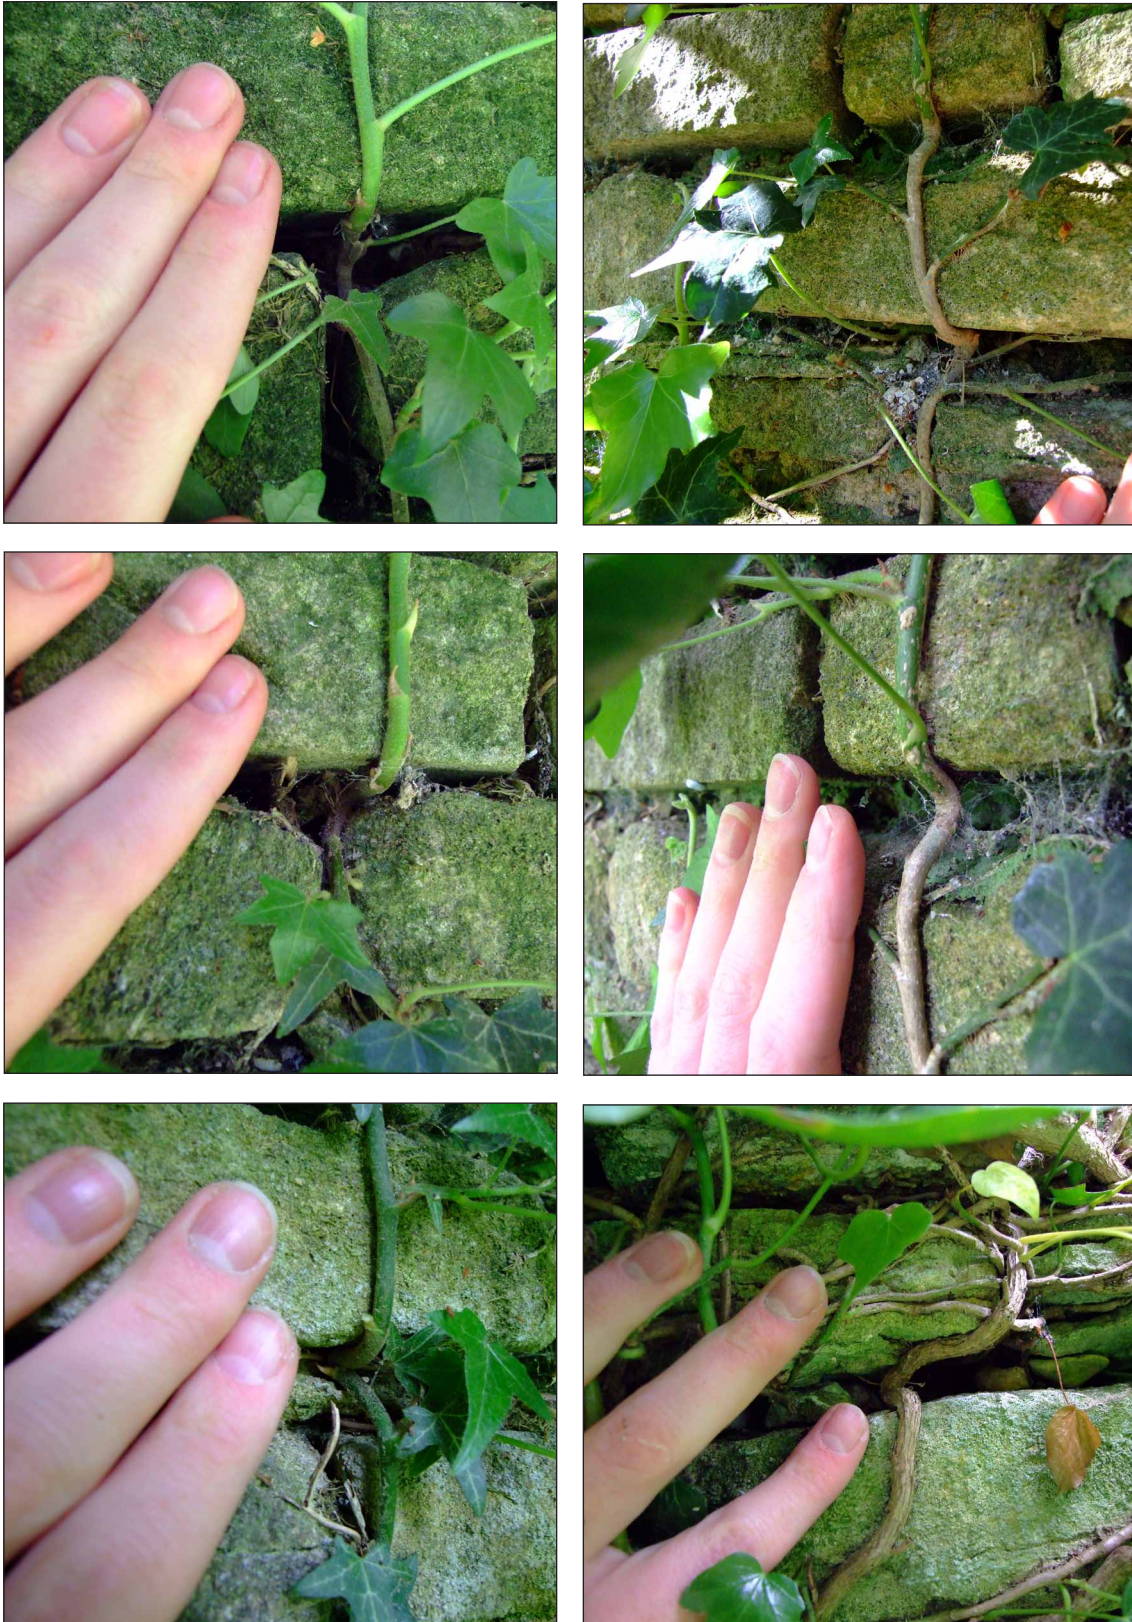
*Figure 2-8. Typical 'U-turn' exiting behaviour of juvenile ivy stems encountering potential entry points in a wall with poor condition mortar joints, Holywell Cemetery, Oxford.*

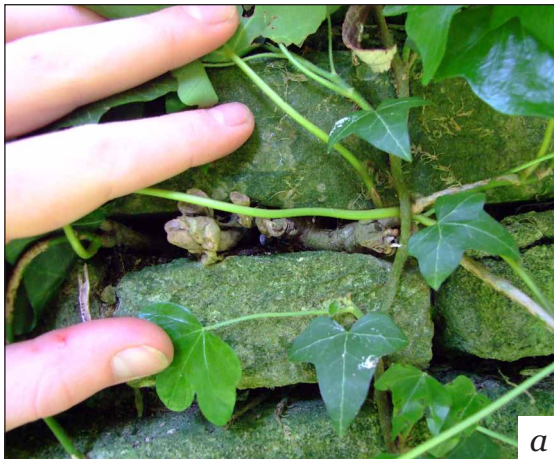
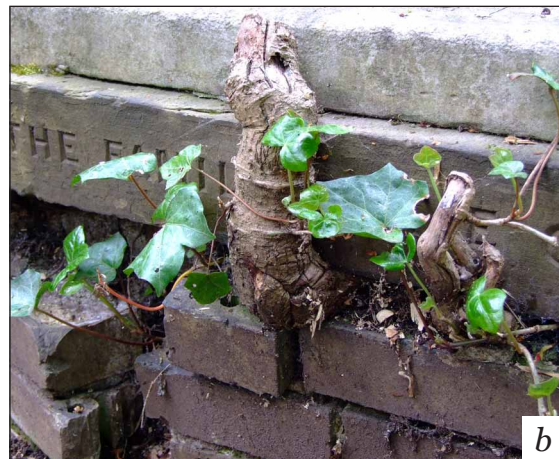
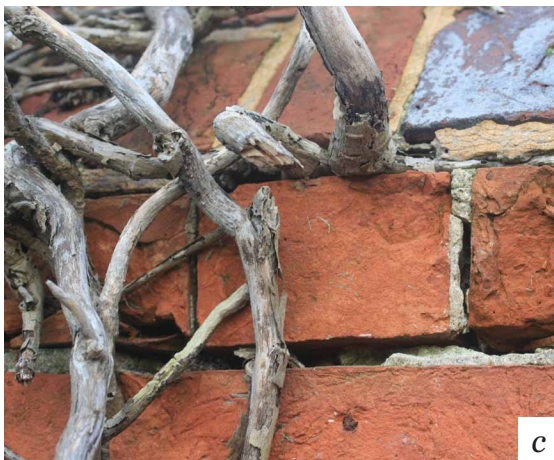
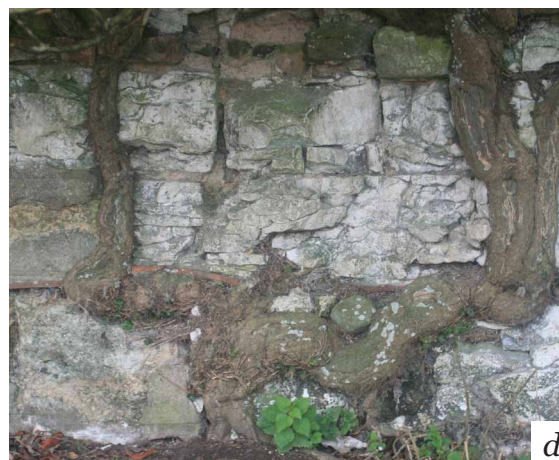
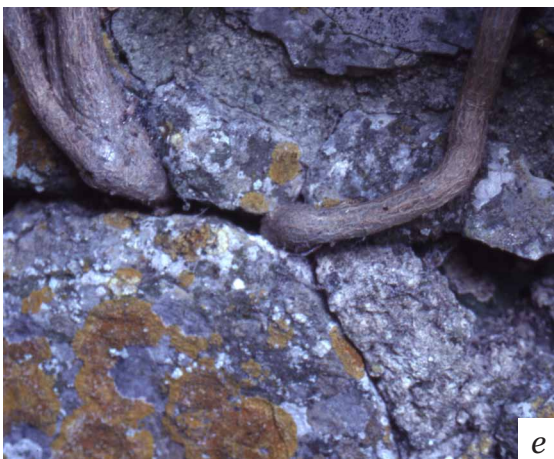
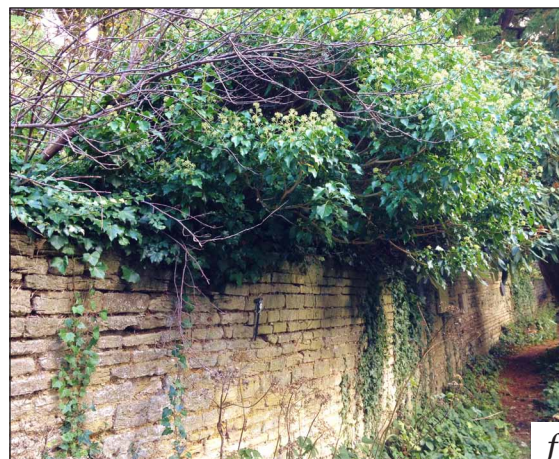
*Figure 2-9. Ivy growth in association with structural deterioration of masonry: (a) thickening and re-sprouting of cut ivy stems in mortar joints, Holywell Cemetery, Oxford; (b) punched out bricks by thick re-sprouting ivy stems, Hampstead Cemetery, London; (c) stems growing into poorly repaired pointing mortar, Littlehampton Fort, West Sussex; (d) thick stems growing through a stone masonry wall, Thornton Abbey, North Lincolnshire; (e) woody stems growing through a historic wall in poor condition, Chudleigh, Devon; (f) Spreading arboreal canopy contributing to bulging of the wall head, Holywell Cemetery, Oxford (c,d,e ©Alan Cathersides).*

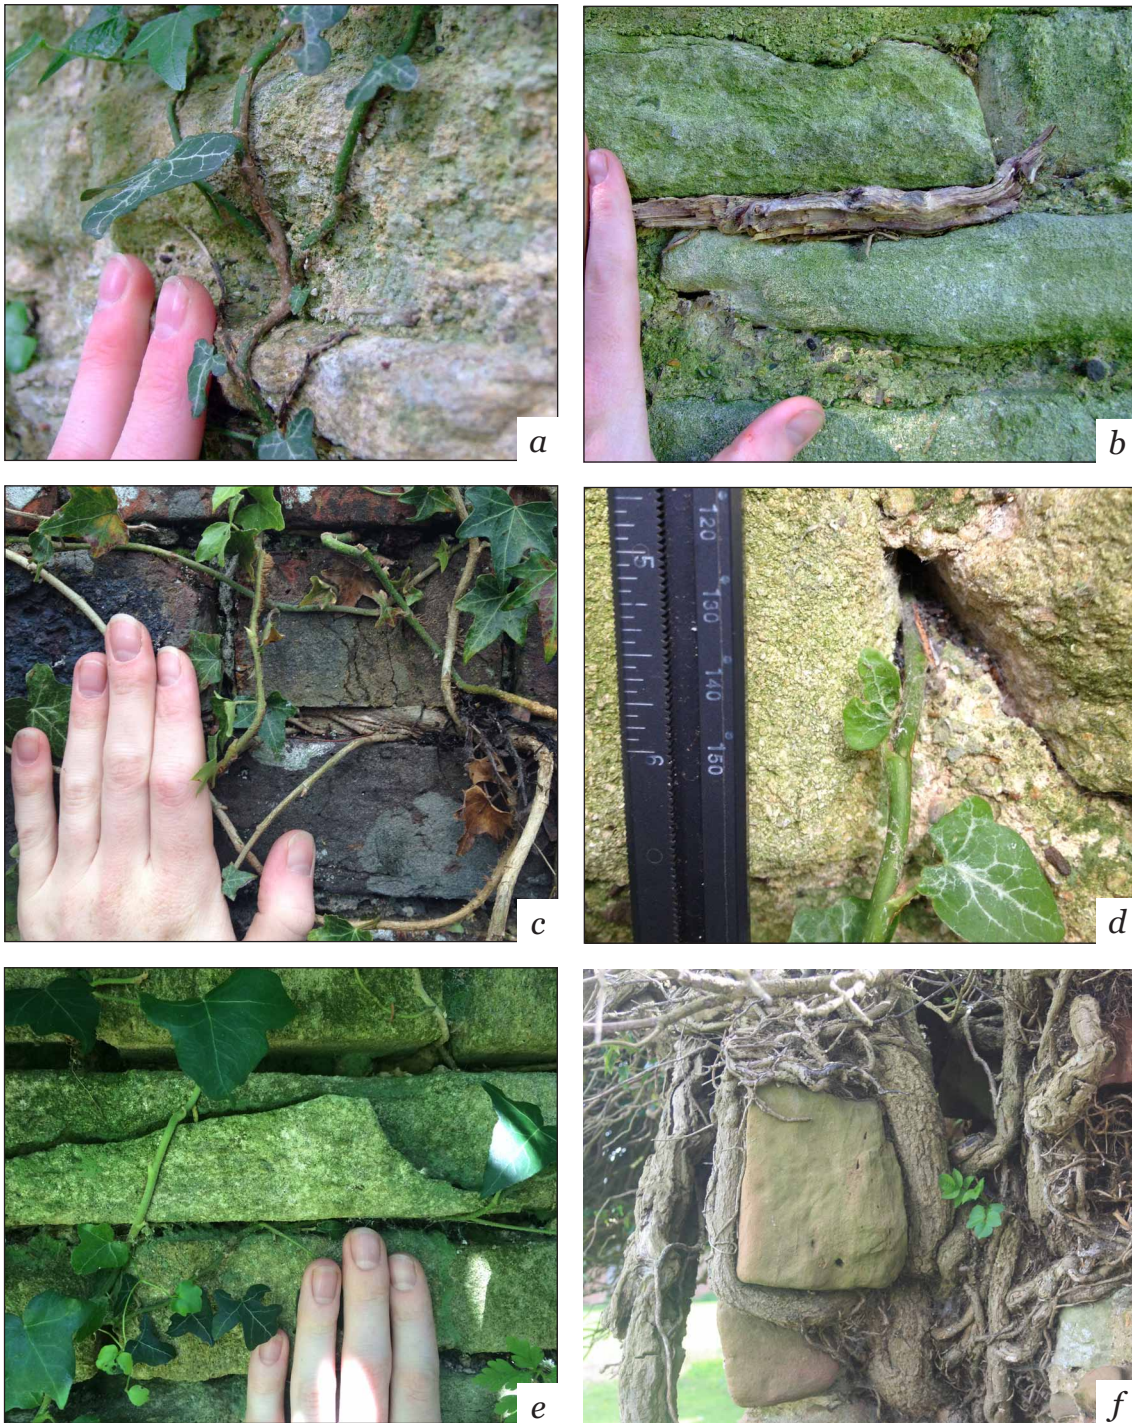
*Figure 2-11. Examples of typical growth responses of juvenile ivy stems to different kinds of wall features: (a) stems closely follow the contours of shallow mortar joints; (b) thickened stems in joints are difficult to remove completely; (c) stem thickening within joints may cause stress cracking of adjacent masonry blocks; (d) stems entering small holes can grow into internal void space (where this already exists) as they cannot turn and exit; (e) stems growing in and around surface deterioration can aid detachment of loose pieces of stone; (f) stems growing through walls (from one side to another) and around masonry blocks can cause considerable damage, but may also support poor condition walls. (f ©Alan Cathersides)*

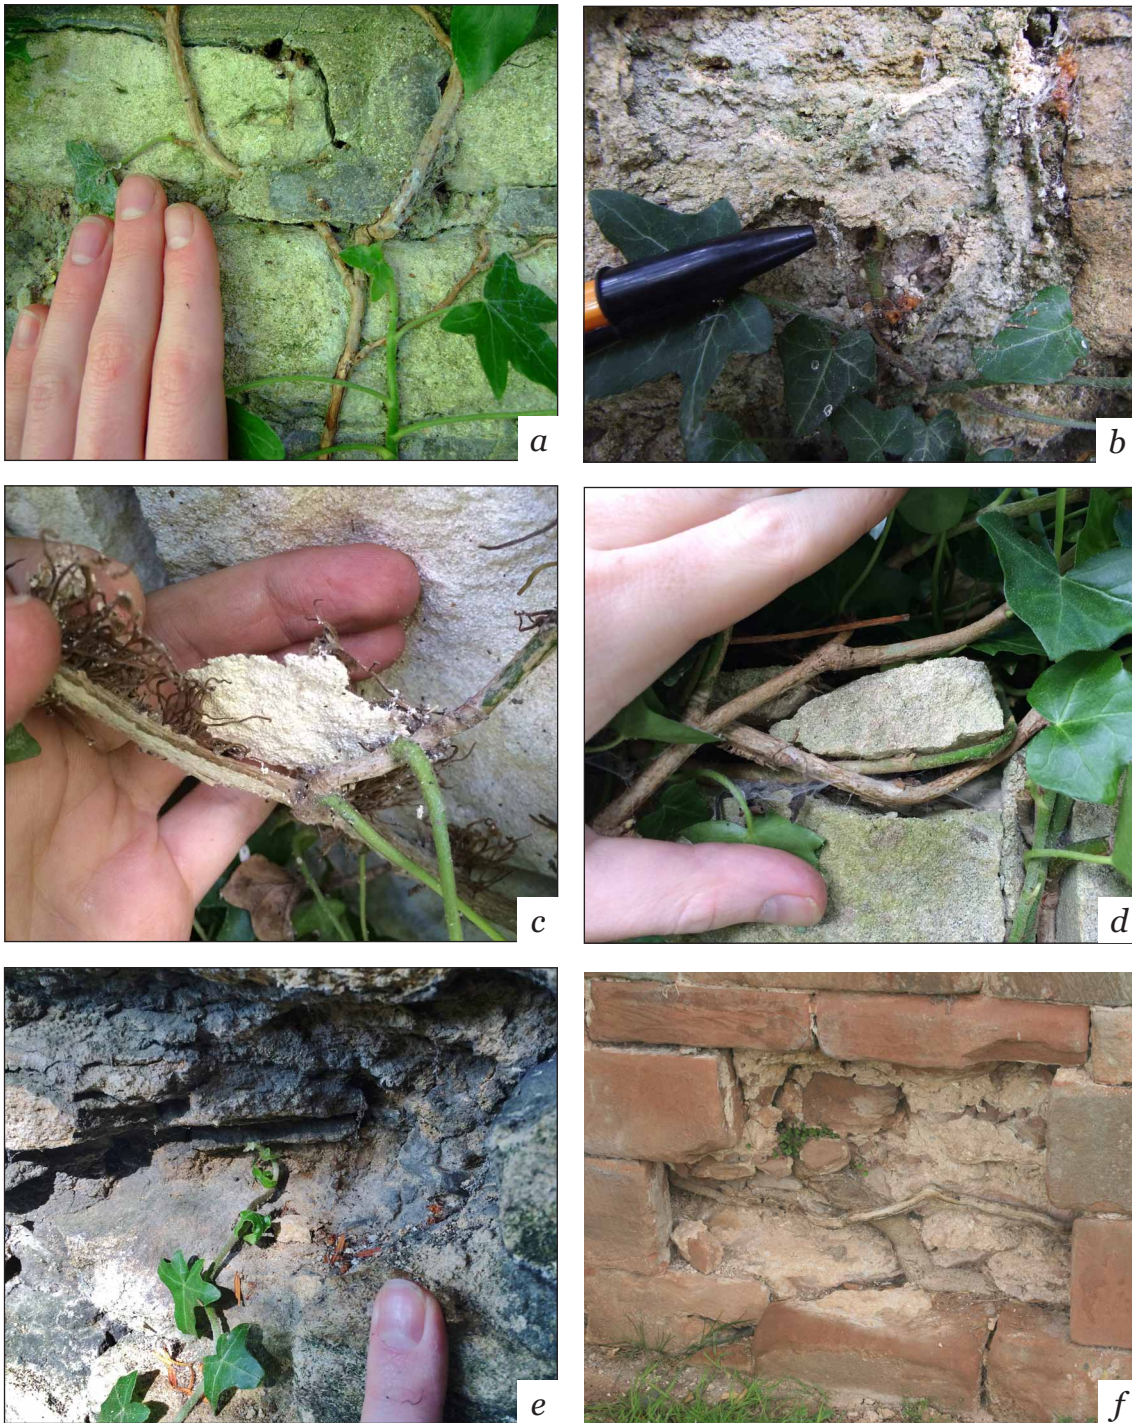
*Figure 2-12. Ivy stems interacting with existing deterioration features: (a) growth under loosened pointing repairs (Holywell Cemetery, Oxford); (b) penetration into badly deteriorating and friable limestone (Holywell Cemetery, Oxford); (c) aerial rootlet attachment to spalling limestone (Wytham Woods test walls); (d) shoots growing between a fractured limestone block (present before colonisation and possibly caused by frost damage, Wytham Woods test walls); (e) stem growth into, around, and out of larger voids; (f) stems growing into, thorough and out of walls can cause serious damage to walls (Maxstoke Priory, Warwickshire). (f ©Alan Cathersides)*

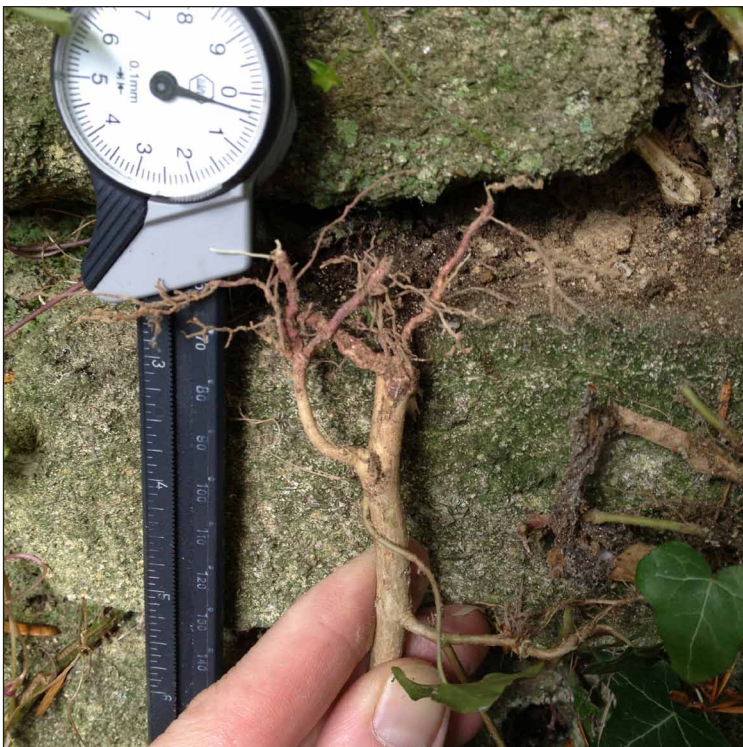
*Figure 2-13. An example of ‘rooting-in’ by a juvenile ivy stem growing in a recessed mortar joint of a deteriorating limestone wall, Holywell Cemetery, central Oxford (0.5 m above ground level).*

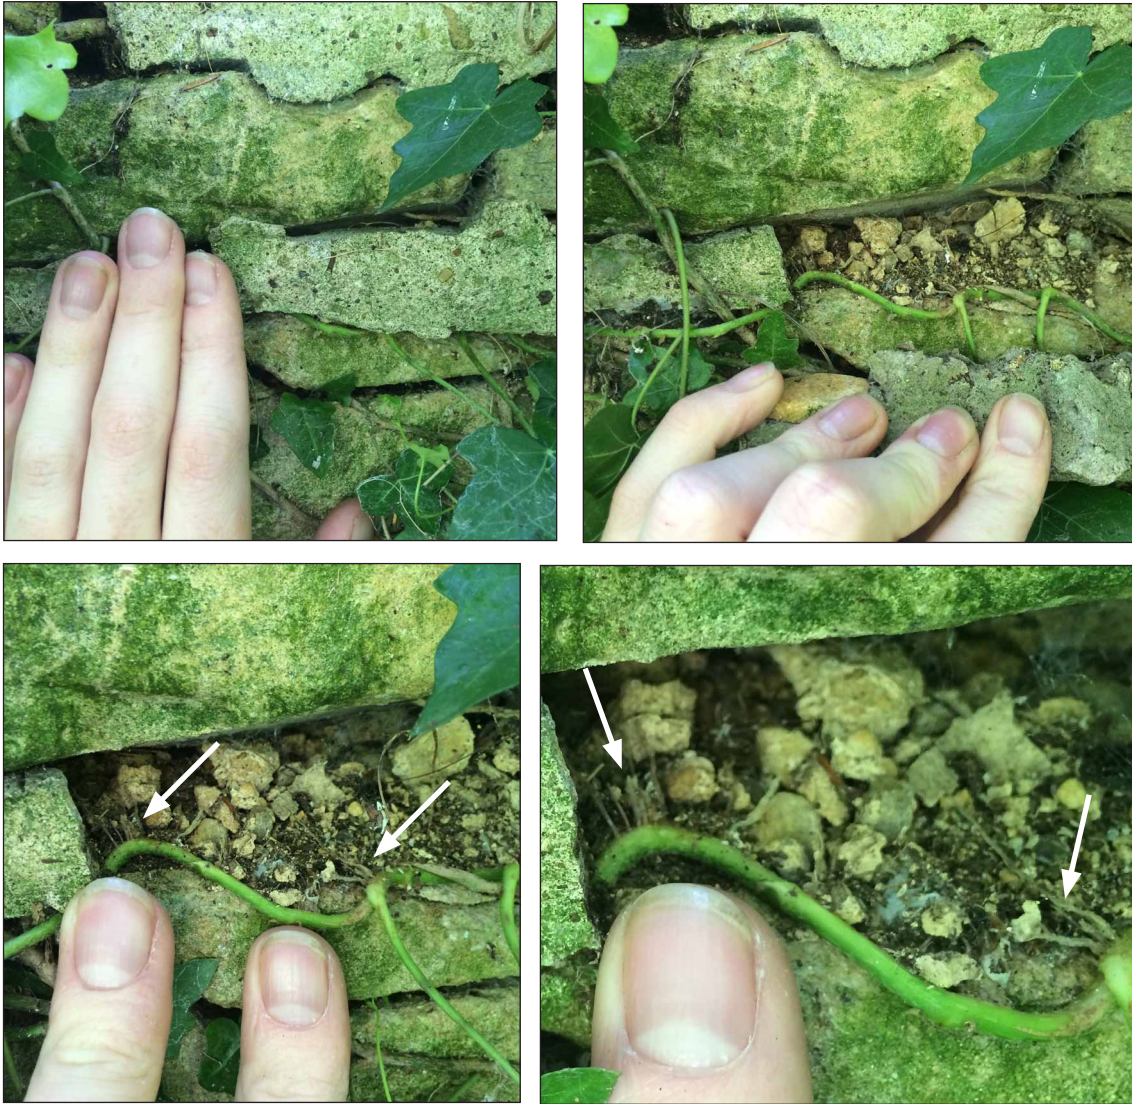
*Figure 2-14. 'True' roots sprouting from a juvenile stem growing under a mortar repair, in the presence of darkness, moisture and weathered debris, Holywell Cemetery, Oxford (recently sprouted roots indicated).*

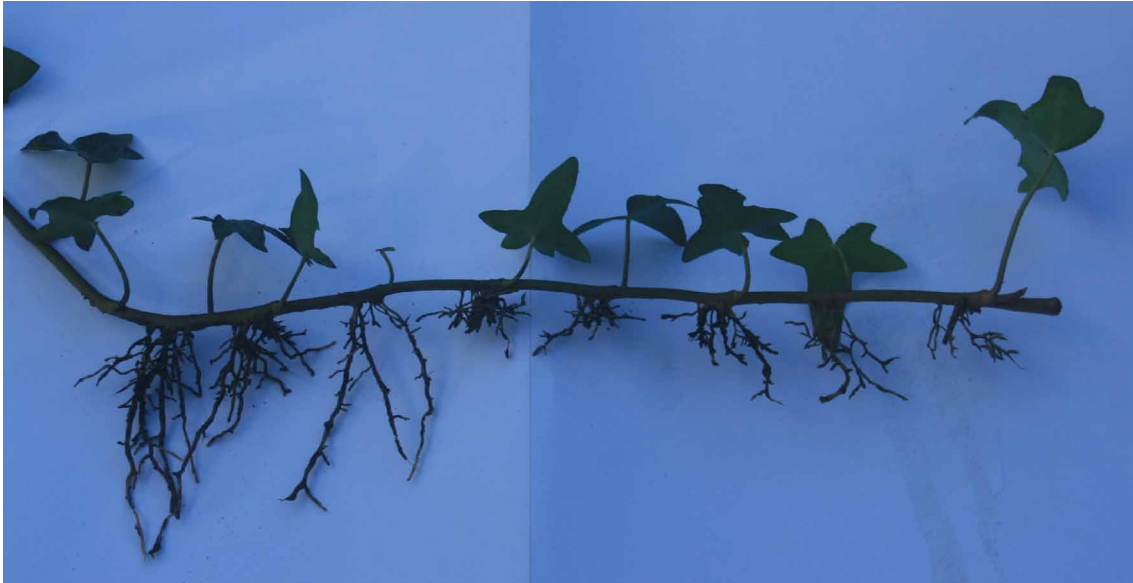
*Figure 2-15. 'True' roots readily sprout from juvenile ivy stems when in contact with moisture and soil. Here, an example of layering involving roots sprouting from leaf nodes of a stem lifted from a forest floor ©Alan Cathersides.*

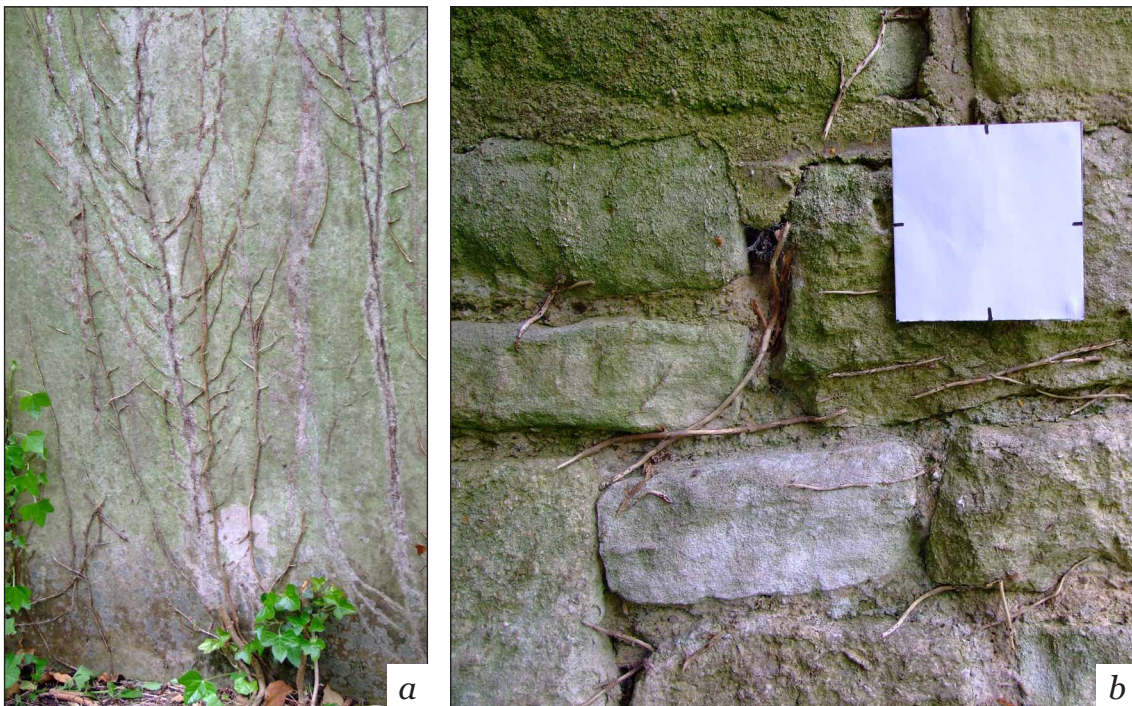
*Figure 2-18. Examples of aesthetic ‘damage’ following the removal of clinging ivy stems: (a) stem remnants and ‘staining’ of a headstone (Hampstead Cemetery, London); (b) stem remnants on a limestone masonry wall (Holywell Cemetery, Oxford, scale = 10 cm<sup>2</sup>).*

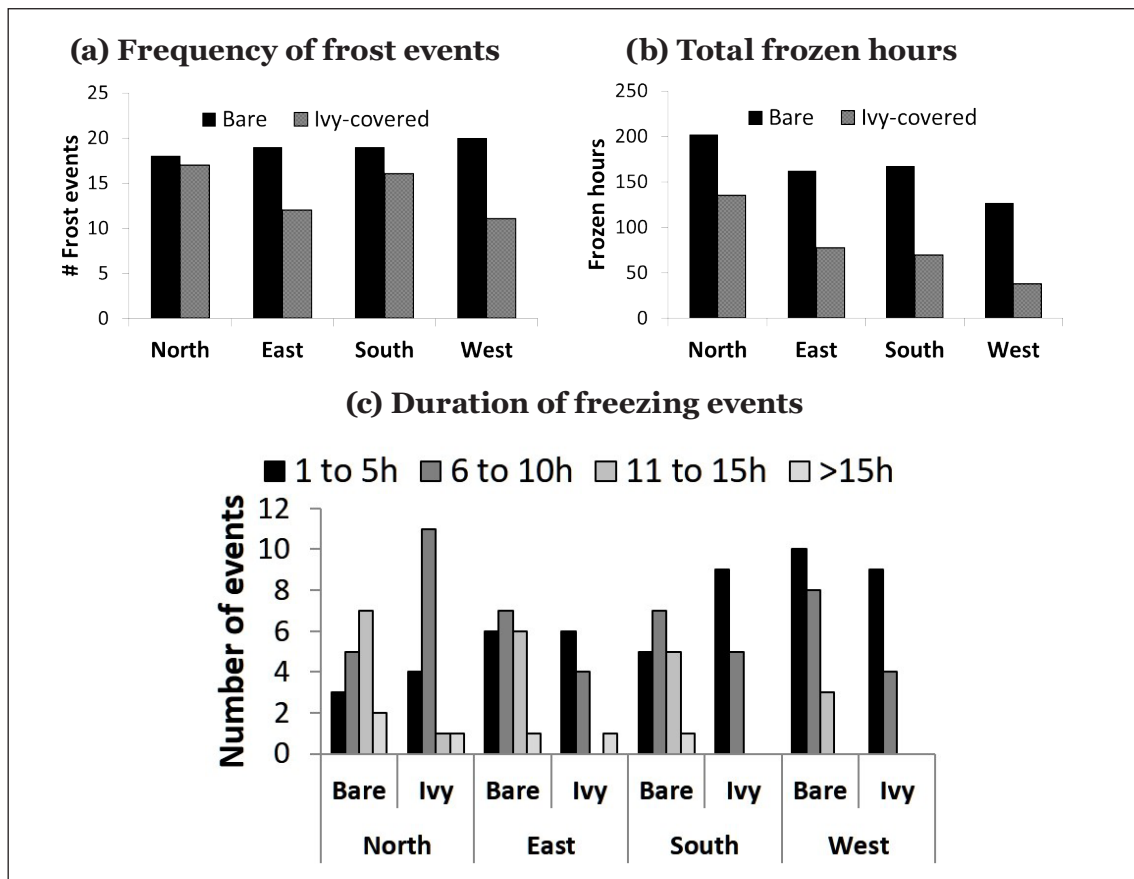
Figure 3-6. The influence of ivy cover and wall aspect on freezing events recorded at the Wytham Woods test wall in winter 2012/13 and 2013/14: (a) number of individual frost events (fluctuations above and below 0°C); (b) total number of hours of freezing temperatures (also see Figure 3-7b); (c) frequency of individual freezing events of different duration (in hours).

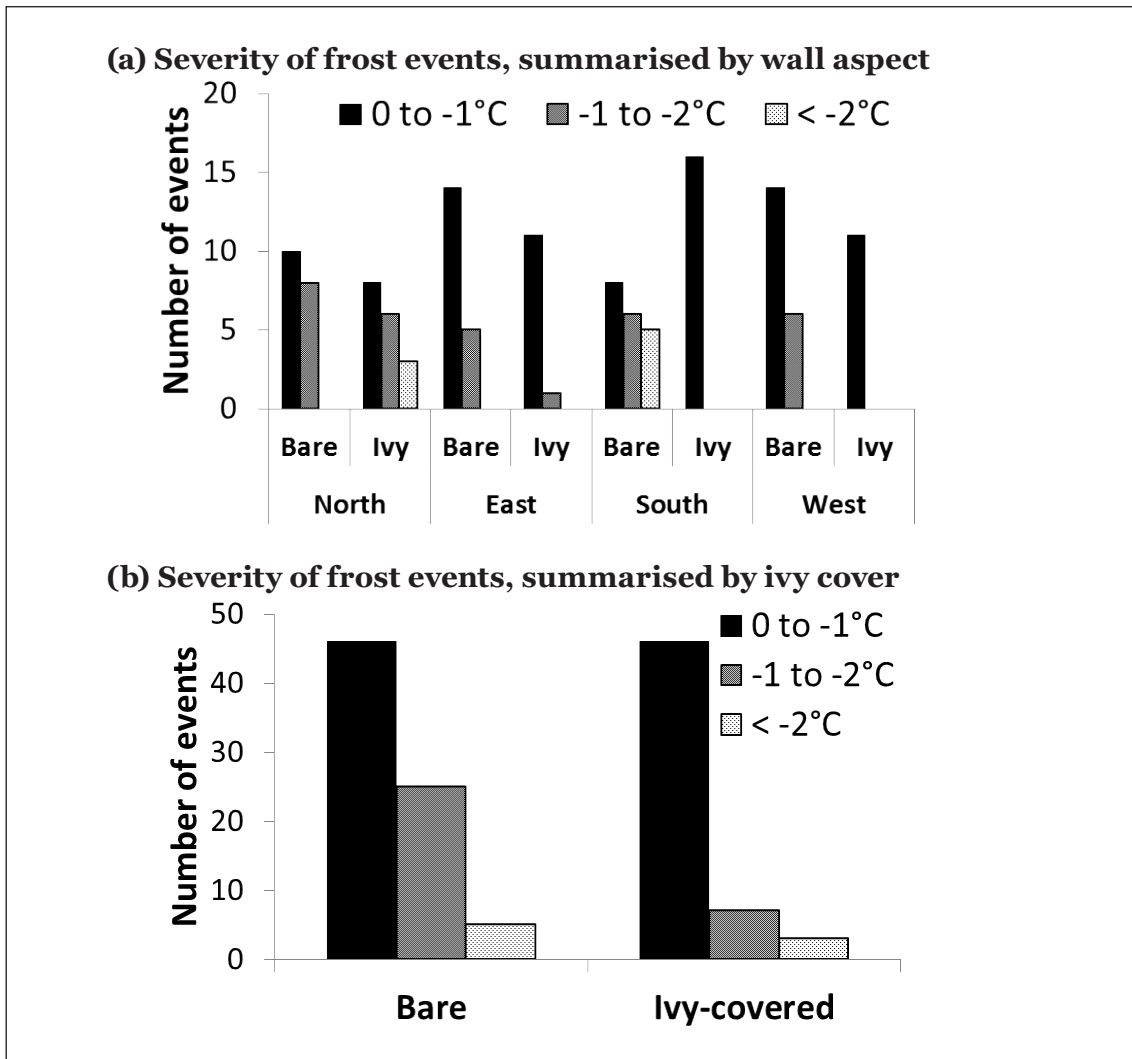
Figure 3-7. Number of frost events of differing severity recorded at the Wytham Woods test wall in winter 2012/13 and 2013/14 summarised by: (a) wall aspect and (b) ivy cover.

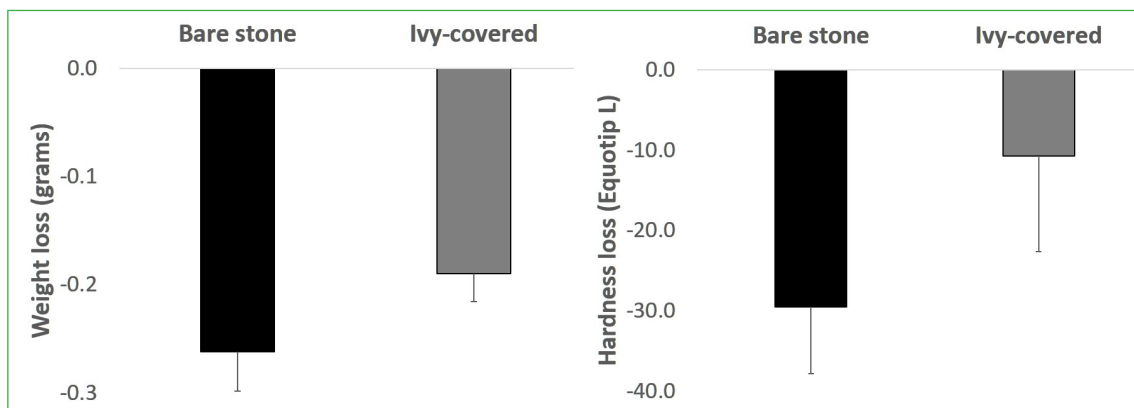
*Figure 3-8: Deterioration of Elm Park limestone as a result of freezing cycles simulated in an environmental chamber representative of 'bare stone' and 'ivy-covered' conditions: (a) loss of mass (average + SD,  $n = 5$ ) and (b) change in surface hardness after a 6-week simulation.*

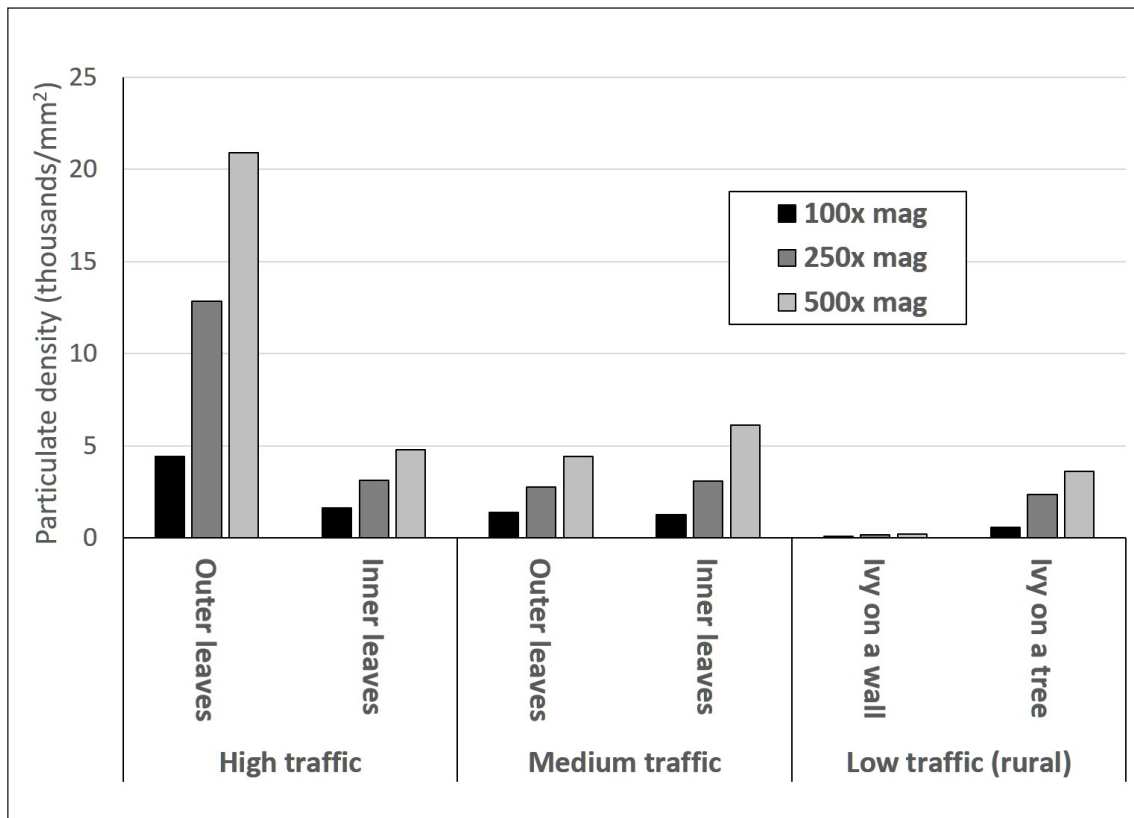
*Figure 3-9: Densities of airborne particulates on leaves taken from the outer and inner parts of ivy canopies growing on walls in Oxford: high traffic volume = London Road; medium traffic volume = Walton Street; low traffic volume = Wytham Woods. Counts were made at three different magnifications (100x, 250x and 500x). Average values of four different leaves from each site are shown. (Produced using data from Sternberg et al., 2010)*

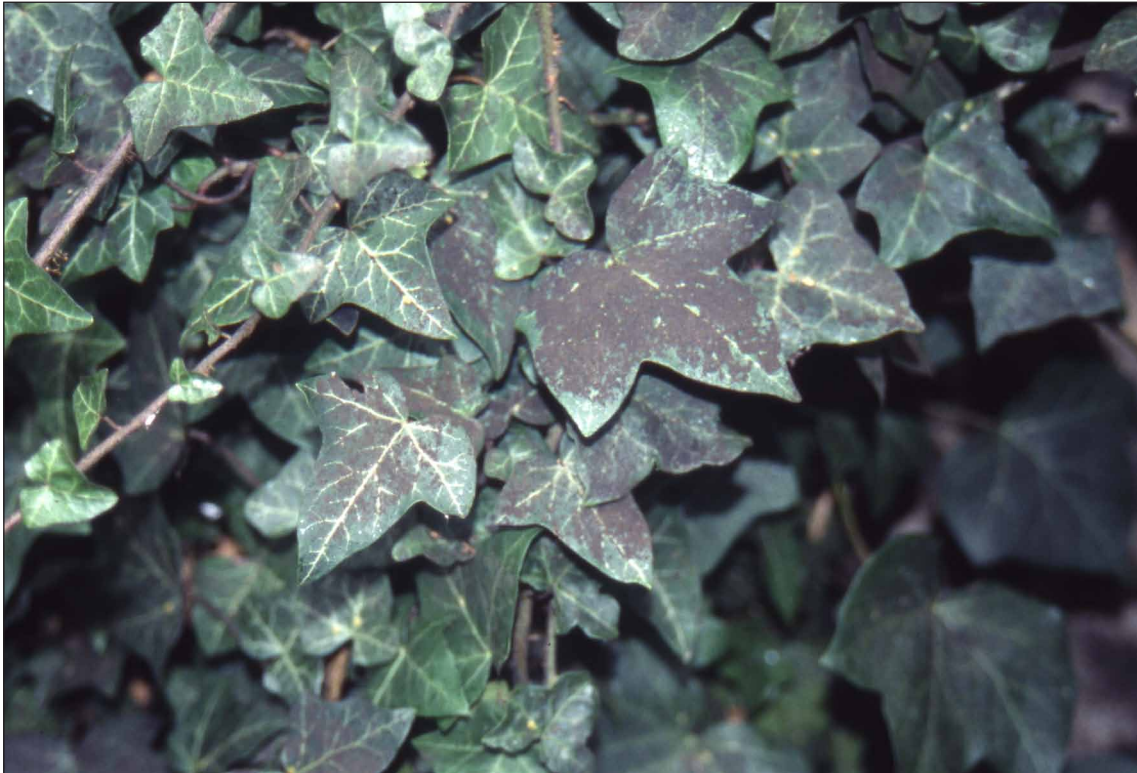
*Figure 3-10: Ivy foliage can capture a remarkable amount of airborne pollution in urban areas with high traffic flow. This example is from London Road, Oxford (taken in February 2007, ©Alan Cathersides).*
