## Ivy on Walls

Prepared for Historic England by Dr Martin Coombes and Prof Heather Viles, Oxford Rock Breakdown Lab (OxRBL), University of Oxford; and Alan Cathersides, Historic England

Discovery, Innovation and Science in the Historic Environment

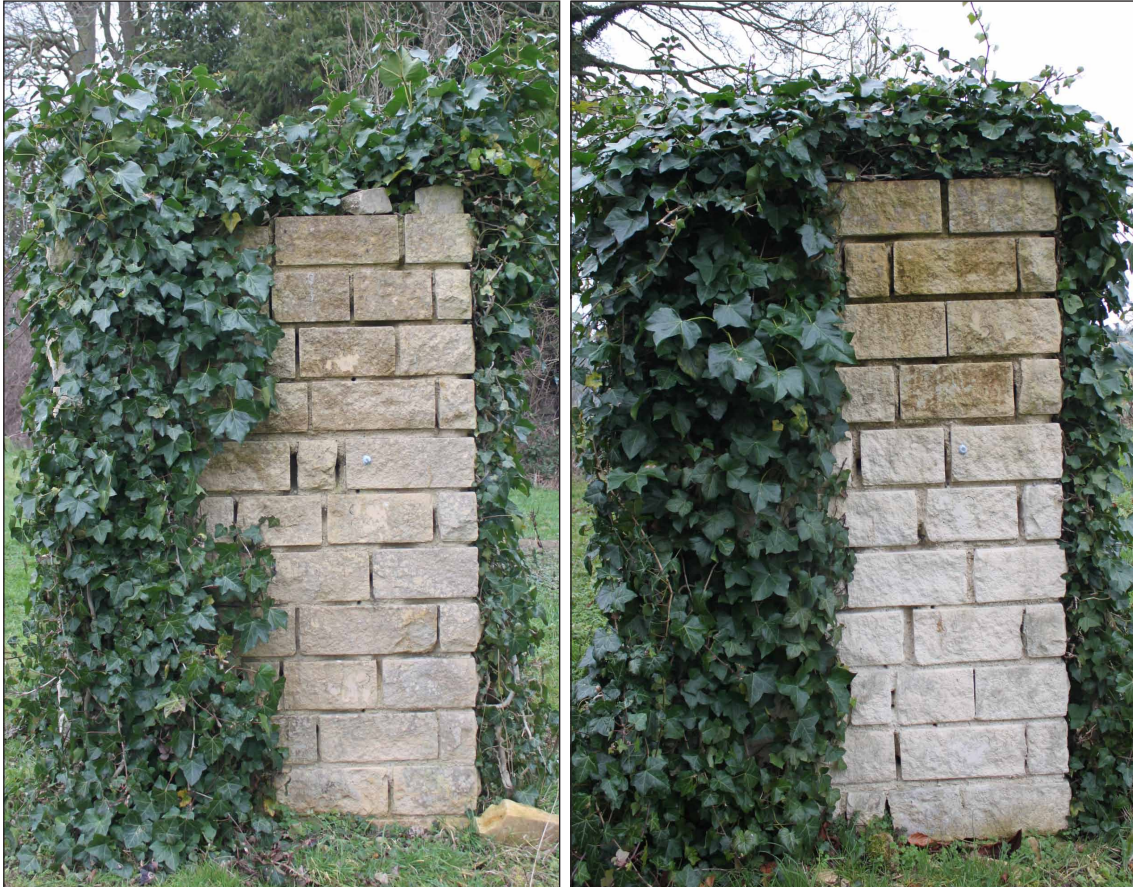
*Figure 3-11. Photographs illustrating the influence of wall orientation (aspect) and height on stone discolouration at the Wytham Woods test wall. Note the greening towards the top of the north-facing wall relative to other areas of stone.*

The influence of wall height on stone discolouration was also examined in combination with ivy cover using data collected in July 2015. Overall, the tops of walls had darkened significantly more than the middle and bottom sections ( $p = 0.01$ ). Exposed stone had also darkened significantly more than ivy-covered stone ( $p = 0.04$ ), but the strength of this effect varied with wall height (Figure 3-14a). For example, on all four aspects the tops of walls had discoloured more without a cover of ivy ( $p = 0.01$ ) whilst there was less of a difference on the lower sections. Ivy appeared to have limited darkening at the tops of the walls, which may otherwise occur relatively quickly where more directly exposed to moisture (rainfall) and sunlight. Similarly, wall height had a significant effect on greening ( $p = 0.007$ ), with greater colour change at their tops compared to lower sections (see Figure 3-11). The influence of ivy on greening was not clear in July when these measurements were taken, and in some cases stone was more discoloured under the ivy canopy (particularly the east-facing wall, Figure 3-14b).

These measurements highlight an interacting influence of wall orientation and height and, in particular, seasonal effects on stone soiling and discolouration over time. The greatest differences between ivy-covered and exposed stone occurred during the wetter/cooler winter and spring months, probably in association with the growth of microorganisms. Shading of stone by ivy foliage, and its influence on stone surface microclimates, may mediate microbial growth to some extent, particularly at the tops of walls but this requires further research.

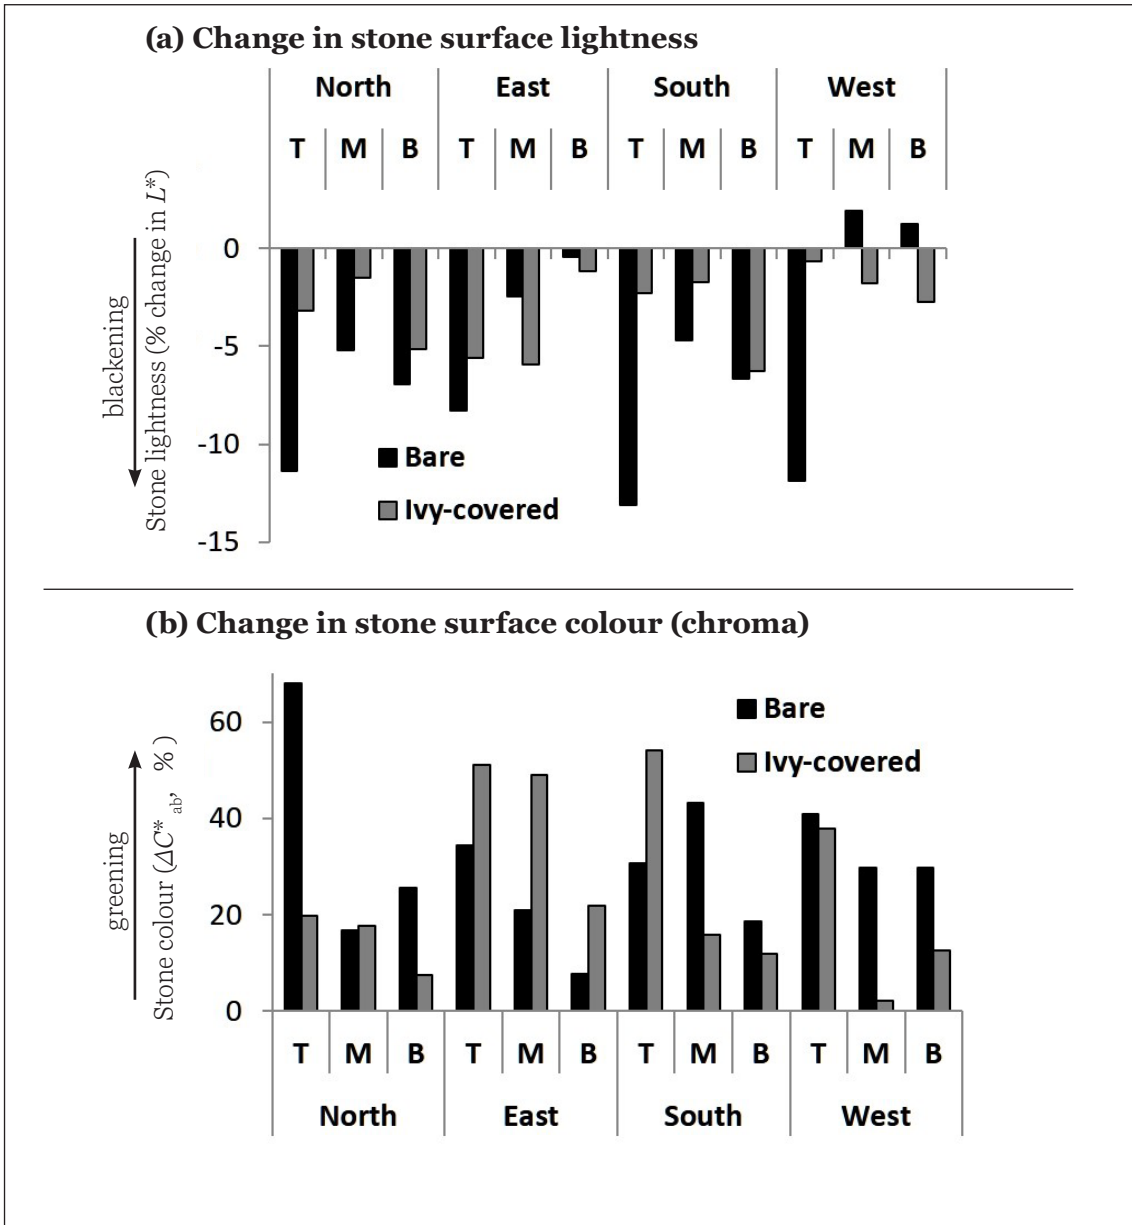
Figure 3-14. Stone surface (a) darkening and (b) discolouration at the Wytham Woods test wall recorded in July 2015 relative to baseline measurements (April 2013). Four wall aspects and three wall heights were measured (T = top of wall, M = middle of wall, B = base of wall).

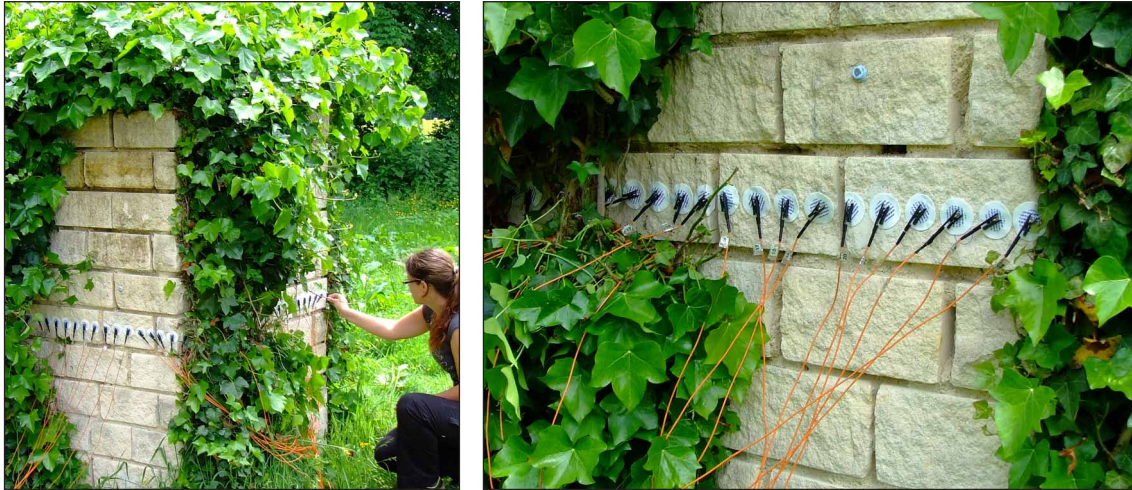
Figure 3-18. Geoelectrical survey being conducted at the Wytham Woods test wall in July 2014. Electrodes were placed in horizontal transects across ivy-covered and exposed sections of each aspect.

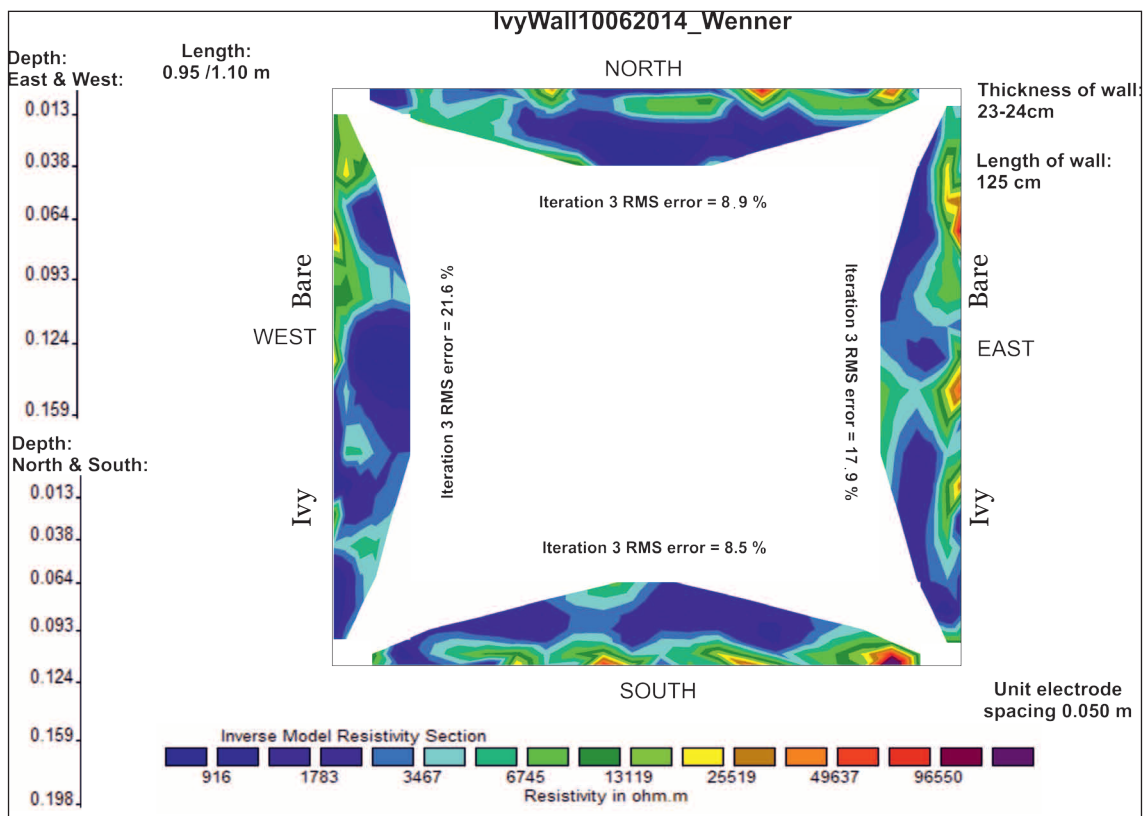
Figure 3-19. Electrical resistivity (ERT) profiles (Wenner configuration) for the Wytham Woods test wall (July 2014). Blue colours are indicative of higher moisture. Each wall has one side covered with ivy and one without any ivy side, as indicated.

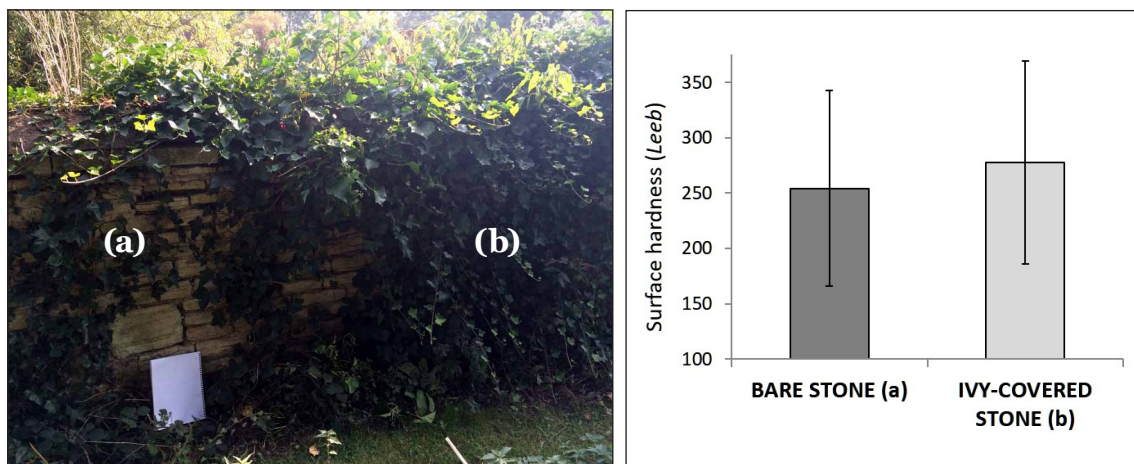
*Figure 3-22. Surface hardness of poor-condition limestone with and without a cover of ivy, Holywell Cemetery, Central Oxford (mean values  $\pm$  SD,  $n = 200$ ). Data are for 21-Sep-2014, A4 notepad for scale).*

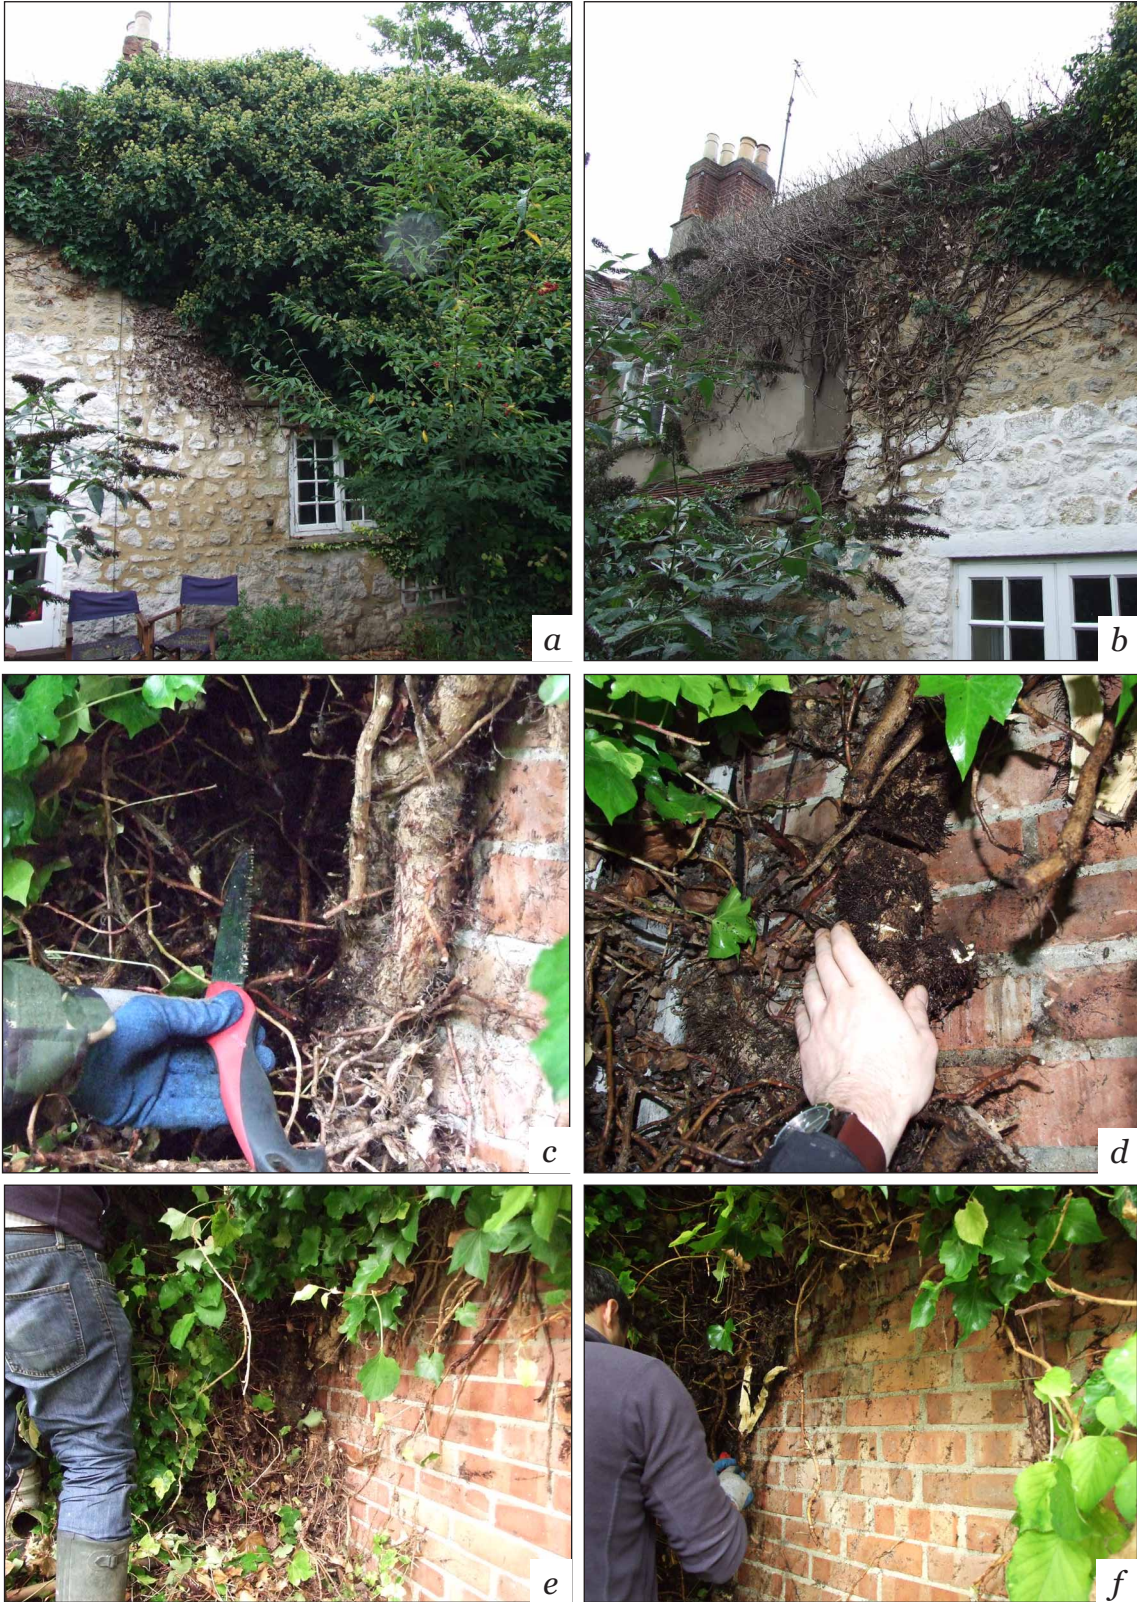
*Figure 4-1. Photographs of ivy and its management on a stone and brick cottage, Walton Street, Oxford.*

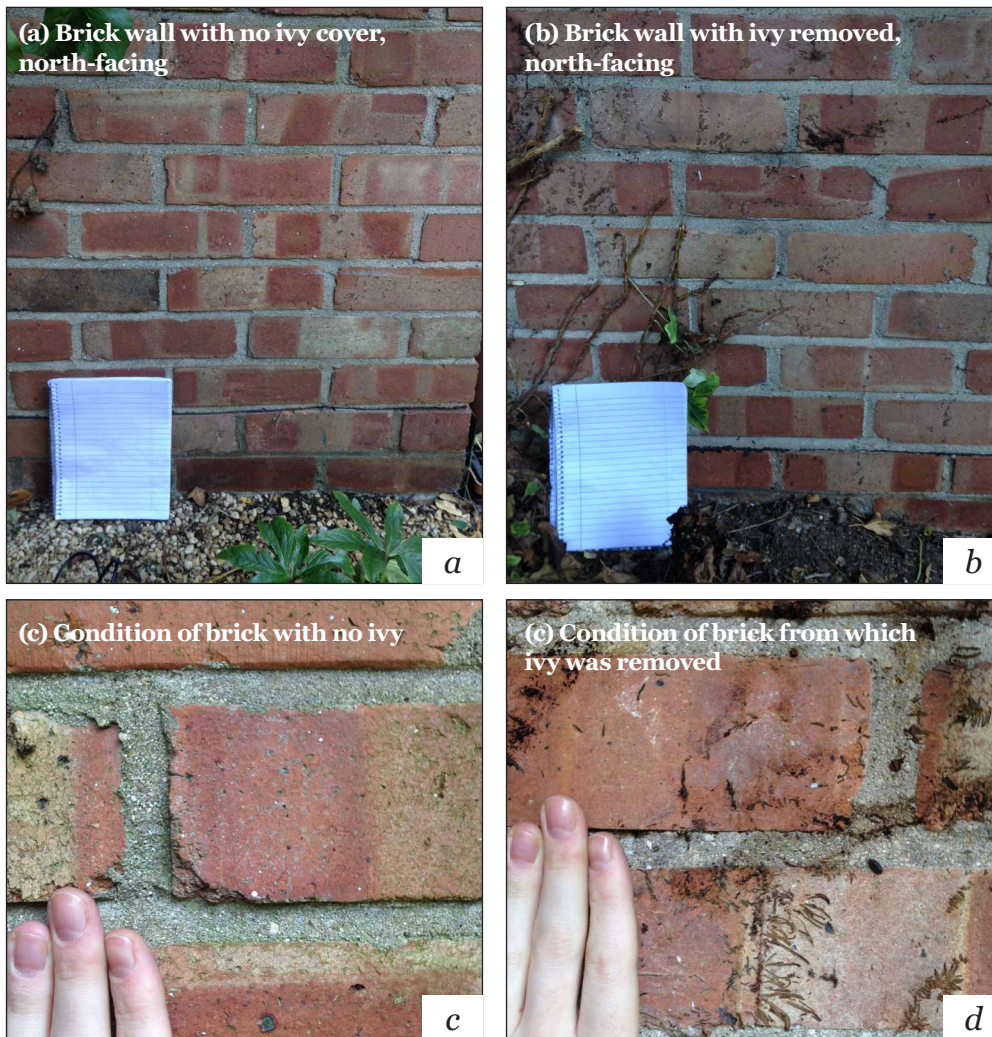
*Figure 4-2. Areas of brickwork on which surface moisture readings were taken: (a) and (c) an area without any previous ivy cover; (b) and (d) adjacent area from which a complete cover of ivy has been removed.*

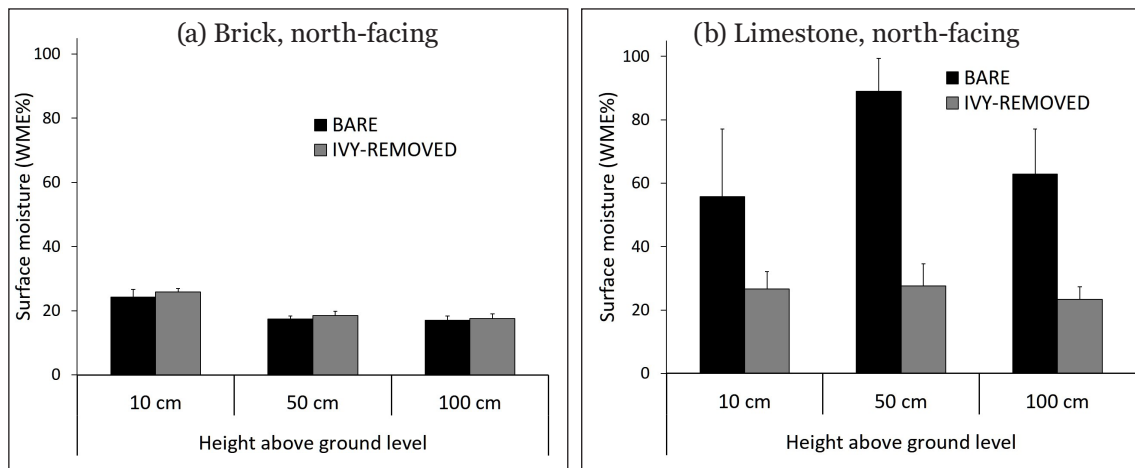
Figure 4-3. Surface moisture of a brick and limestone wall in areas where ivy had recently been removed, and adjacent areas free of ivy growth, Walton Street, Oxford. Average + SD of ten measurements in each location made using a Protimeter.

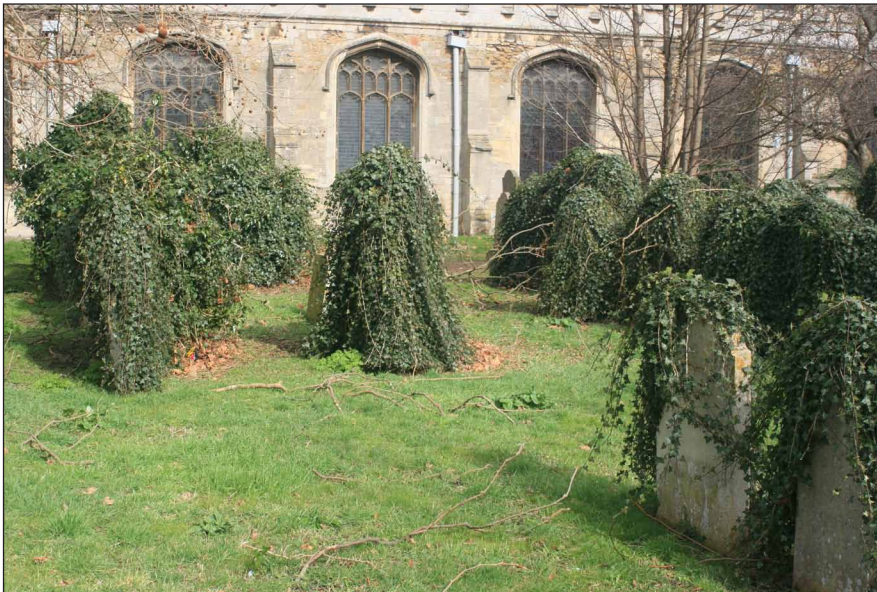
*Figure 4-4. St Thomas-à-Becket churchyard, Ramsey, Cambridgeshire*  
©Alan Cathersides.

St Thomas-à-Becket Churchyard, Ramsey, Cambridgeshire, contained extensive and unusual ivy growth. The churchyard contained a remarkable, probably unique, number of gravestones completely encased in ivy growth. Individual stones, and in some cases whole rows of stones, were encased, often with neighbouring stones fully exposed (Figure 4-4). In March 2008 the project team were brought in to assess the impact of the ivy on gravestones. All ivy was removed from three gravestones and partially removed from a fourth to serve as a demonstration.

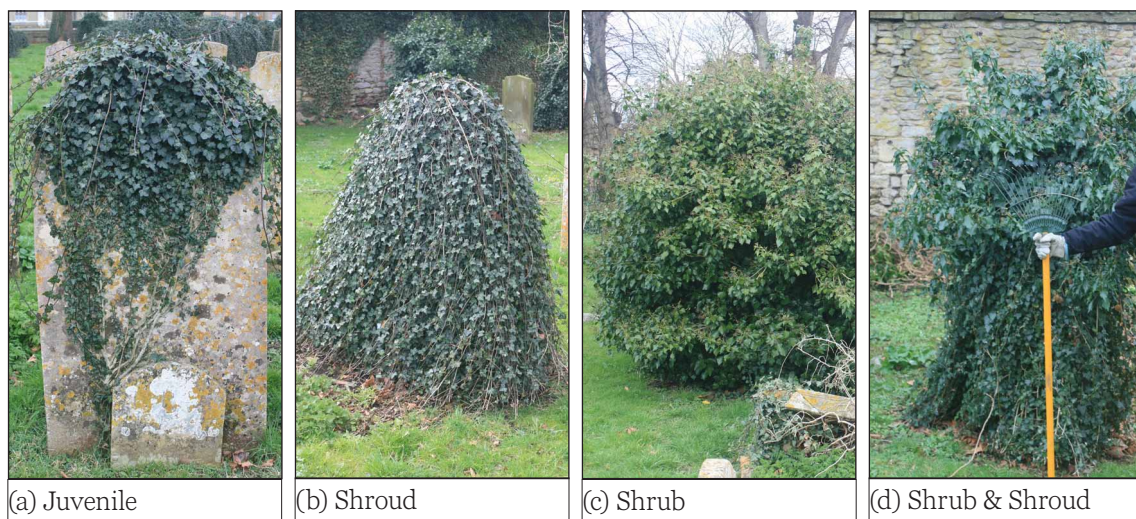
*Figure 4-5. Four types of ivy cover: (a) Juvenile; (b) Shroud; (c) Shrub; (d) Shrub & Shroud. Ramsey, March 2008 (all ©Alan Cathersides).*

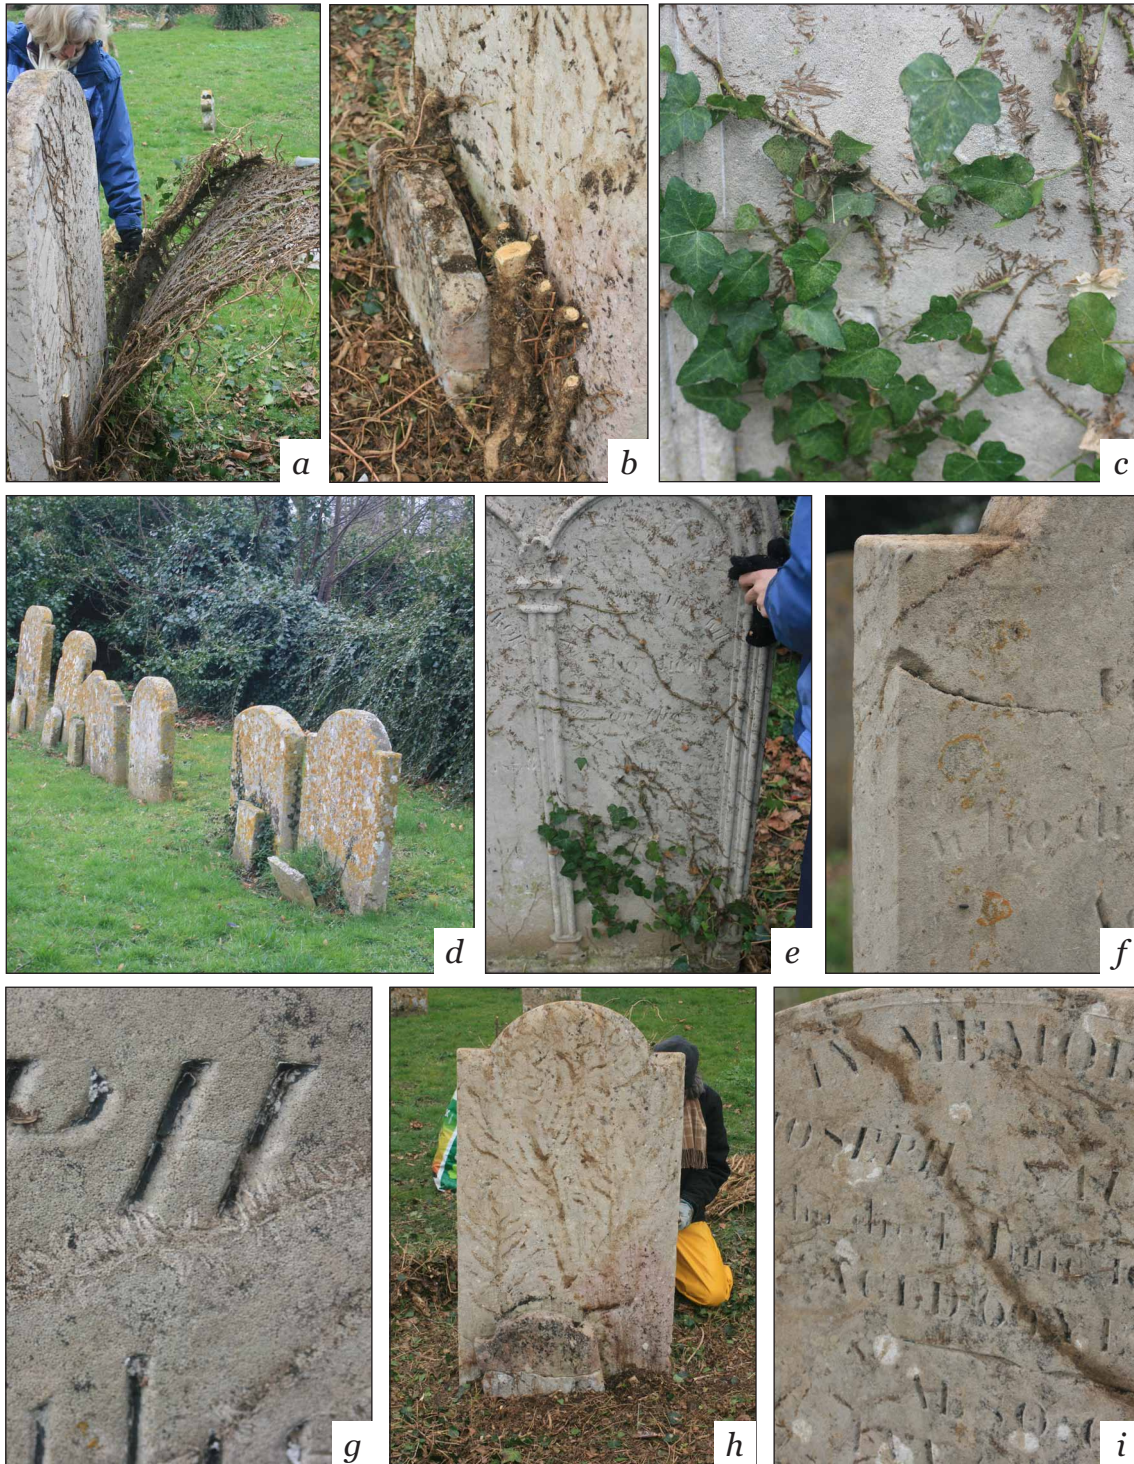
*Figure 4-7. (a) main framework of stems peeling away from stone surface; (b) growth between gravestones and 'footstones'; (c) juvenile stems adhered more firmly to the surface than older stems; (d) example of ivy 'hedge' behind row of uncovered stones; (e) removal of ivy from fragile or intricate features needs to be undertaken with care; (f) flaws or previous damage may be protected by a covering of ivy but put at risk if exposed; (g) aerial rootlet marks left once stems are removed; (h) and (i) brown staining on gravestones. Ramsey, March 2008 (all ©Alan Cathersides).*

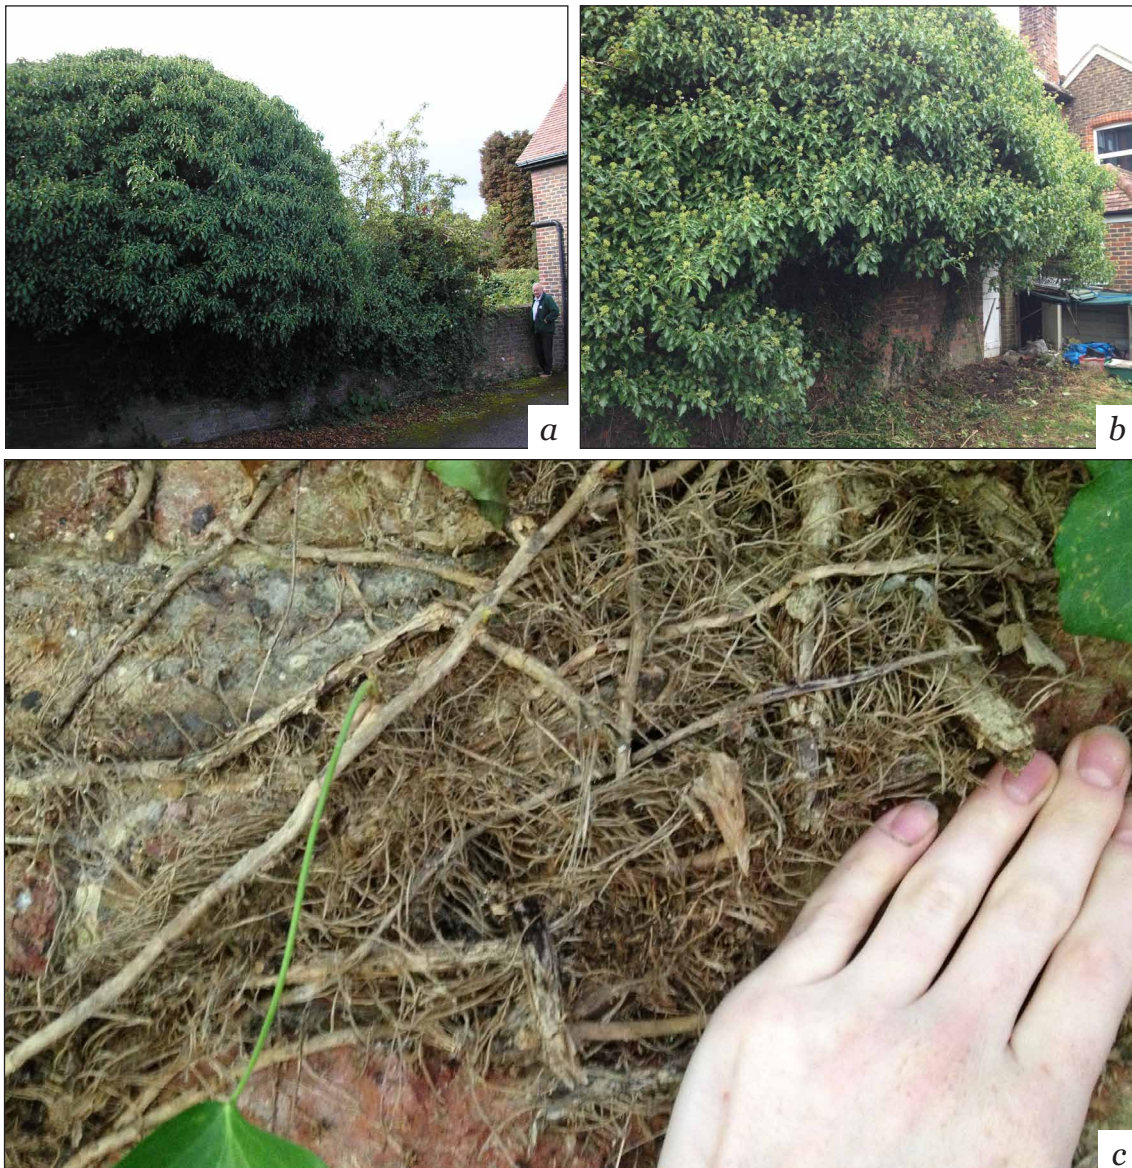
*Figure 4-8. Ivy canopy prior to removal (a) north-facing side of the wall; (b) south-facing side of the wall (c) mat of stems growing against the wall surface. Warnham, 2014.*

Ivy was growing up from the base of the south-facing side of the wall, against the taller section, with a large canopy of arborescent growth reaching at least 2 m above the wall top. The canopy overhang was 1 m on the south side and 1.5 m on the north side of the wall (Figure 4-8a-b). The middle section of the southern aspect was entirely covered (from base to top) in a dense mat of stems and foliage (Figure 4-8c). The canopy overhang on the north side extended down to 1 to 2 feet above ground level (Figure 4-8a). A section of the wall was entirely free of ivy on both sides (no climbing growth and no canopy cover) providing ideal 'control' comparisons with the covered sections of wall. A section cut from the main stem indicated that the plant was at least 23 years old.

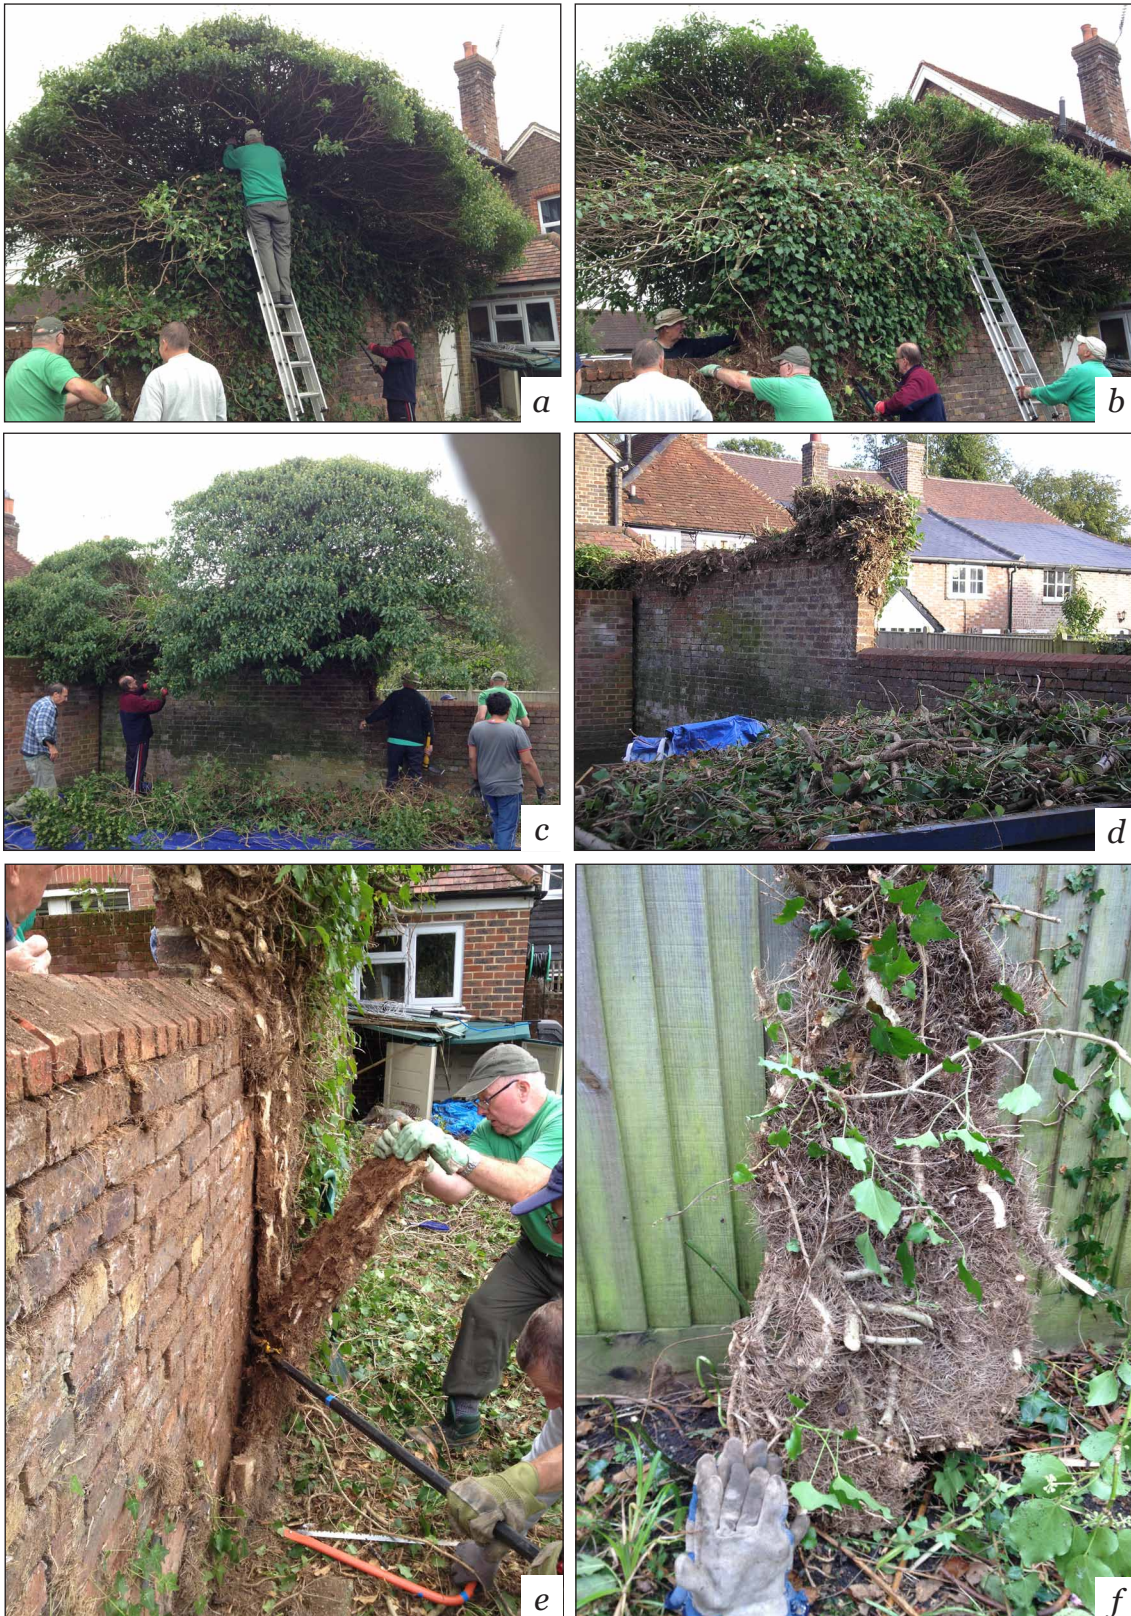
*Figure 4-9. Spreading flowering stems were first removed, followed by vertical foliage covering the wall. The dense mat of stems was sawn and prised off using a crow-bar were possible.*

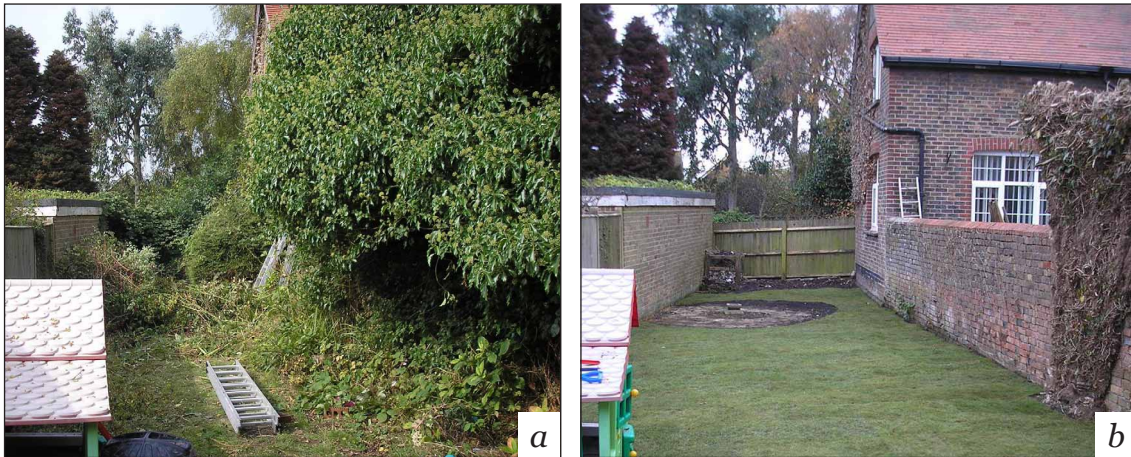
*Figure 4-10. (a) Before removal (b) post-removal (notice the section of growth including the main ‘trunk’ that could not be removed due to structural concerns.*

Whereas all of the ivy canopy and most of the climbing growth was successfully removed, the section containing the main 'trunk' (including where the ivy was rooted into the ground) was exceptionally rigid and thick. Attempts to snap this growth using leverage raised concerns about the stability of the wall, and it was decided that this section of growth (the middle portion of the southern face of the wall) should be left, and that it was probably affording some degree of structural support for the wall (Figure 4-10b).

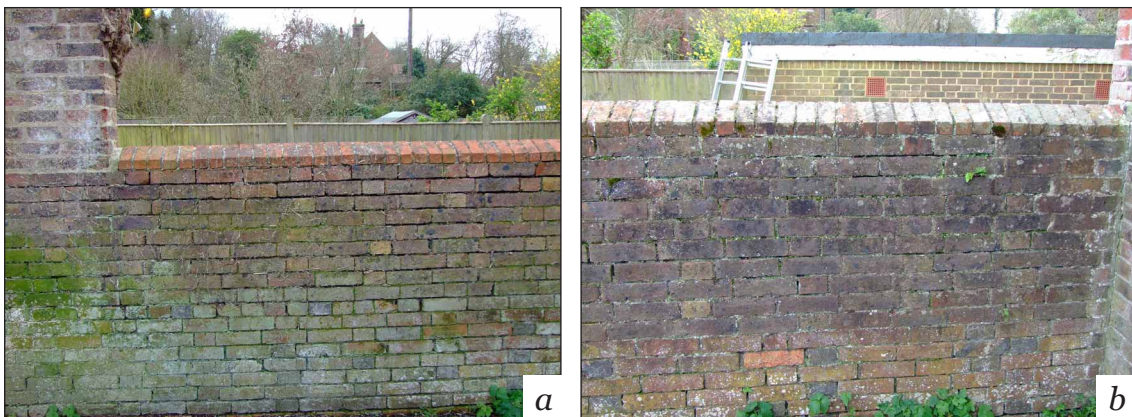
*Figure 4-11. Sections of wall from which ivy was removed (a) and adjacent area without any ivy cover (b). Note slightly recessed mortar joints where ivy was removed.*

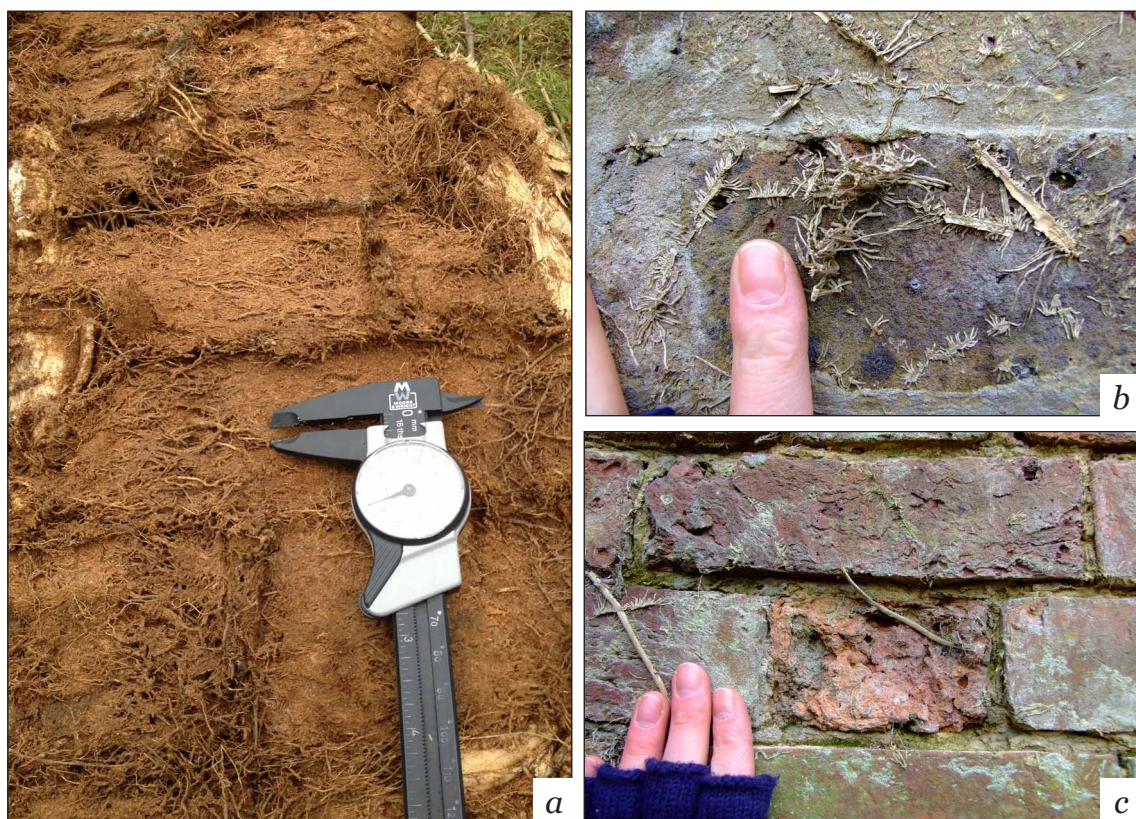
*Figure 4-12. (a) mortar joint imprint on underside of ivy root mat; (b) aerial rootlets attached to bricks after removal of stems; (c) evidence of deterioration (present in both ivy covered and bare areas).*

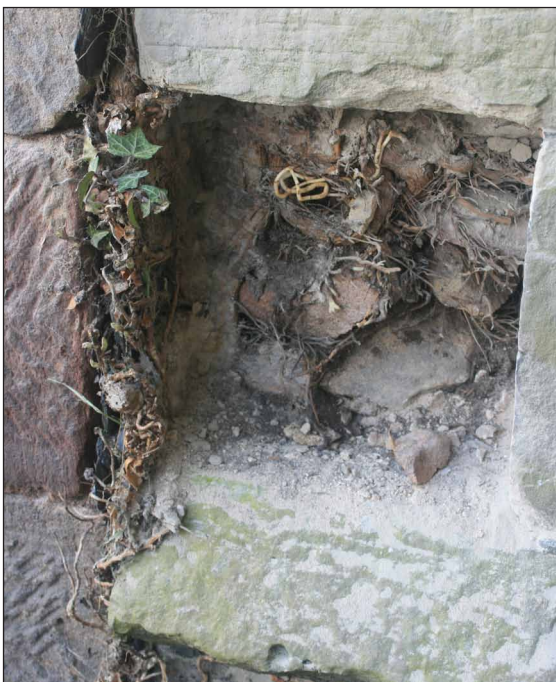
(c) Initial removal of a single external stone revealed ivy stems and roots within the wall core.

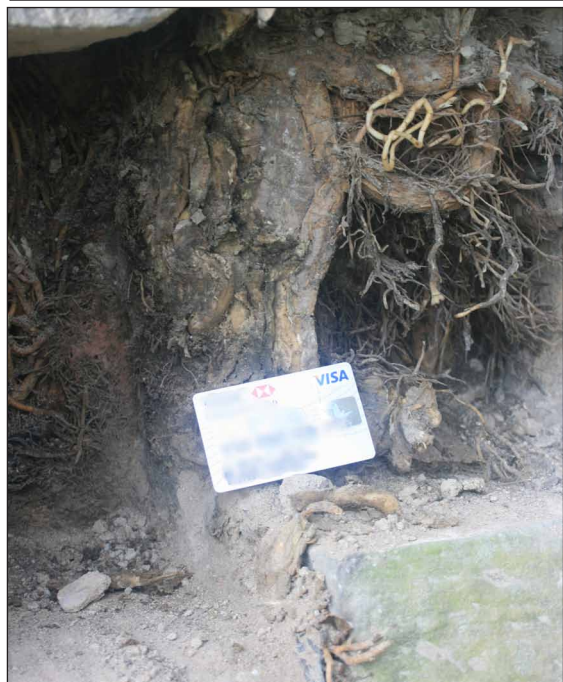
(d) Removal of two external stones showed a mass of stems filling the crack and stems with true roots within the wall core.

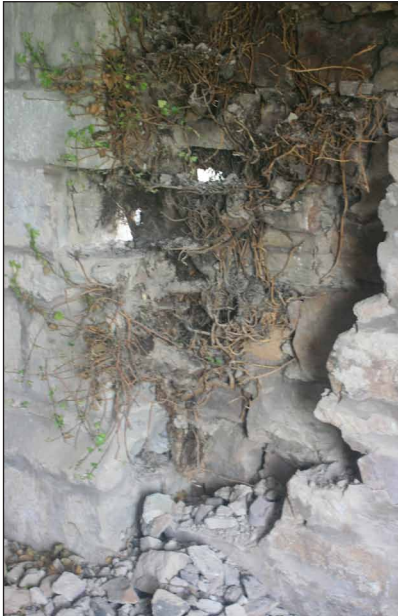
(a) Mass of ivy stems and roots within the core after removal of several layers of internal stone.

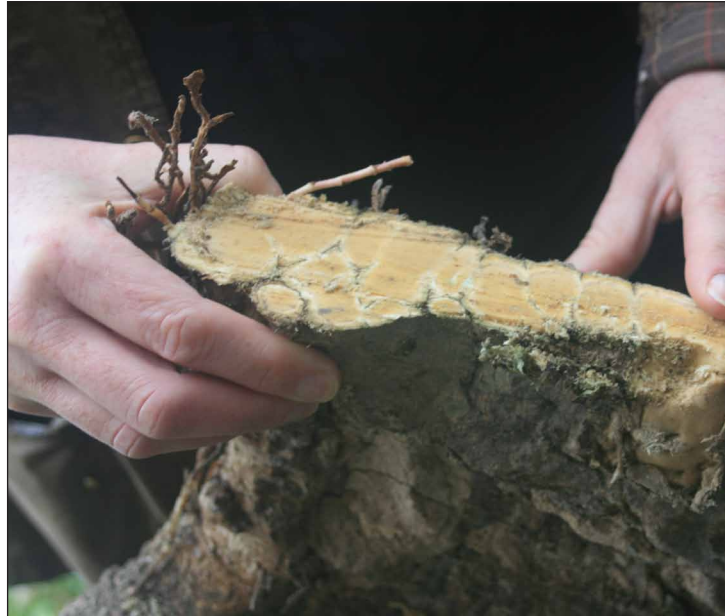
(b) Mass of compressed ivy stems removed from the base of the crack.

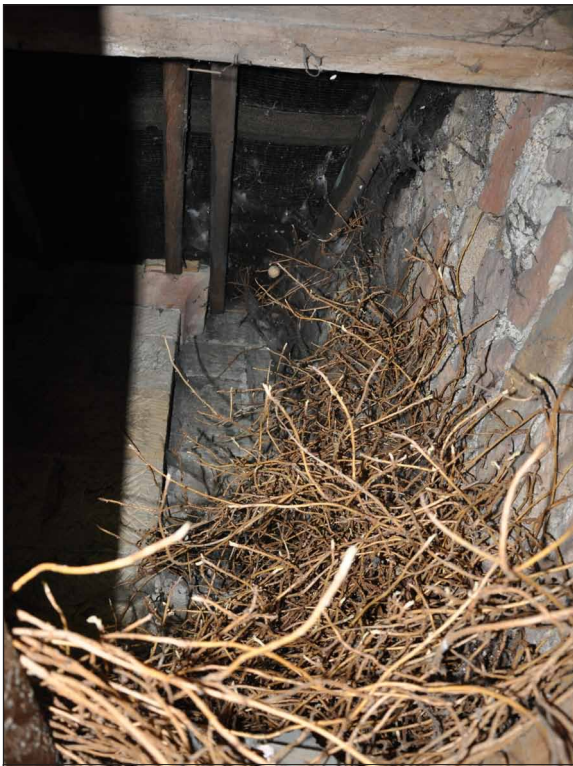
(c) Mass of ivy stems within the porch roof space.

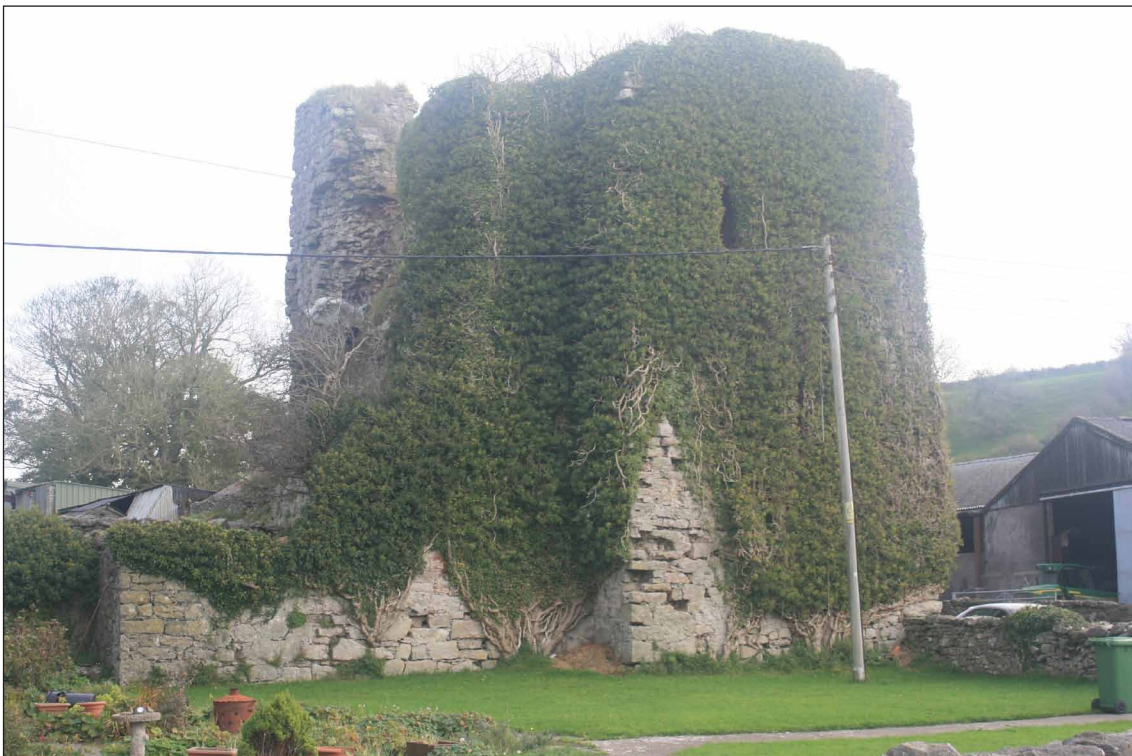
*Figure 4-20. Main tower of Gleaston Castle ©Alan Cathersides.*

Gleaston Castle in Cumbria was built in the 14th century and is both scheduled and listed (Grade I). The ruins consist of several sections of curtain wall and the remains of two towers and the keep, which is still quite substantial (Figure 4-20). The nature of ivy growth and its interaction with the wall masonry structure was inspected in 2009.

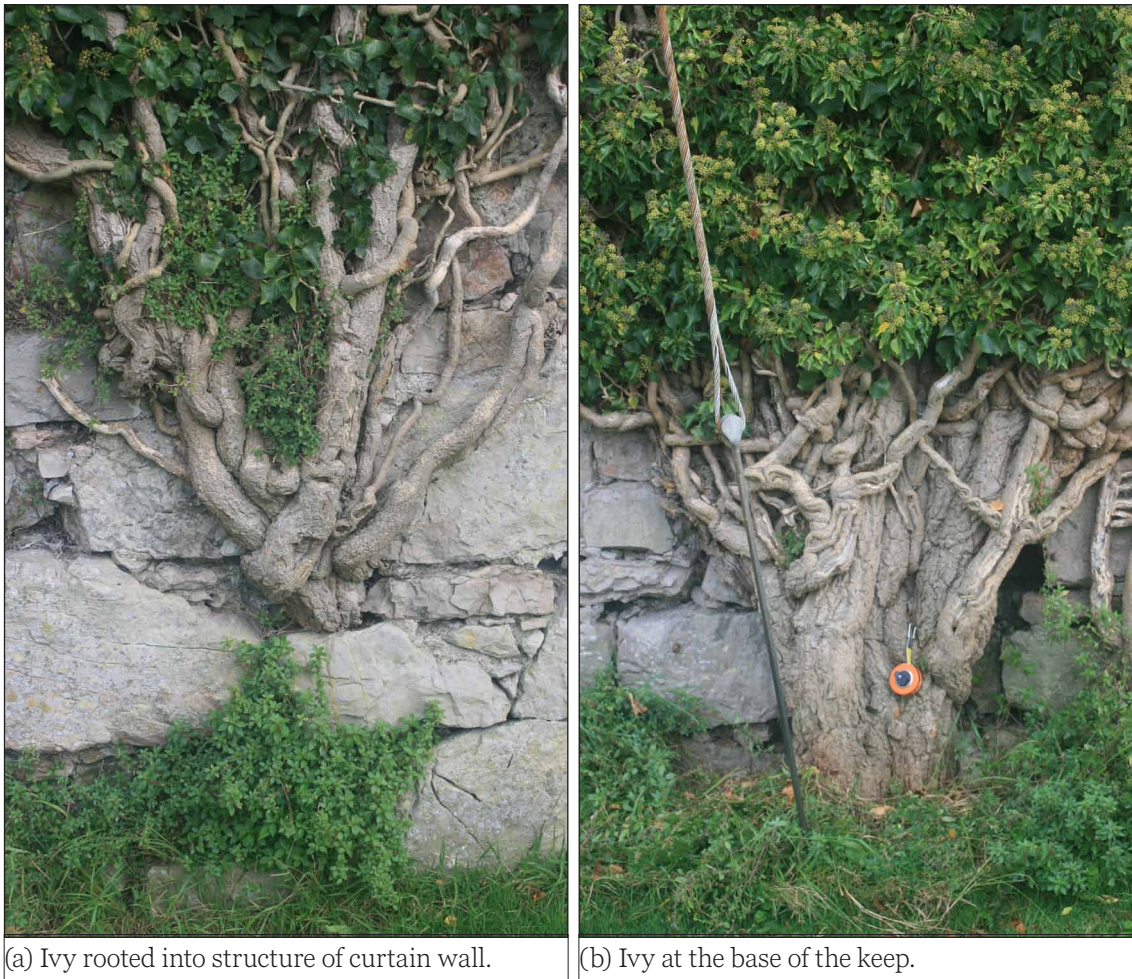
*Figure 4-21. Ivy rooting into walls and the ground, Gleaston Castle (both ©Alan Cathersides)*

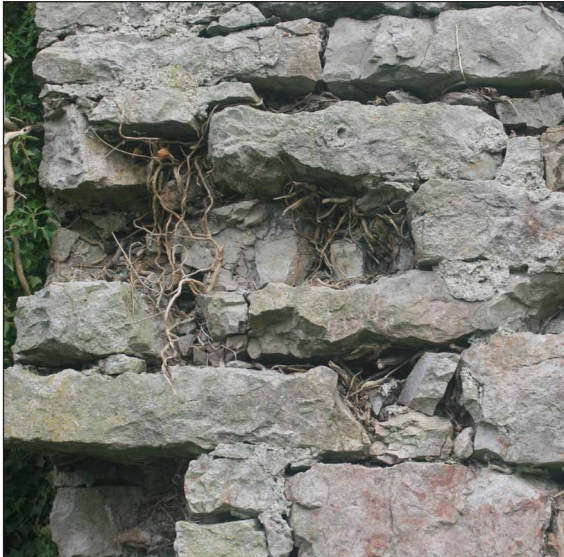
(a) Ivy stems following eroded mortar lines at Gleaston Castle.

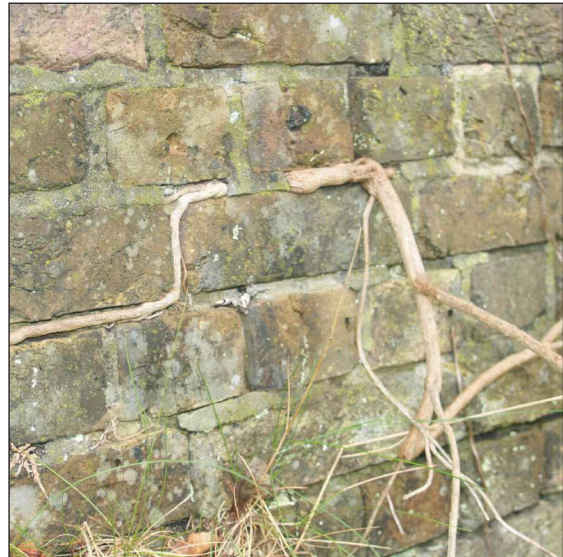
(b) Ivy stems following eroded mortar lines at Dover Western Heights.

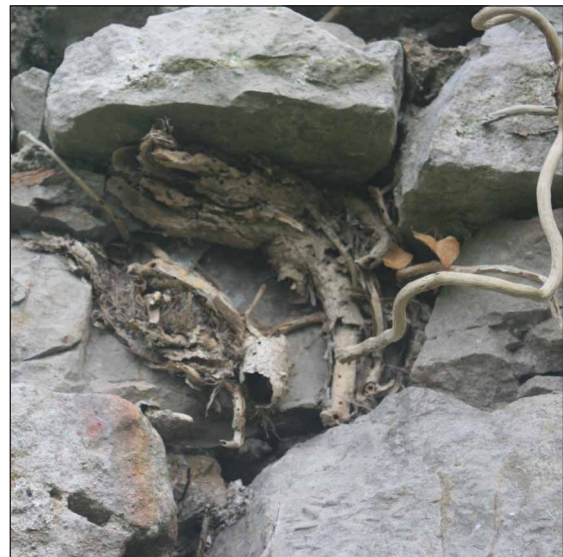
(d) Stones at Gleaston Castle dislodged by expanding ivy stems.
