Thaxted Guildhall Town Street Thaxted Essex

Tree-ring Analysis of Oak Timbers

Research Report Series no. 17/2021

THAXTED GUILDHALL
TOWN STREET
THAXTED
ESSEX

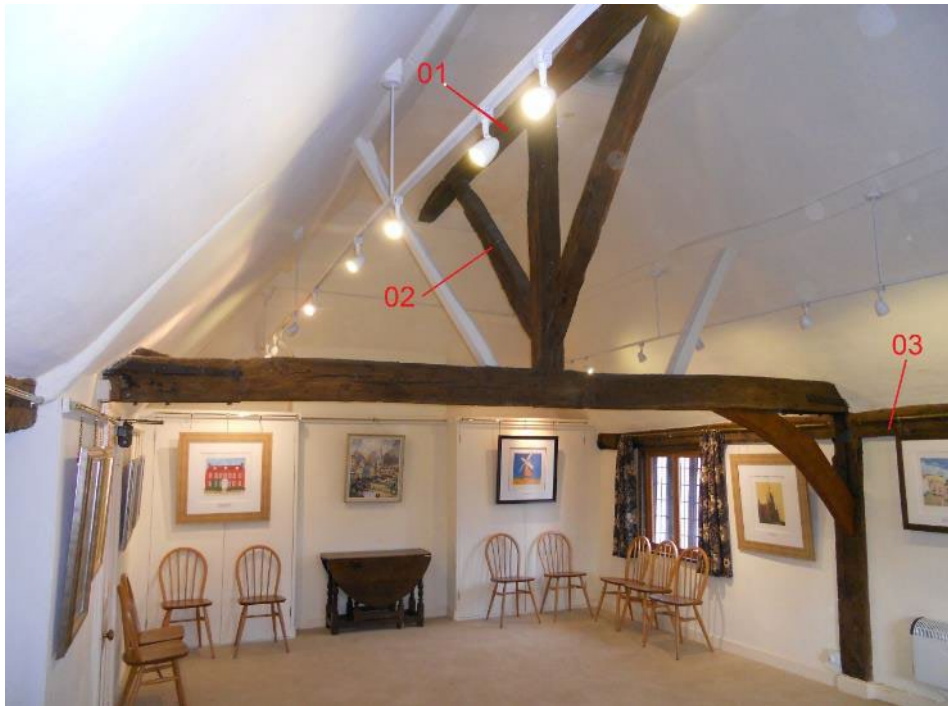
Figure 3: Photograph of the east side of the second floor looking north, showing the timbers sampled for dendrochronology (photograph Martin Bridge)

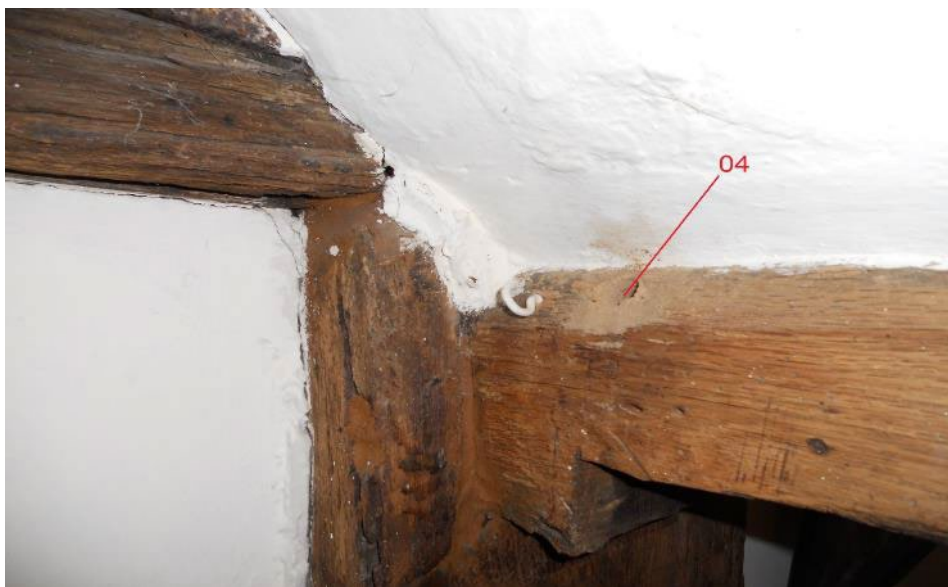
Figure 4: Photograph of the south (front) end of the central valley wallplate showing the position of coring through complete sapwood (photograph Martin Bridge)

One timber (txgh04) retained complete sapwood and was from a tree felled in the very early spring of AD 1419. Most other samples retained their heartwood/sapwood boundaries and five had some sapwood rings. It appears that the dated samples form a relatively coherent group (Fig 12), most likely felled at about the same time, although it is clear that they cannot have all been felled at exactly the same time as txgh04 was felled in AD 1419 and txgh07 and 2ETB have last measured rings of AD 1421 and AD 1422 respectively.

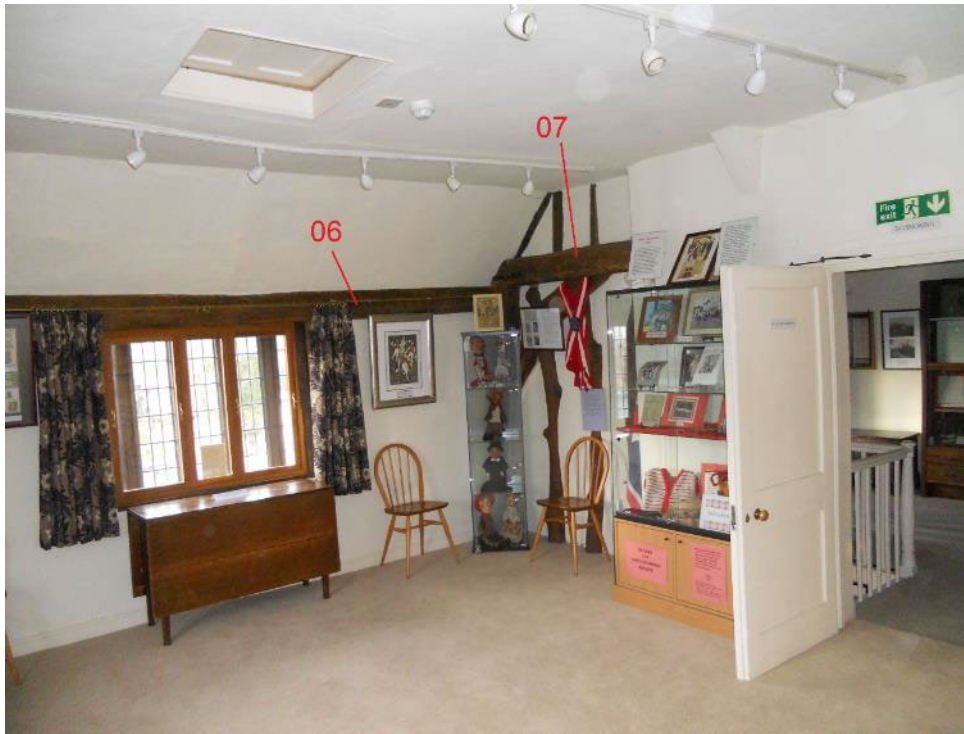
Figure 5: Photograph of the west side of the second floor, looking west, showing timbers sampled (photograph Martin Bridge)

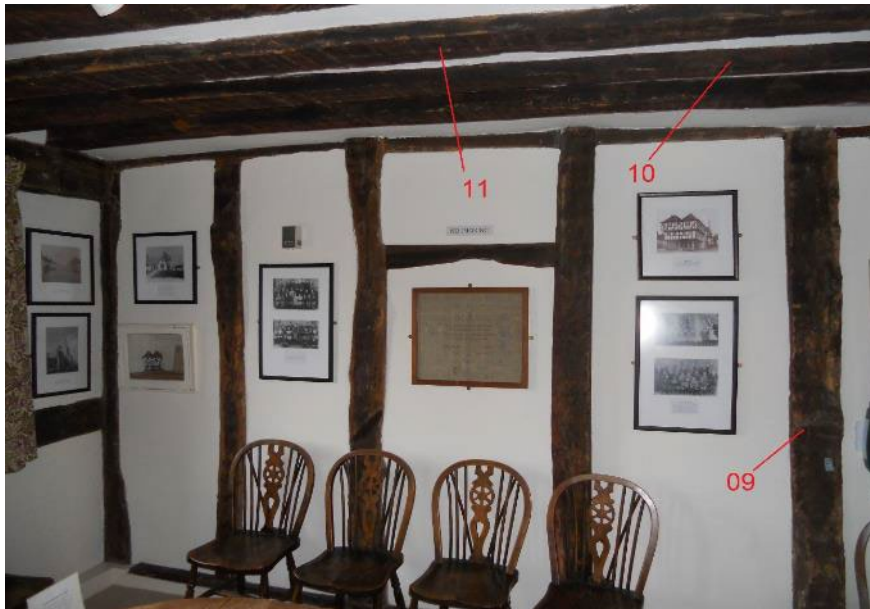
Figure 7: Photograph of the wall separating the Small Room and the Council Chamber on the first floor, showing some of the timbers sampled for dendrochronology (photograph Martin Bridge)

It is notable that the partition wall between the Small Room and the Council Chamber on the first floor contains a number of studs, some of which have mortices and trenches that do not relate to their current position, and at least some of which are likely to be re-used. The two dated by dendrochronology, however, appear to be contemporaneous with the rest of the main structure. Richard Till, author of ‘The cutlers of Thaxted 1350–1420’ (Till 2018) suspects that construction was more likely in the early part of the date range (Till pers comm) and notes that the Cutler’s Guild was at its strongest in the second quarter of the fifteenth century, but that a number of nearby properties were in a poor state of repair and being replaced at around the same time, perhaps providing some of the re-used timbers.

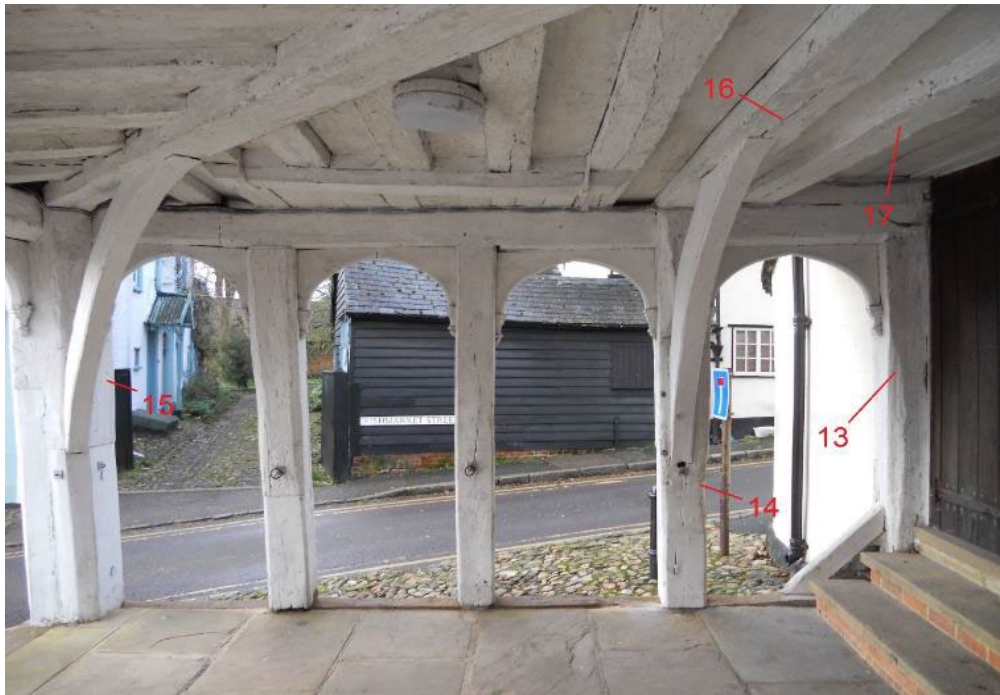
Figure 9: Photograph looking west showing some of the timbers sampled from the covered market area (photograph Martin Bridge)

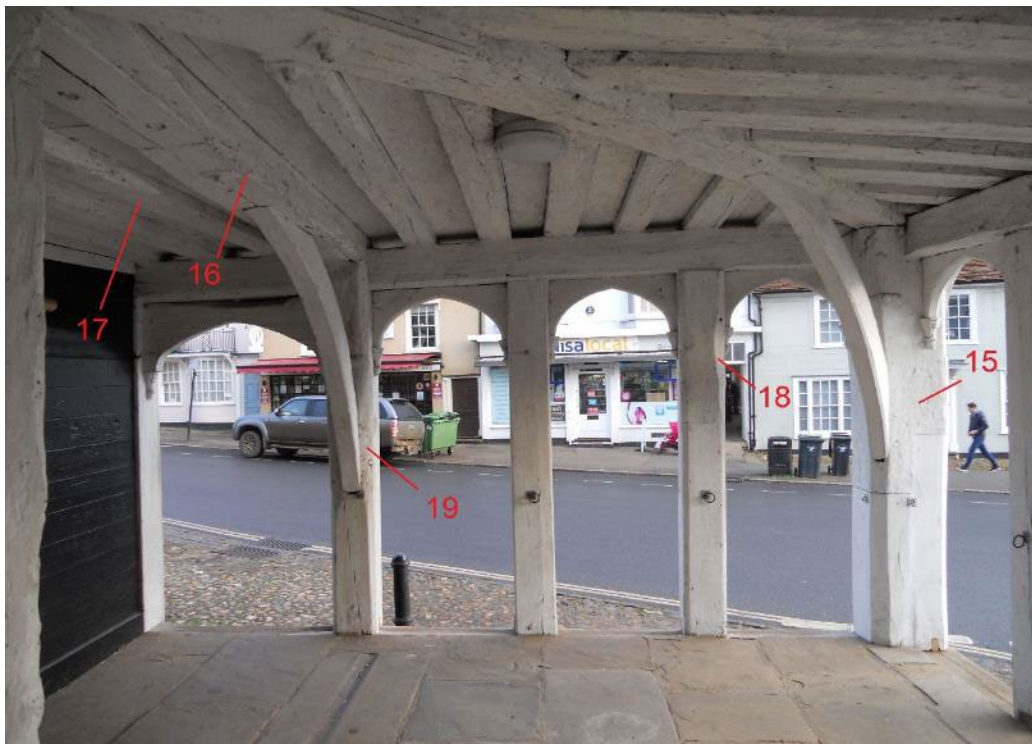
Figure 10: Photograph of the right-hand side of the covered market area showing timbers sampled for dendrochronology (photograph Martin Bridge)

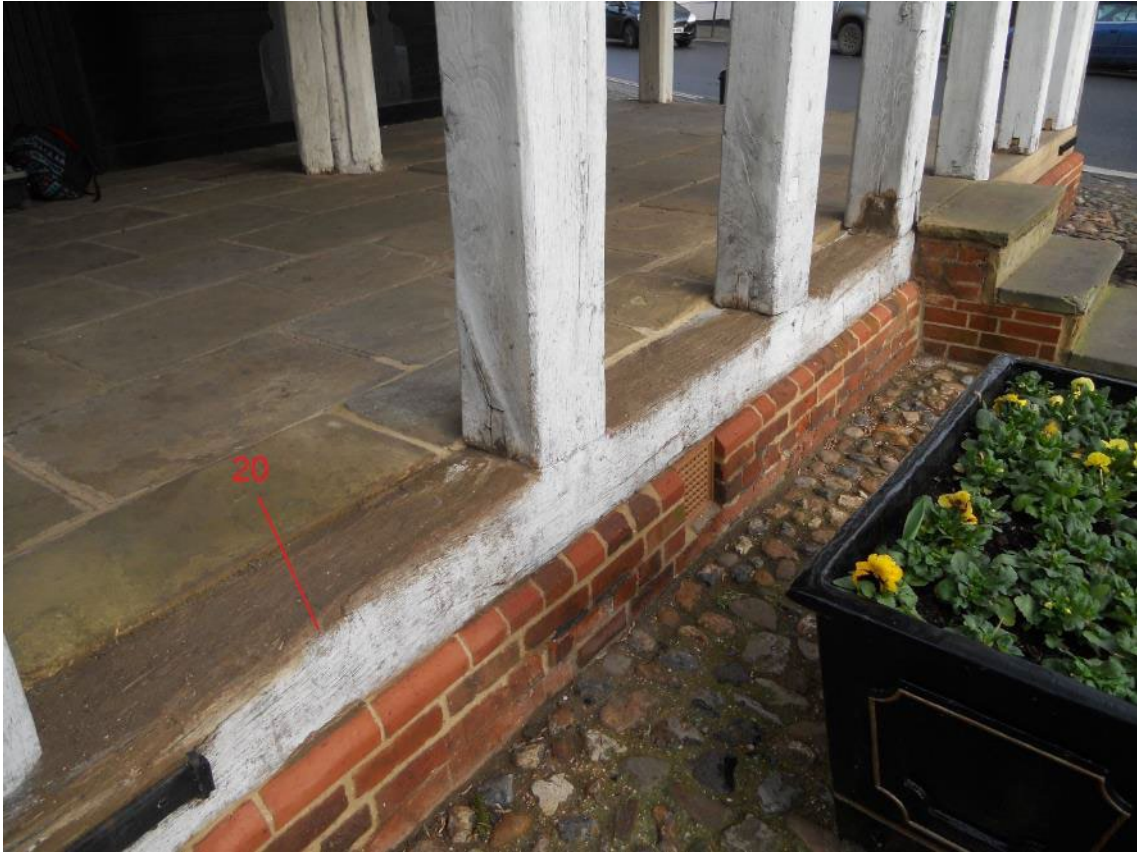
Figure 11: Photograph of the front left side of the covered market area, showing the sill plate sampled for dendrochronology (txgh20) (photograph Martin Bridge)

A total of 21 cores and one *ex situ* cross-sectional slice were obtained from various elements of this building (Table 1a; Figs 2–11). One of the cores (txgh20) and the slice (txgh21) were from the sole plate at the front of the open covered market area (site south) and are presumed to be relatively modern replacements on the basis of known repair phases. One timber (txgh10) was cored twice in an attempt to maximise the number of rings and sapwood obtained. Another sample (txgh05) had approximately 35 rings but fractured in several places and so was discarded from further analysis. Sample txgh15 contained a band of very narrow rings which could not be distinguished with certainty, so only the inner section was used in the

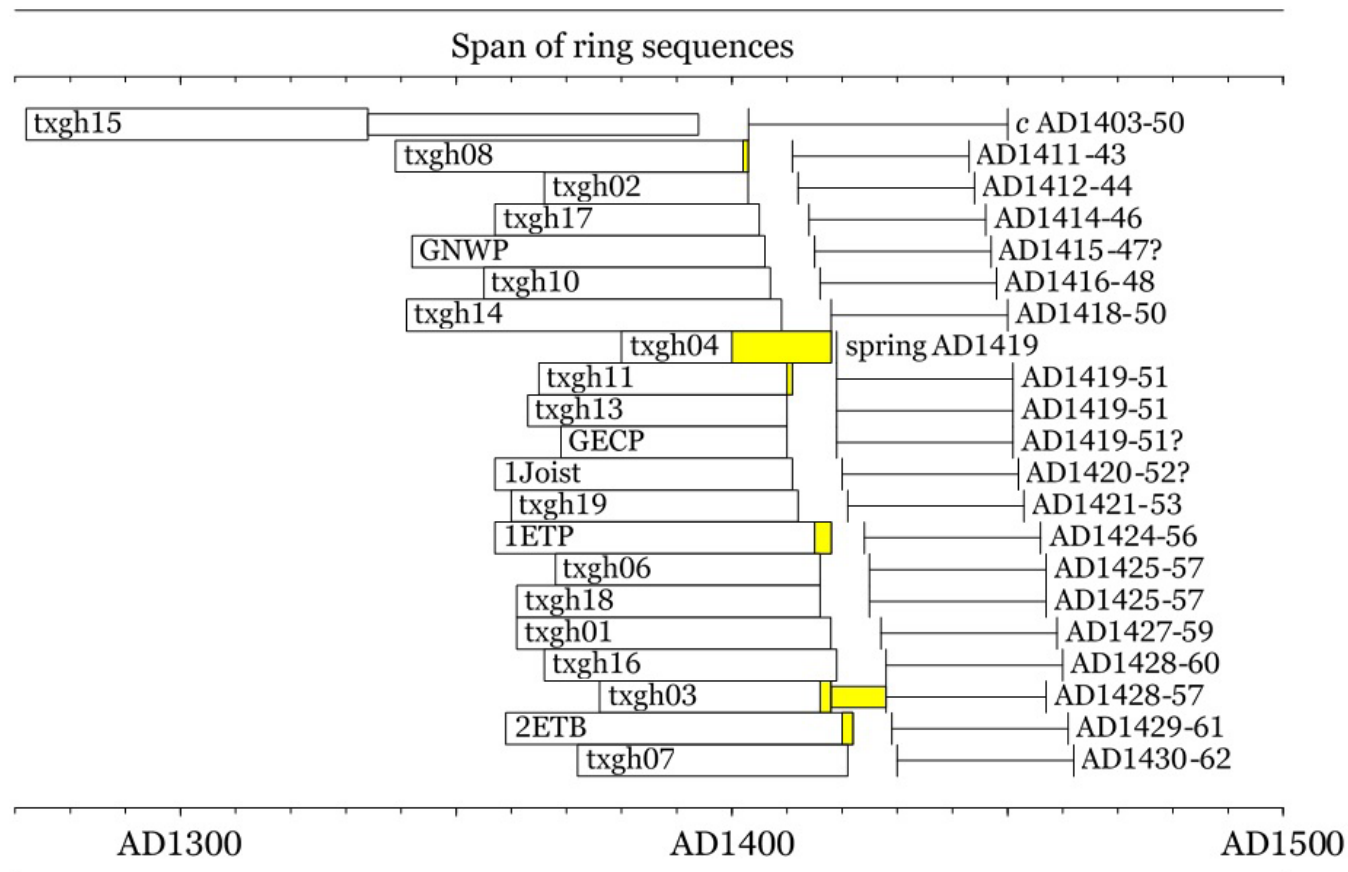
Figure 12: Bar diagram showing the relative positions of overlap of the dated samples, along with their individual interpreted felling date or felling date range, sorted by felling date/date range. White bars represent heartwood rings; yellow bars represent sapwood rings; narrow sections of bars represent additional unmeasured rings

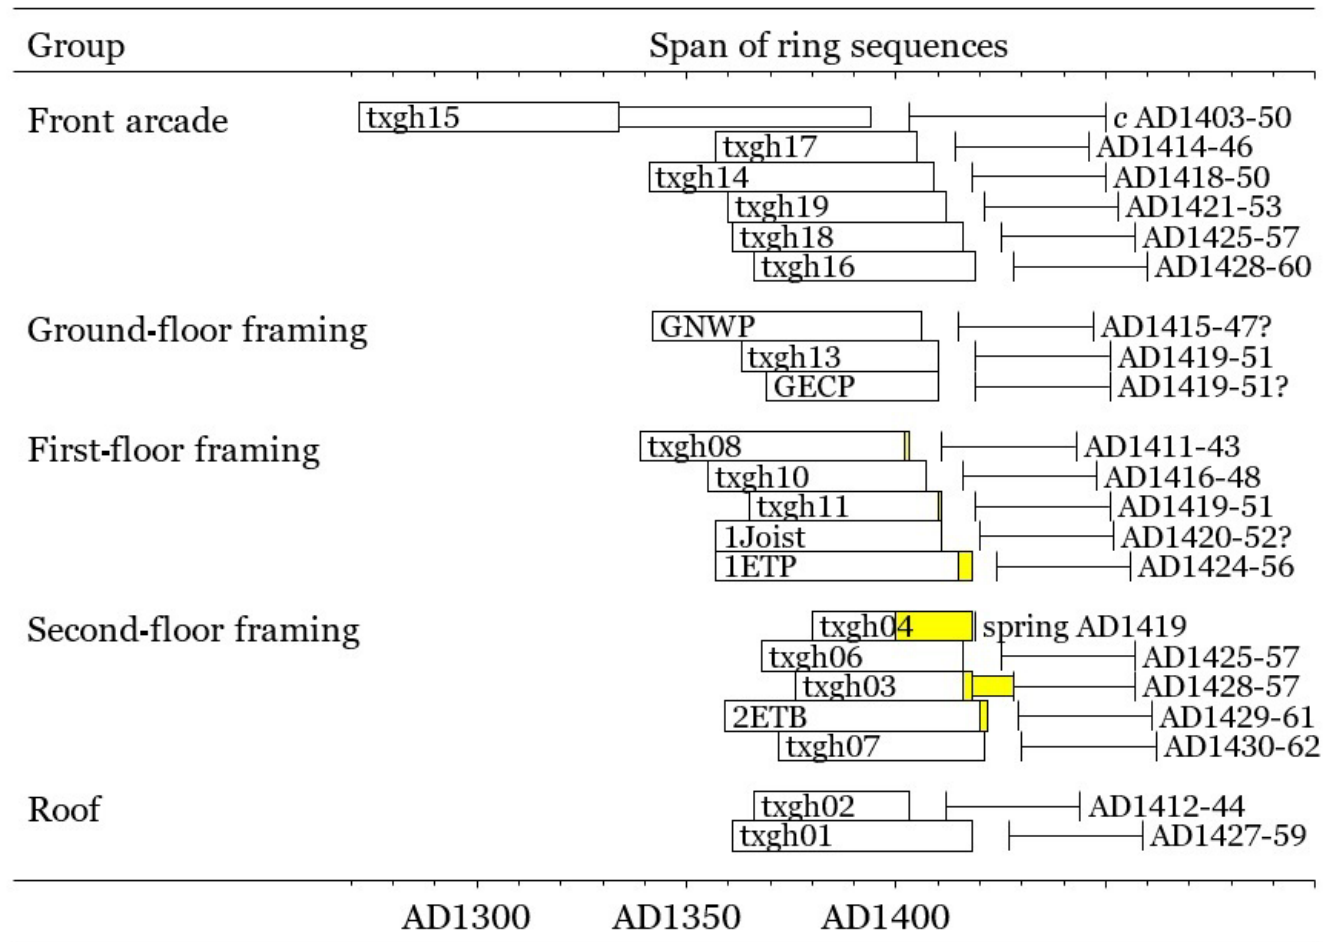
Figure 13: Bar diagram showing the relative positions of overlap of the dated samples, along with their individual interpreted felling date or felling date range, sorted by area and felling date/date range. White bars represent heartwood rings; yellow bars represent sapwood rings; narrow sections of bars represent additional unmeasured rings

The dated timbers have been sub-divided into the separate areas of the building sampled (Fig 13) to ascertain if any clear differences in date could be detected. There are clearly no striking differences in the date profiles of the groups, but perhaps it took a while for enough timbers to be gathered for this extensive building with felling having been carried out over a number of years and some timbers being
